Sanitary Sewer System Infiltration & Inflow Study

November 09, 2020

City of Mineral Point Wastewater Treatment Facility

Delta 3 Engineering, Inc.

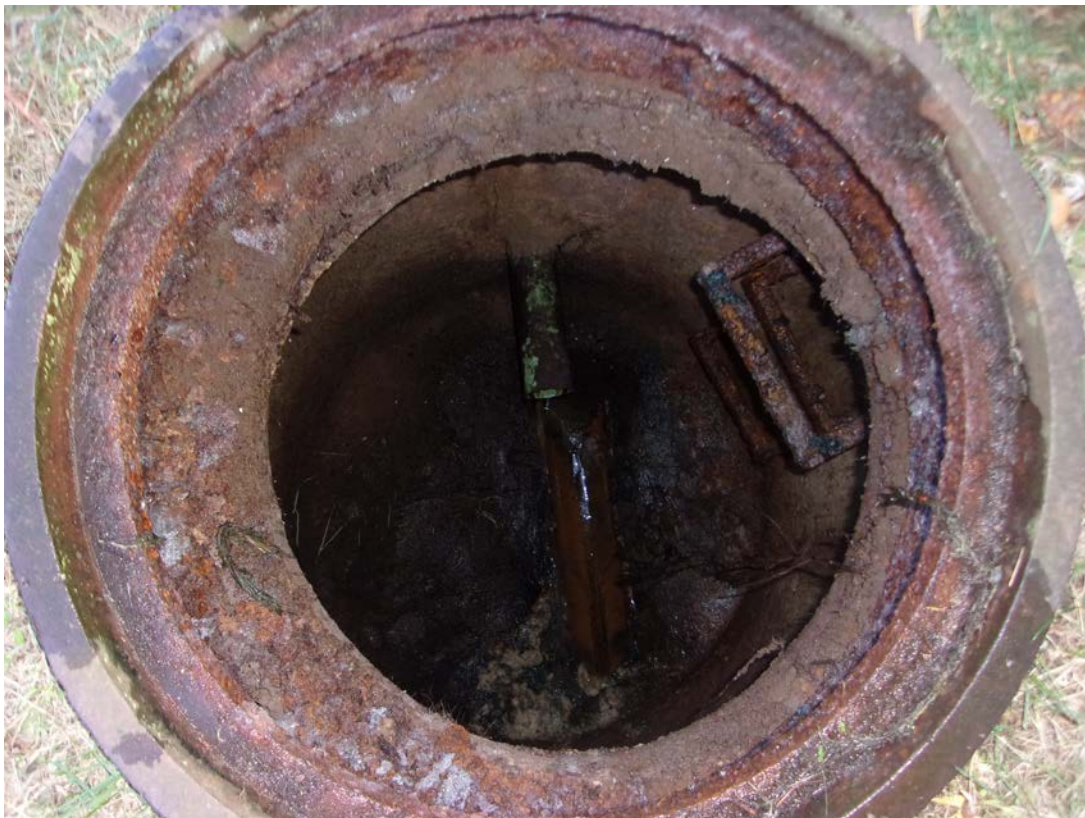
Figure 2.1 – MH44J received an overall rating of 2.0 due to a slid open pick casting, no seal, cracked adjustment rings, roots in structure, and no structure bottom.

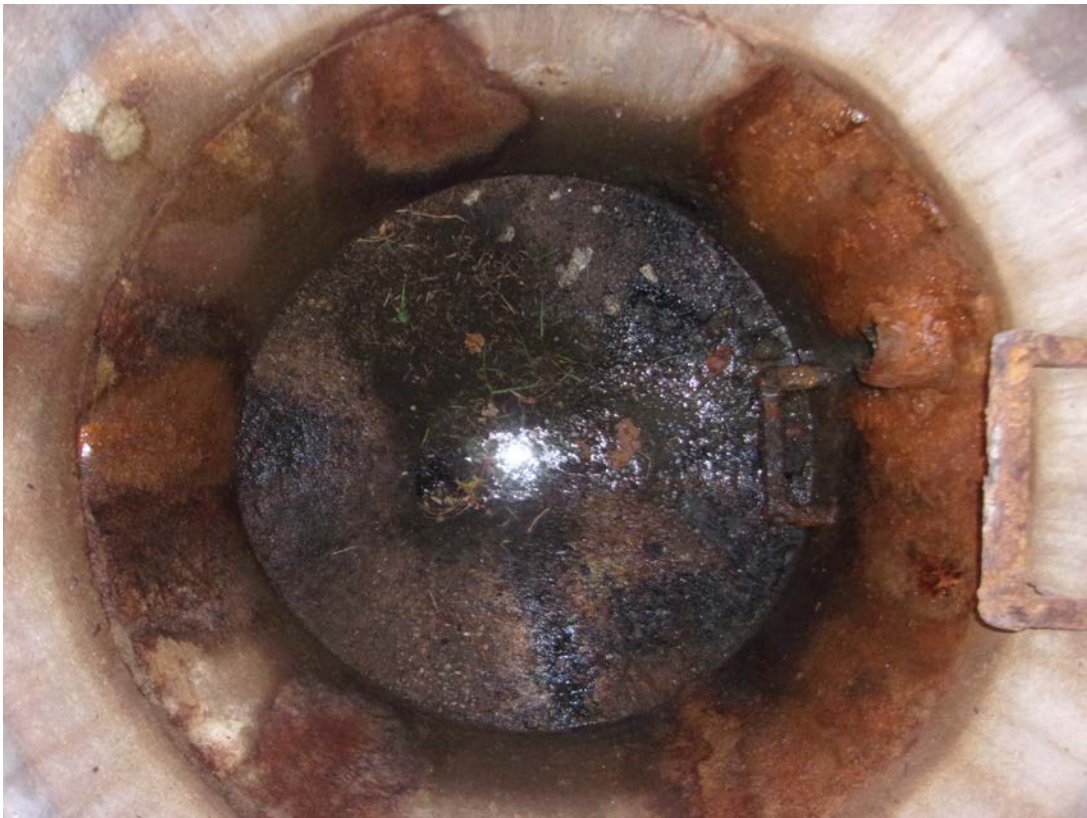
Figure 2.2 – MH13A received an overall rating of 0.0 due to a slid open pick casting that is in a low spot, no seal, mineral deposits, and no structure bottom.

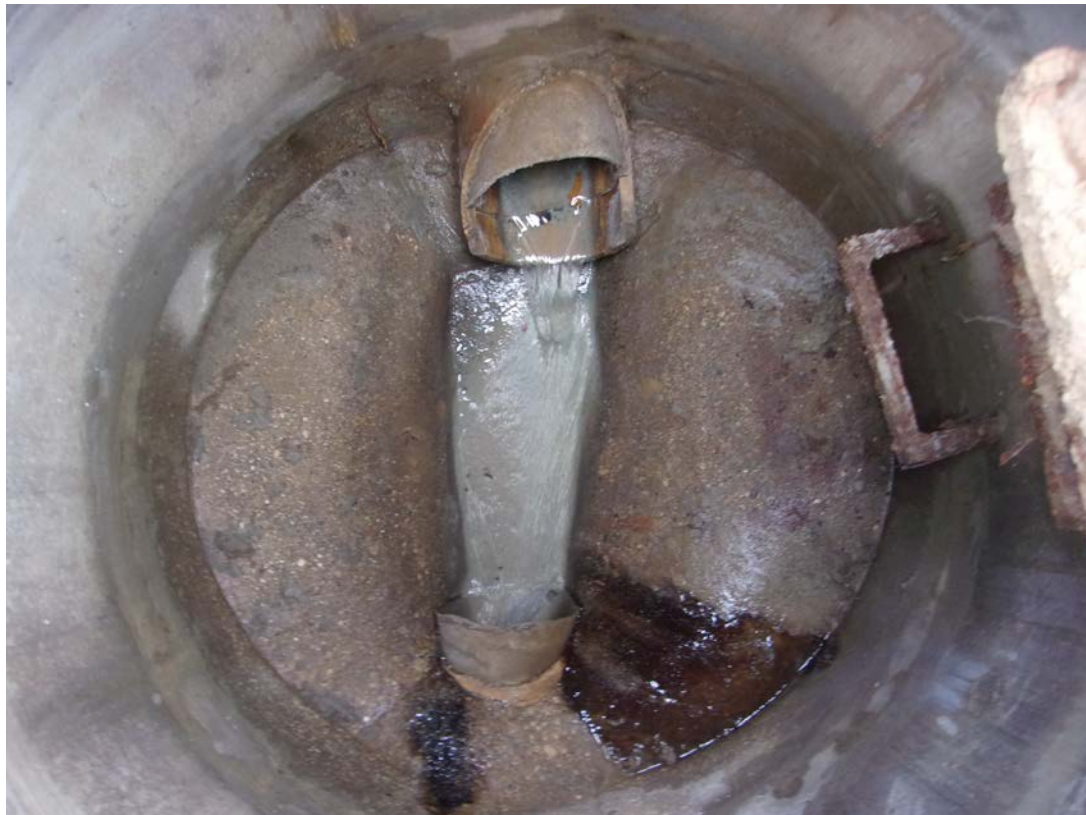
Figure 2.3 – A leaking structure was observed at MH50 resulting in an overall rating of 0.0.

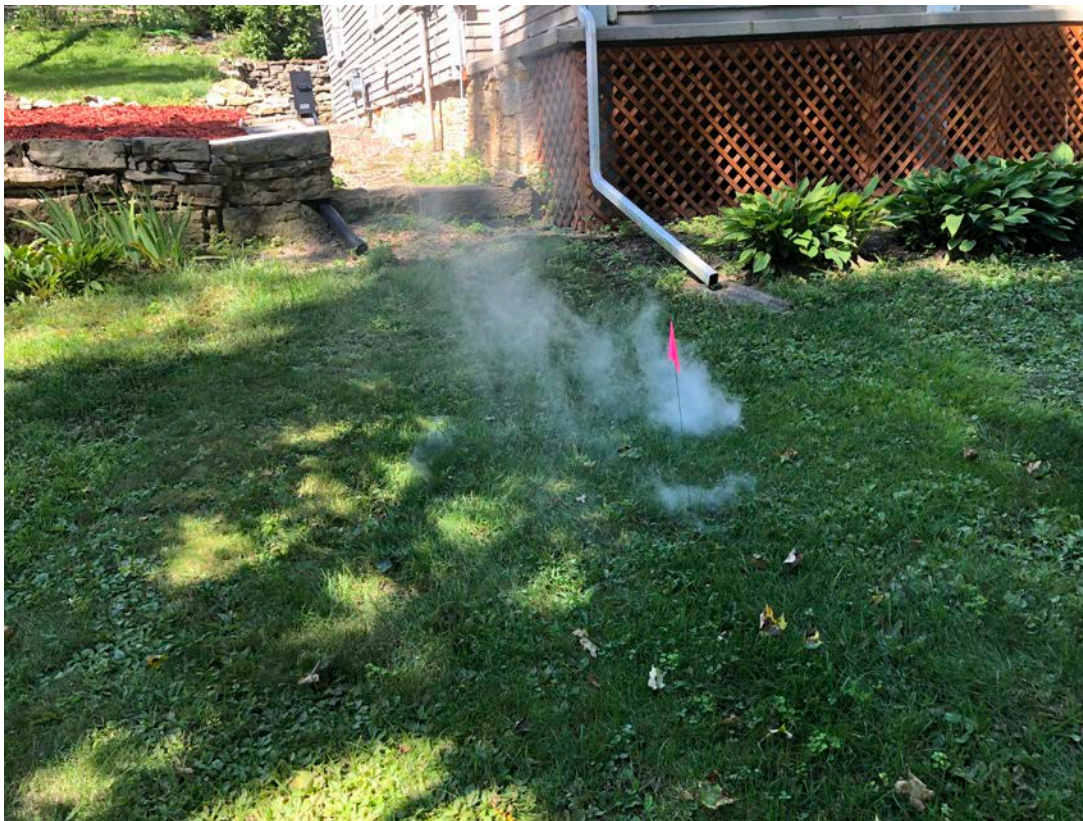
Figure 2.4 – Broken sewer lateral at 250 Shakerag Street.

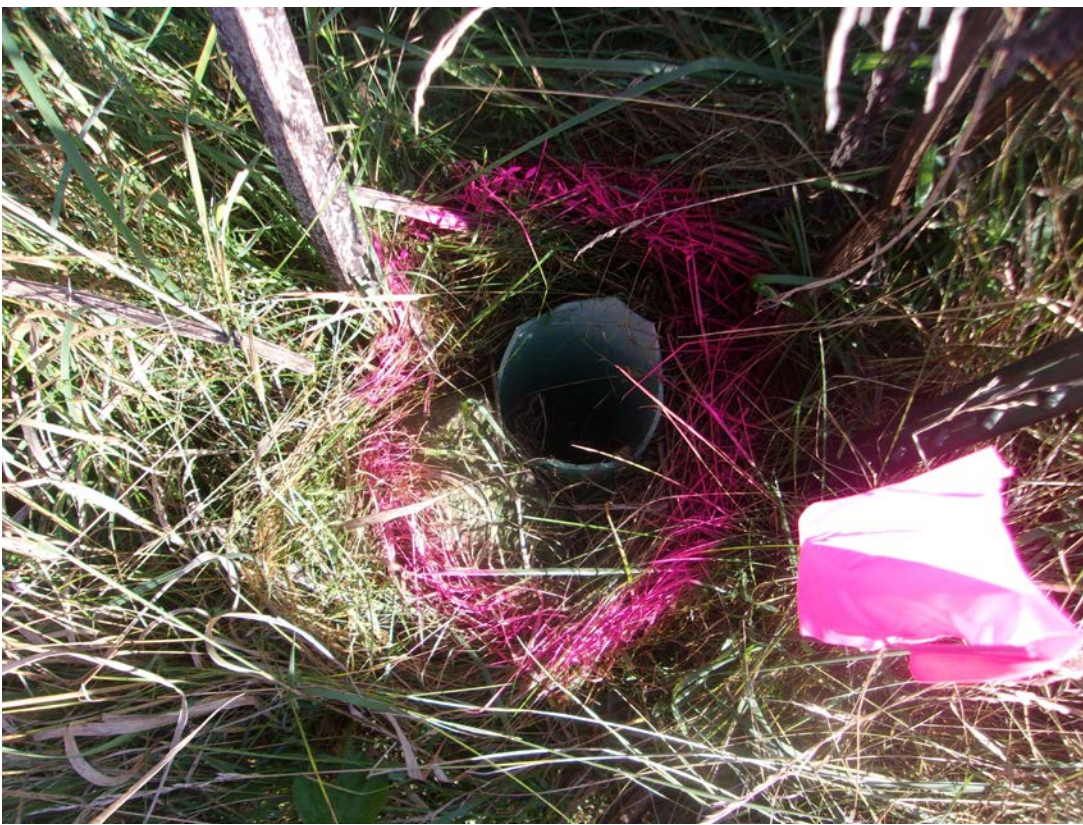
Figure 2.5 – Uncapped 6" cleanout at 3000 Business Park Road.

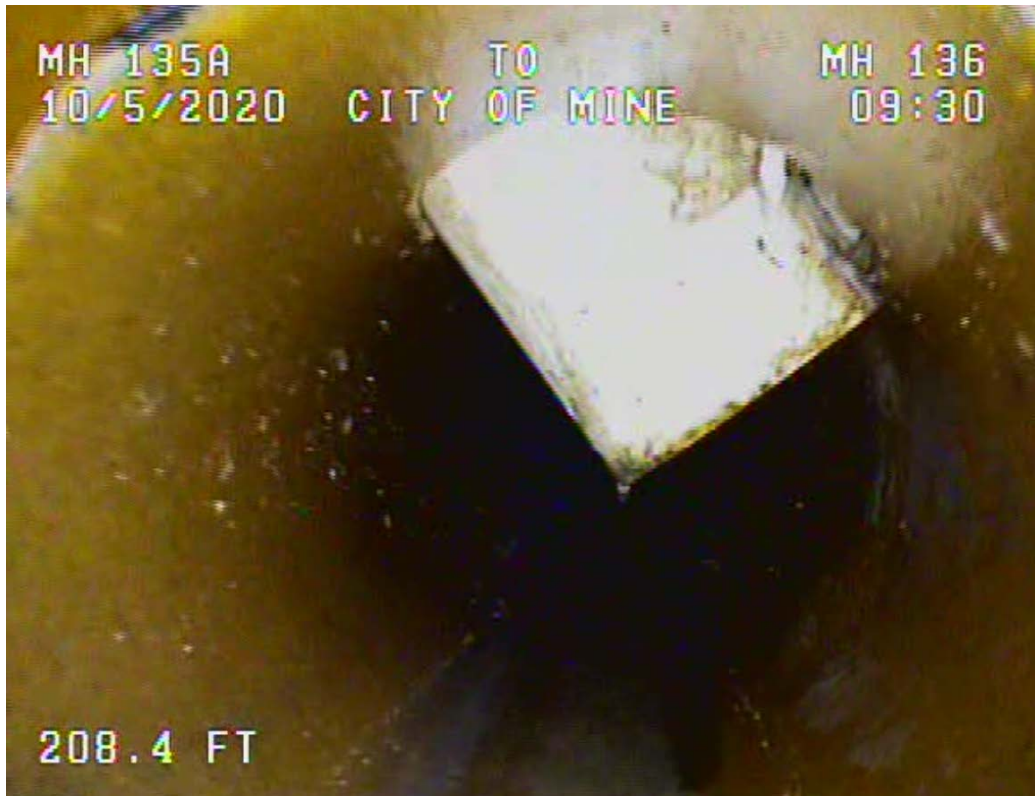
Figure 2.6 – Protruding sewer lateral located between MH135A and MH136.

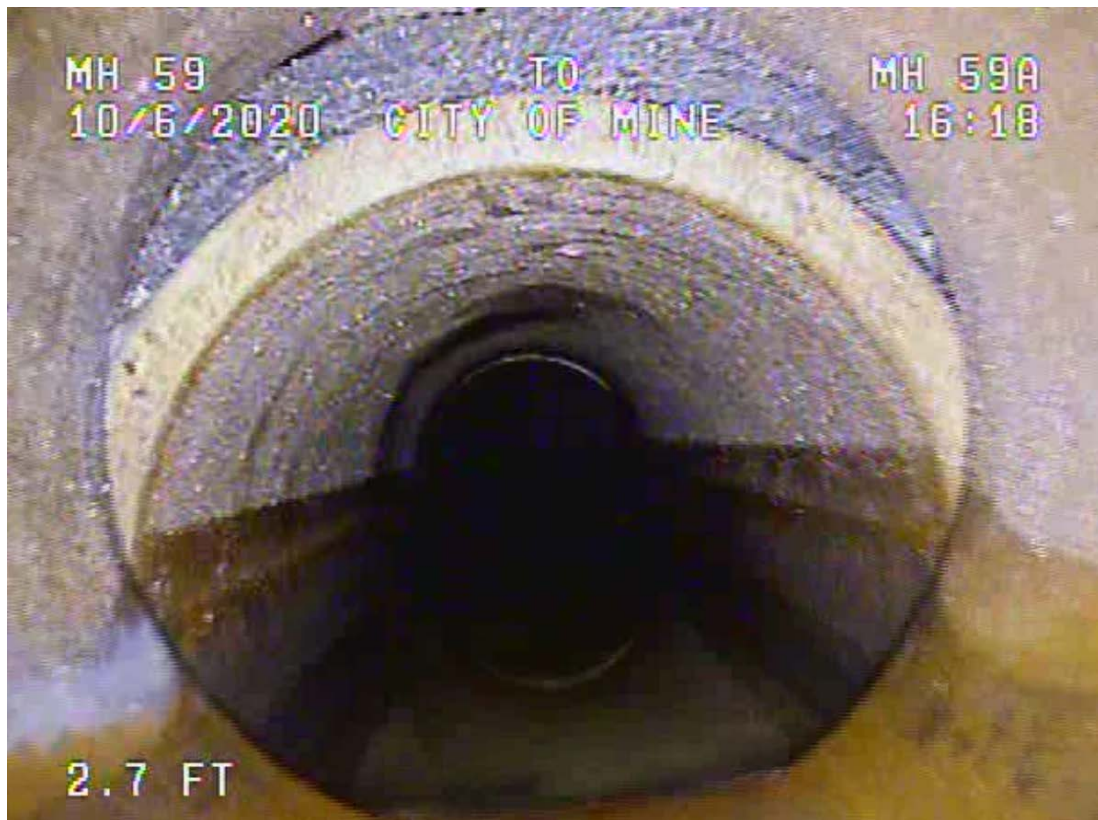
Figure 2.7 – Offset joint with visible void located between MH59 and MH59A.

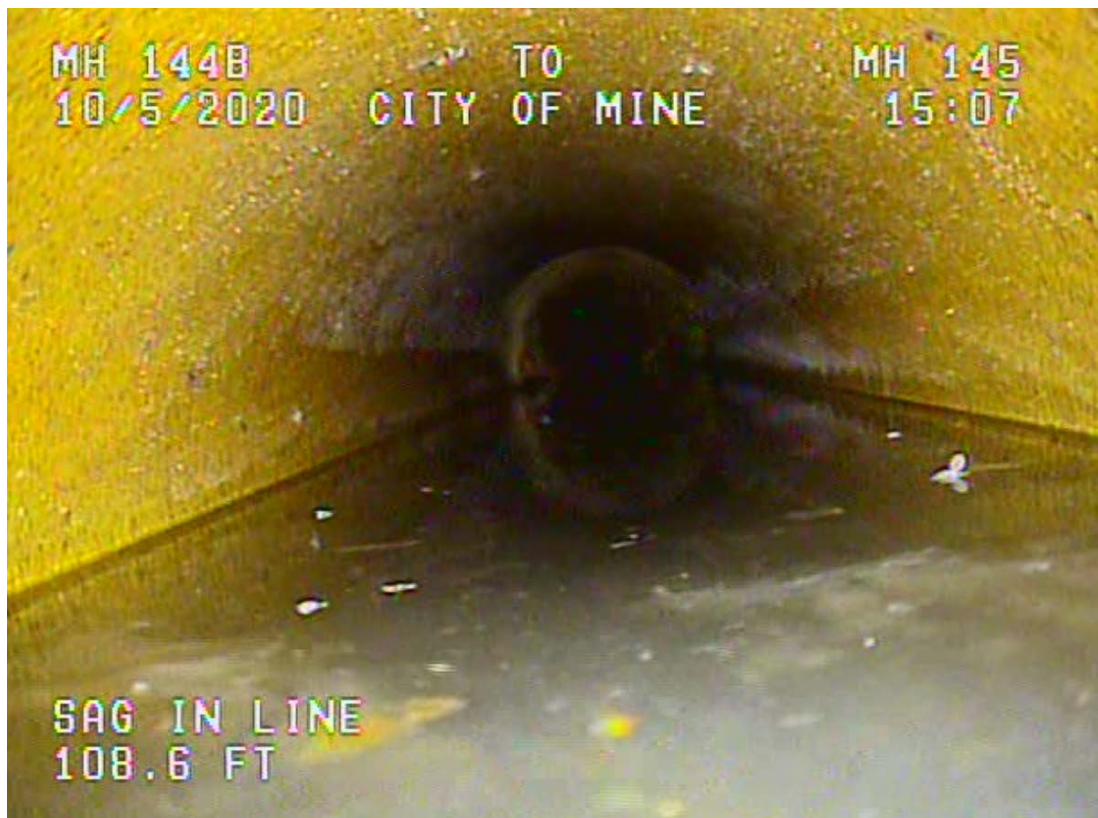
Figure 2.8 – Sag in sewer main between MH144B and MH145.

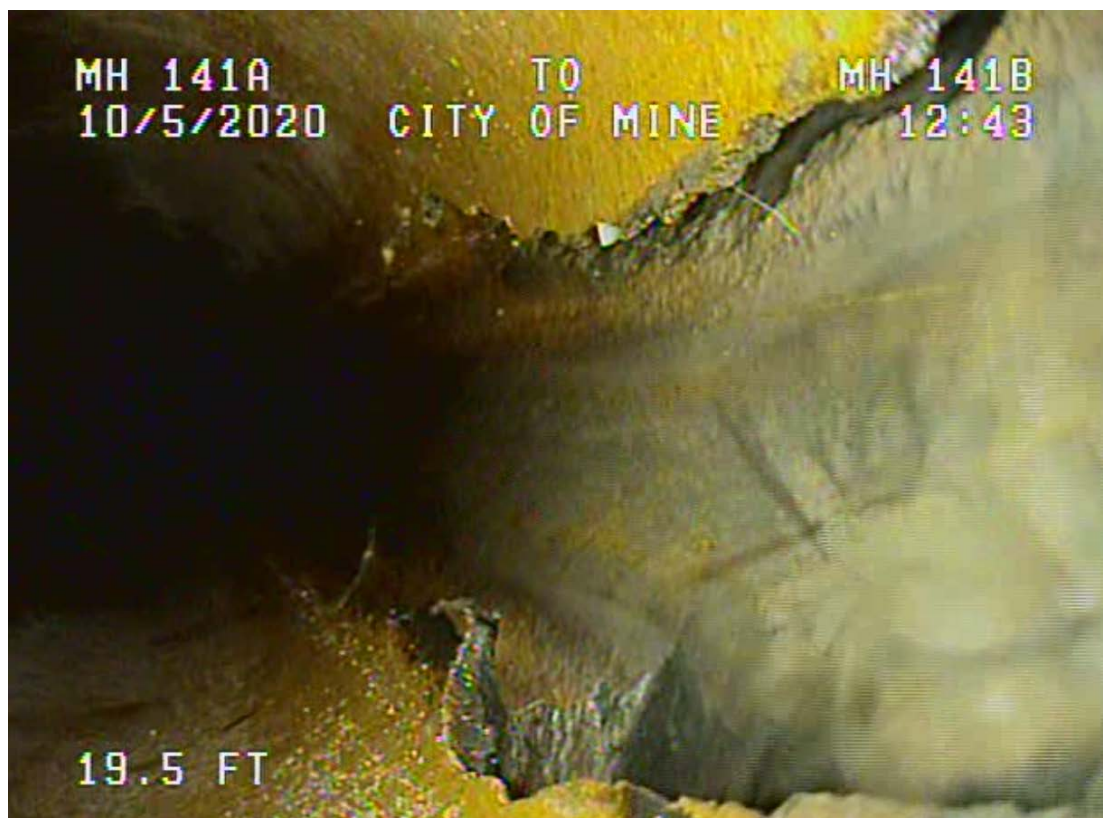
Figure 2.9 – Fractured pipe with visible voids between MH141A and MH141B.

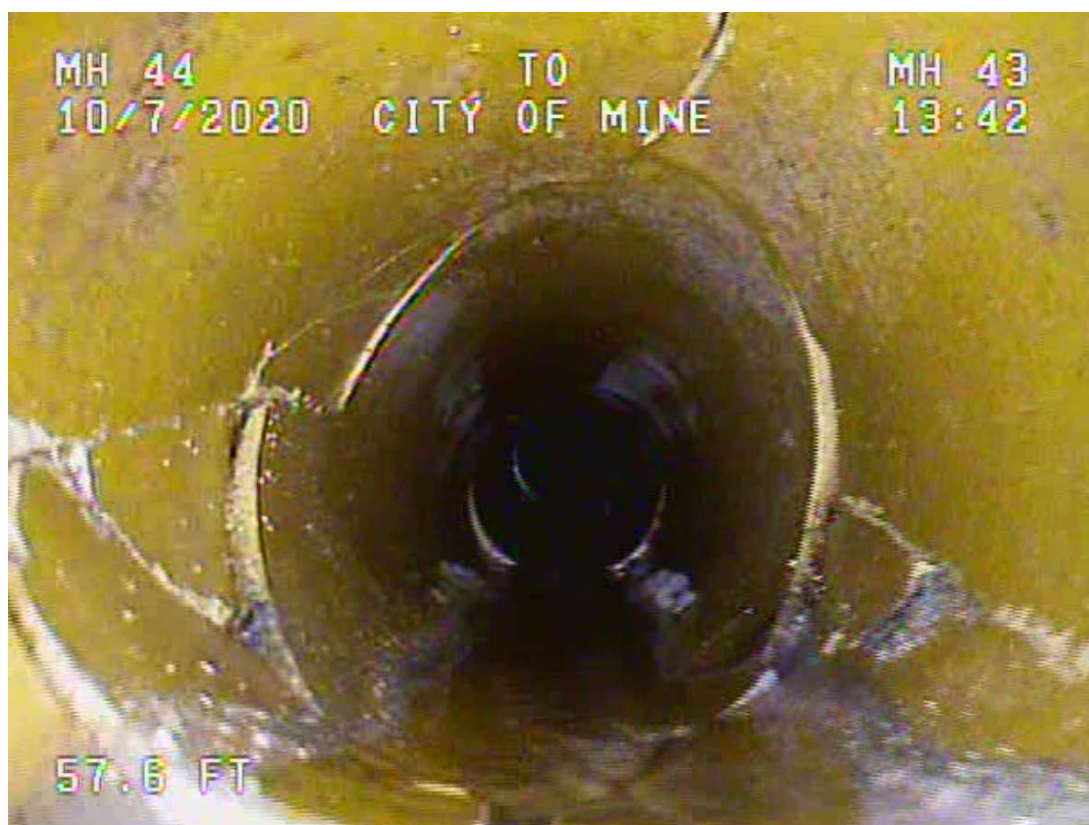
Figure 2.10 – Severely cracked sewer main located between MH43 and MH44.

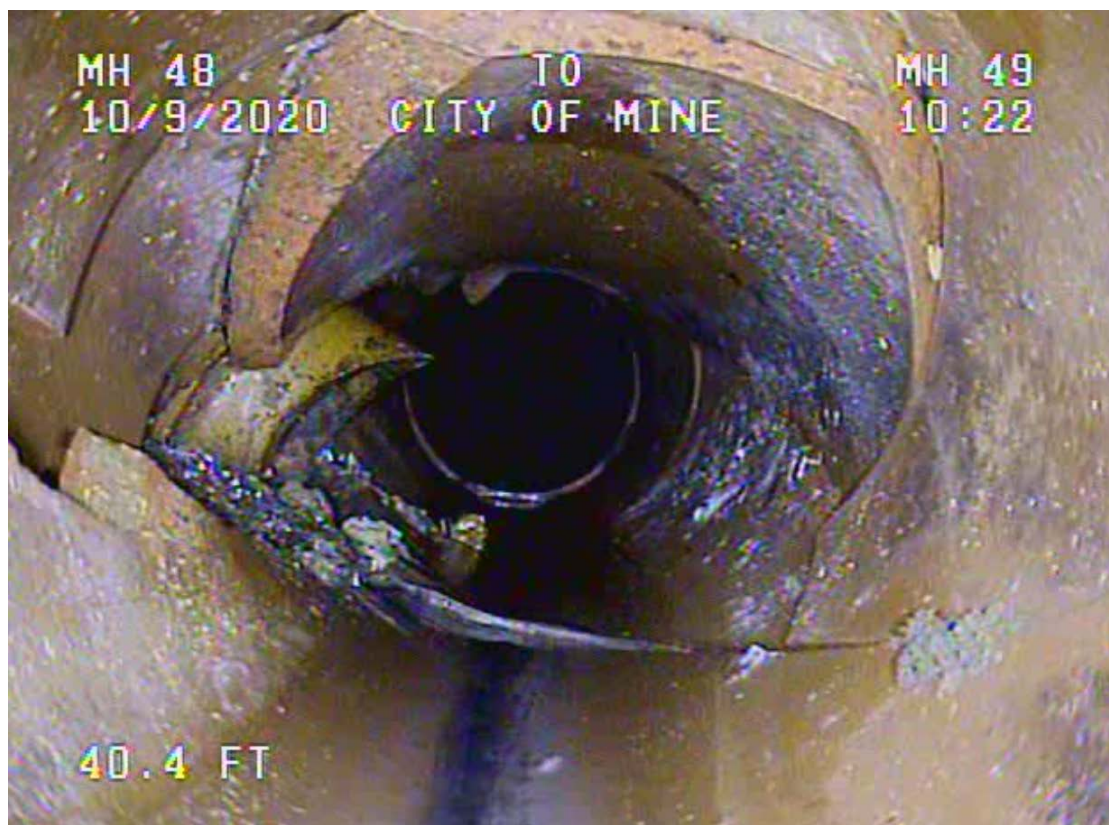
Figure 2.11 – Fractured sewer main located between MH48 and MH49.

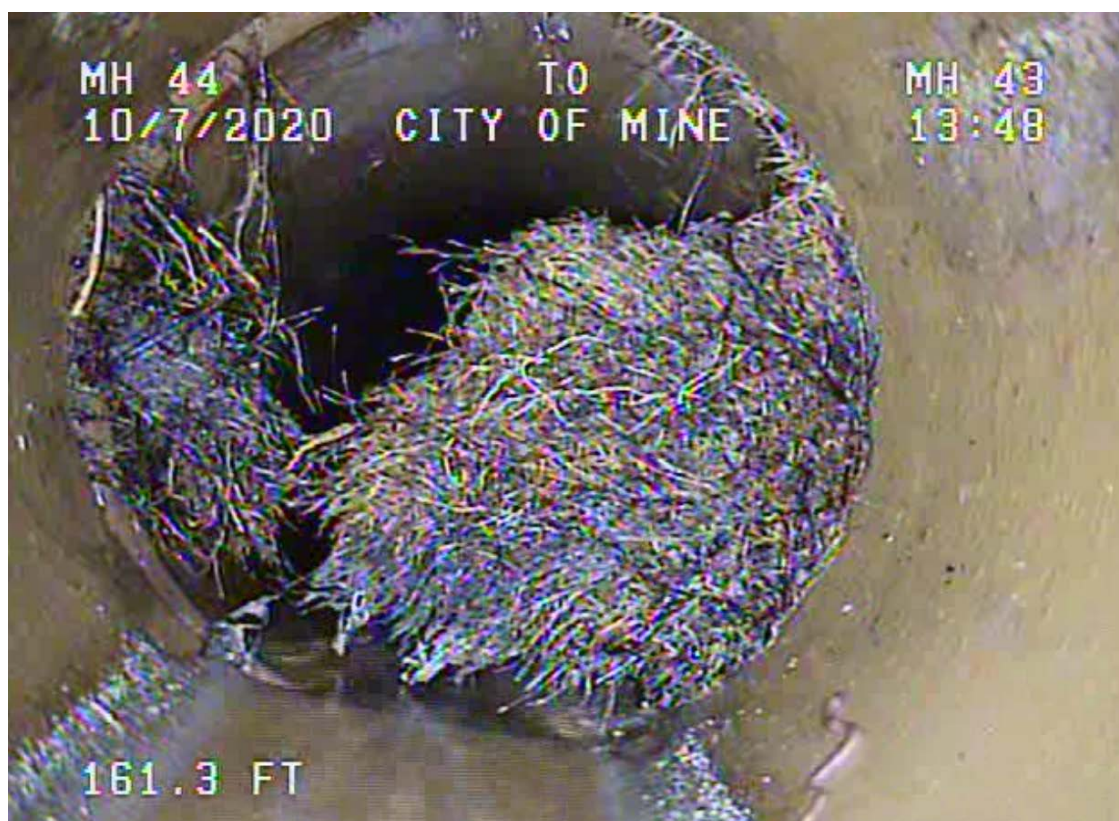
Figure 2.12 – Significant roots in sewer main located between MH44 and MH43.

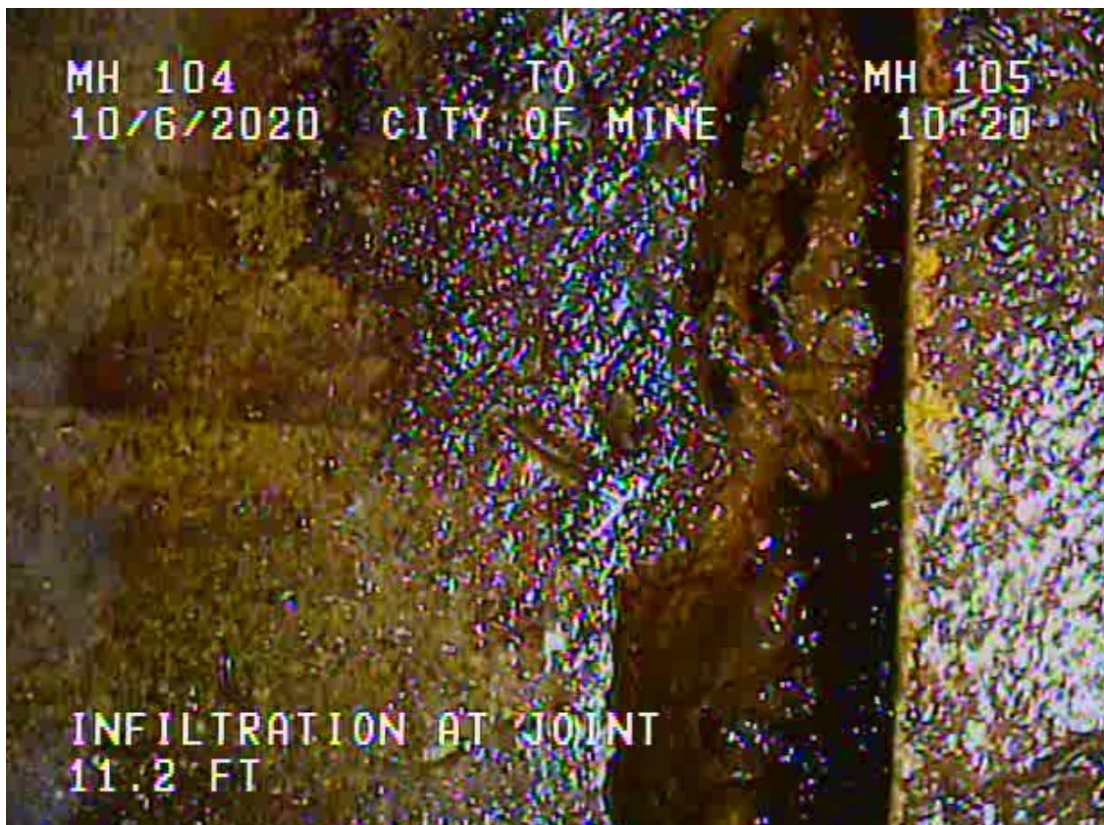
Figure 2.13 – Infiltration at joint in sewer main located between MH104 and MH105.
