EXISTING CONDITIONS
ASSESSMENT UPDATE

FEASIBILITY STUDY REPORT

THORNE MEMORIAL BUILDING

MILLBROOK, NEW YORK

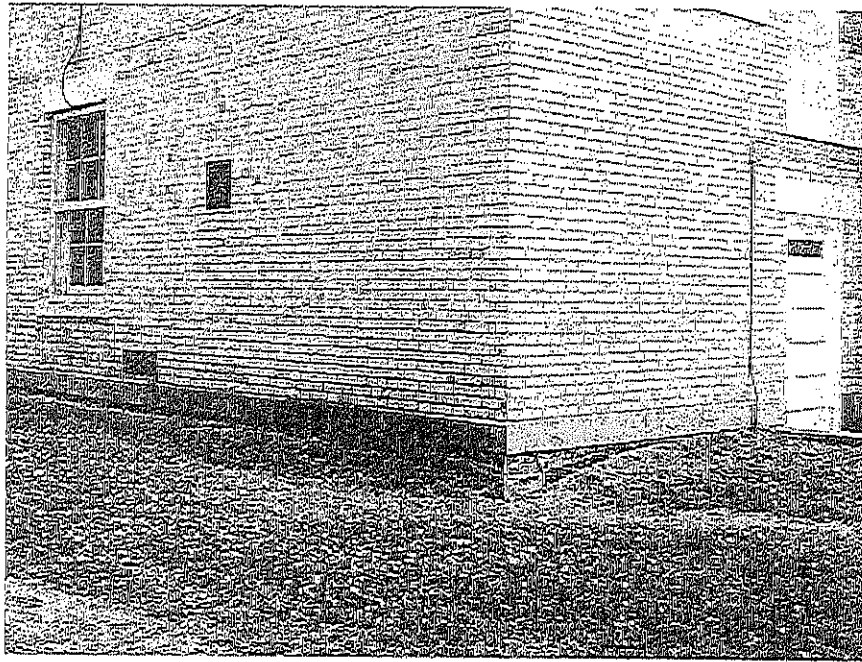
- The ground pitches toward the west end of the building; water collects near the foundation as a result of the gutter overflow. This has caused masonry staining and severe water infiltration to the basement. (*Photo #1*)

Photo #1 - Water overflowing the displaced gutter in the northwest corner has caused severe soil erosion that has resulted in the grade pitching back towards the building. Backsplash from the ground has also stained masonry surfaces and damaged mortar joints. Note the expedient but unsightly surface run conduit emerging from the window head on the left and around the door on the right.

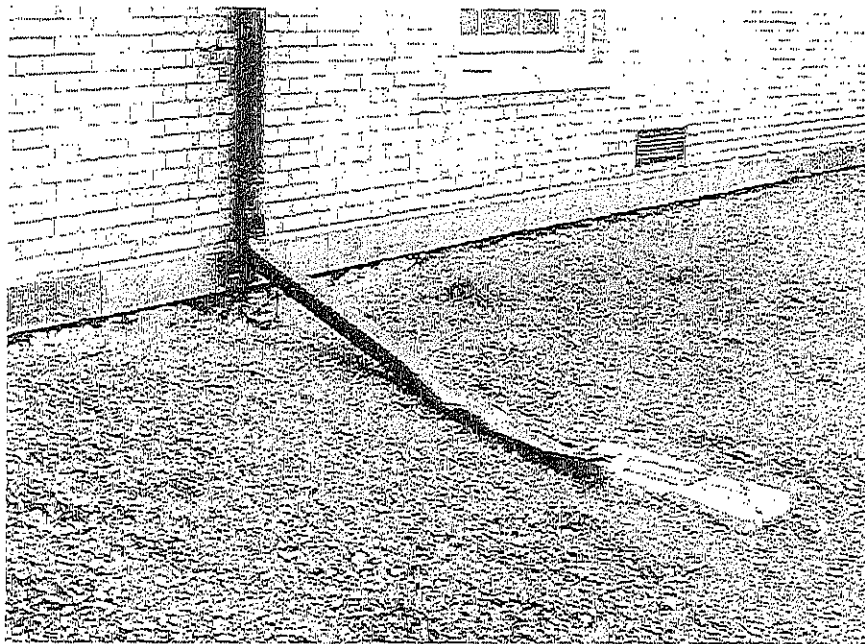
- The metal downspout extension at the base of the building is bent and smashed. The concrete splash block is also cracked and broken, and is inadequate for diverting runoff away from the building. (*Photo #2*)

Photo #2 - A crushed leader extension on the north wall has the potential of causing roof run-off water to back-up in the leader and water infiltration. Note water and rust staining behind the leader on the brick.

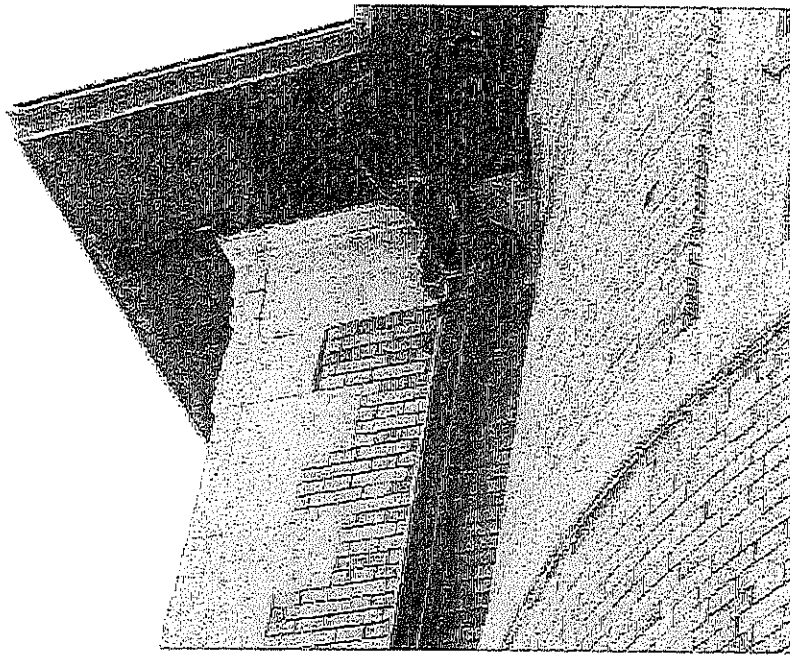
- Mortar between masonry joints is deteriorated, missing and have been improperly repointed.
- Corner stones below the southwest corner have shifted out of place. (*Photo #3*)
- The marble entablature below the copper cornice is rust stained, possibly from water infiltration and contact with the concealed support of the cornice. (*Photo #4*)
- The marble trim around the entry doors and sidelights has rust stains.

Photo #3 - The upper stones have shifted out of place, allowing water to infiltrate the interior.

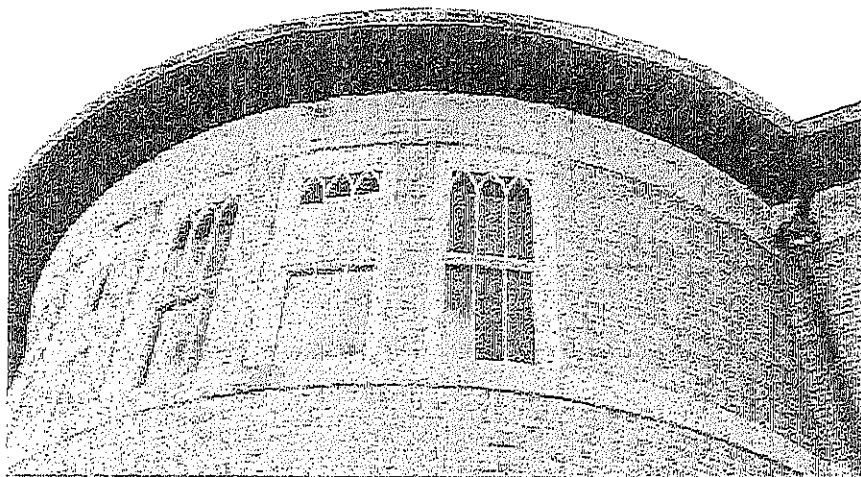
Photo #4 - Staining of marble fascia above second floor windows on the east elevation indicates failures in roofing and gutter systems above.

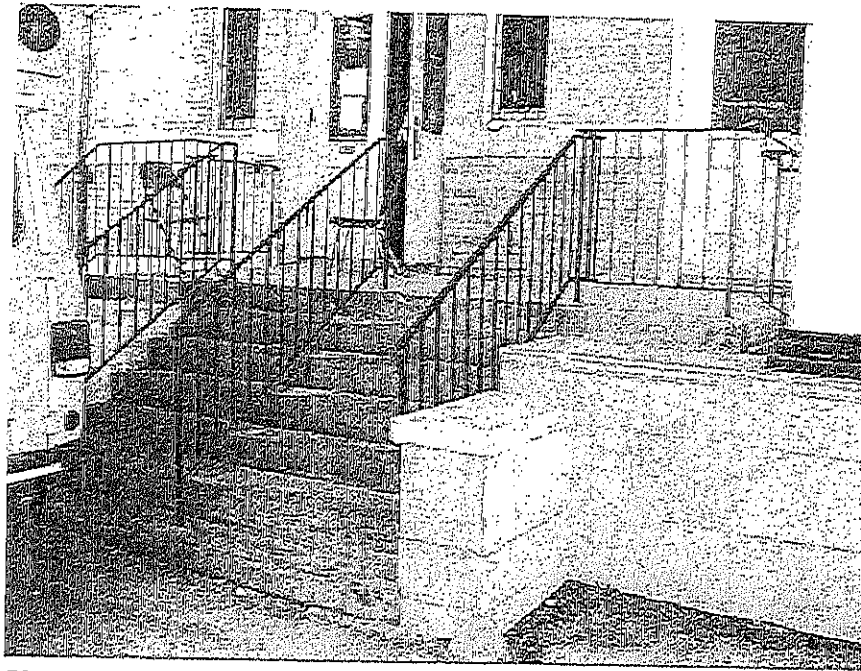
- Several panes of glass are cracked.
- Some of the marble blocks that make up the cheek wall facing below the carriage porch columns are cracked.
- Mortar joints between the marble blocks of the carriage porch are deteriorated and have been improperly pointed. (*Photo #5*)

Photo #5 - Open mortar joints in marble walls and open joints between bluestone steps and marble cheekwalls provide access for water infiltration. The concrete slab poured to raise the level of the porch floor for handicapped accessibility is incompatible with the historic stone materials of the stair structure.

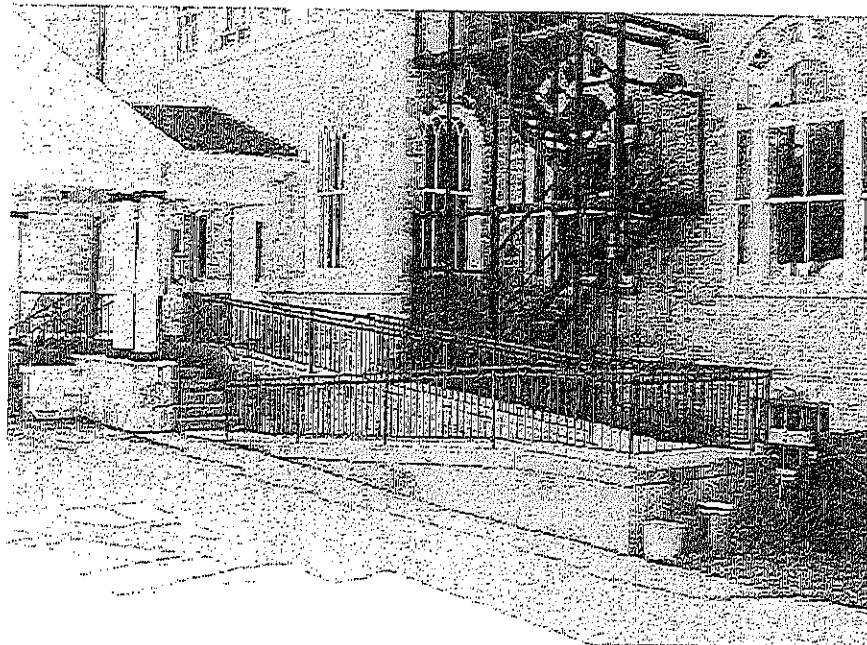
- The metal fire escape and concrete platform are later added features and are visually intrusive. (*Photo #6*)
- Masonry surfaces are generally dirty and severely rust-stained adjacent to the fire escape.

Photo #6 - The metal fire escape on the east elevation has caused substantial rust staining on the masonry walls.

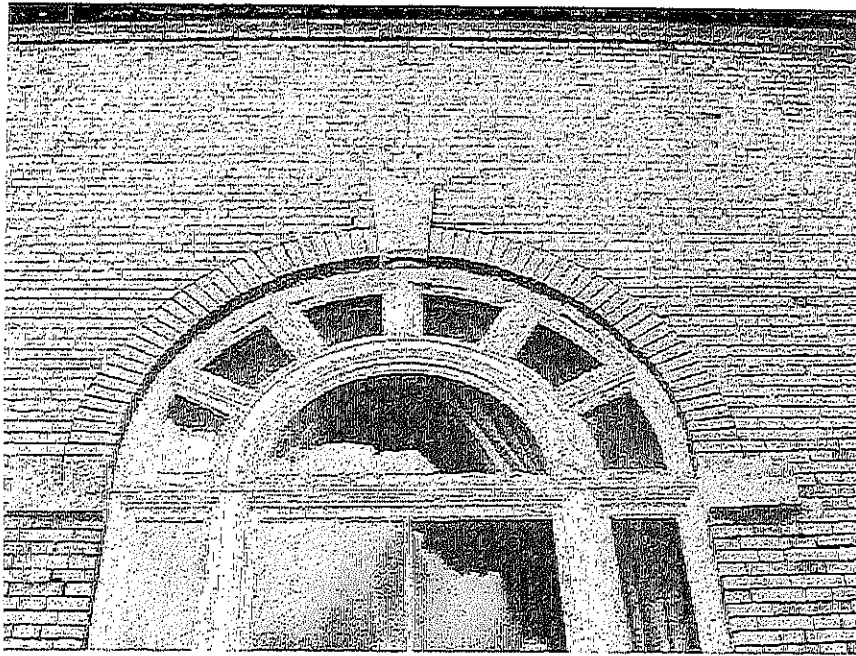
- Masonry mortar joints are deteriorated, missing and have been improperly repointed. (*Photo #7*)
- The southern section of the original roof edge and cornice has been cut back and removed, and replaced with a red brick parapet wall constructed to assist in supporting the metal fire escape at the roof level.

- Some molded bricks in the brick course above the basement windows are spalled, while some have been replaced with inappropriate concrete patches.
- Paint on window frames and sash is deteriorated, exposing the wood substrate. Glazing putty is also deteriorated. (*Photo #7*)

- Wood window frame and sash components are loose and several small pieces are missing. (*Photo #7*)

Photo #7 - Deteriorated paint, loose wood trim, open mortar joints, and missing sealant in the joint between window frame and brick openings permit water and air infiltration.

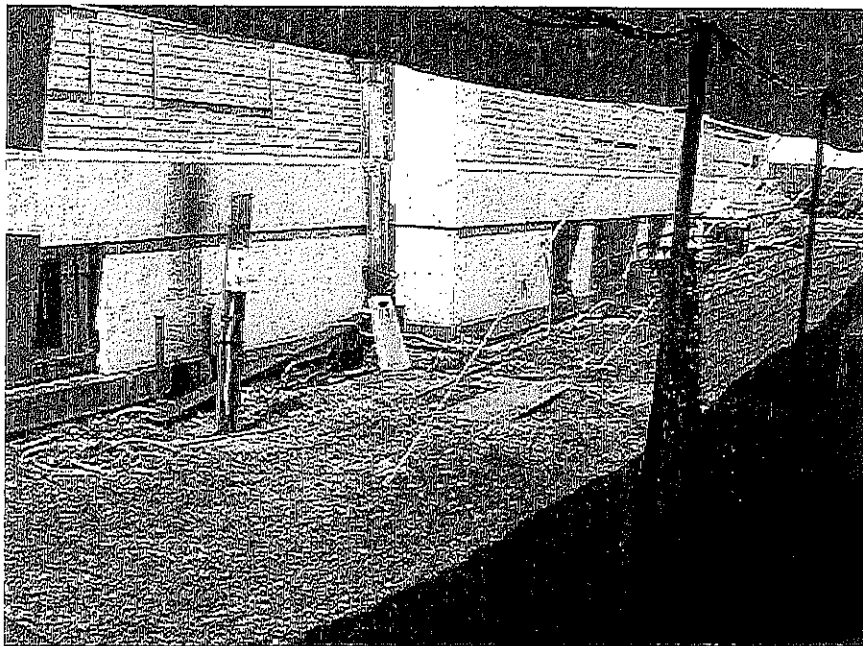
- Several panes of glass are cracked.
- Sealant in joints between window frames and surrounding masonry openings is deteriorated and missing.
- Several air conditioning units are visually obtrusive and are creating water stains on the masonry below. (*Photo #8*)

- The grade pitches towards the building, directing drainage towards the foundation. (*Photo #8*)

Photo #8 - Condensate water from the window air conditioning unit above is staining the marble foundation of the south wall. The leader extensions are typical attempts in directing roof drainage away from the foundation. Although this extension has been temporarily relocated to make room for the tent, the extensions are generally ineffectve since in many places the grade slopes towards the building, directing water toward the basement.

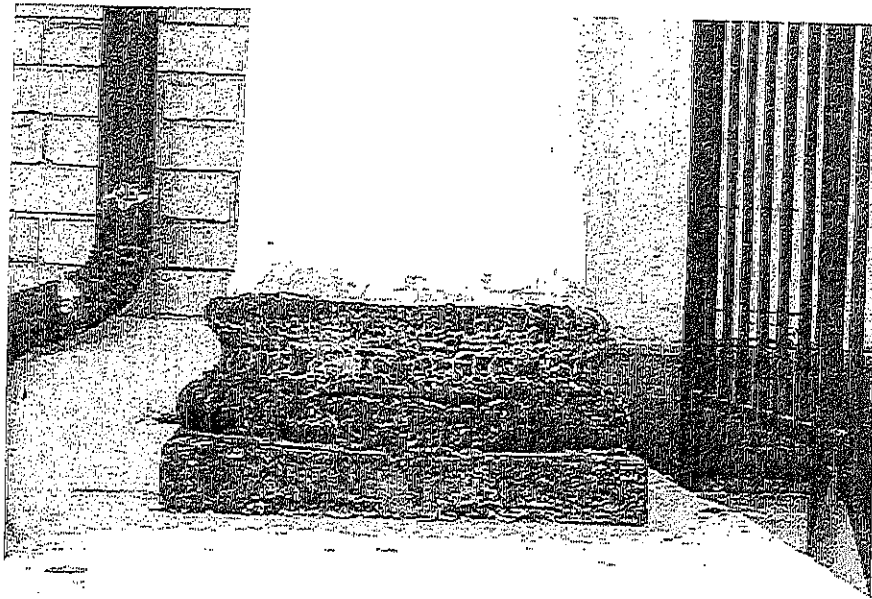
- Vines growing on the masonry along the north side of the entry hold damaging moisture against the wall.
- The paint on the entry porch columns is deteriorated, exposing the wood and metal (column capitals and bases) substrates. (*Photo #9*)

Photo #9 - Deteriorated paint on the cast-iron column base, west entry porch. Note paint deterioration on the base of the column shaft just above the base unit.

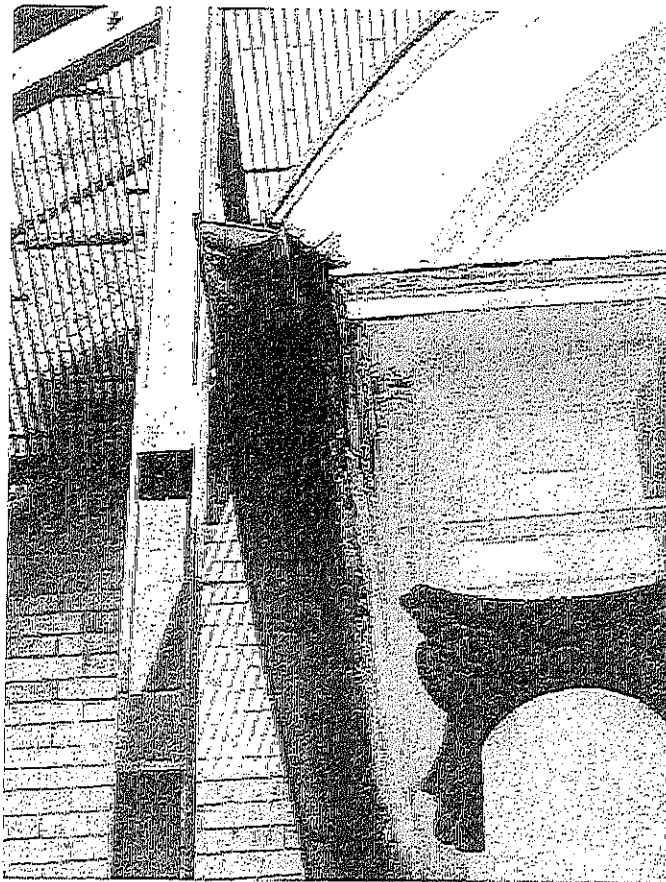
- The wood cornice return on the north side of the entry porch is severely deteriorated. (*Photo #10*)
- A glass pane in the fanlight over the entrance is cracked.

Photo #10 - Deteriorated woodwork along the west porch cornice is concealed by the hung gutter.

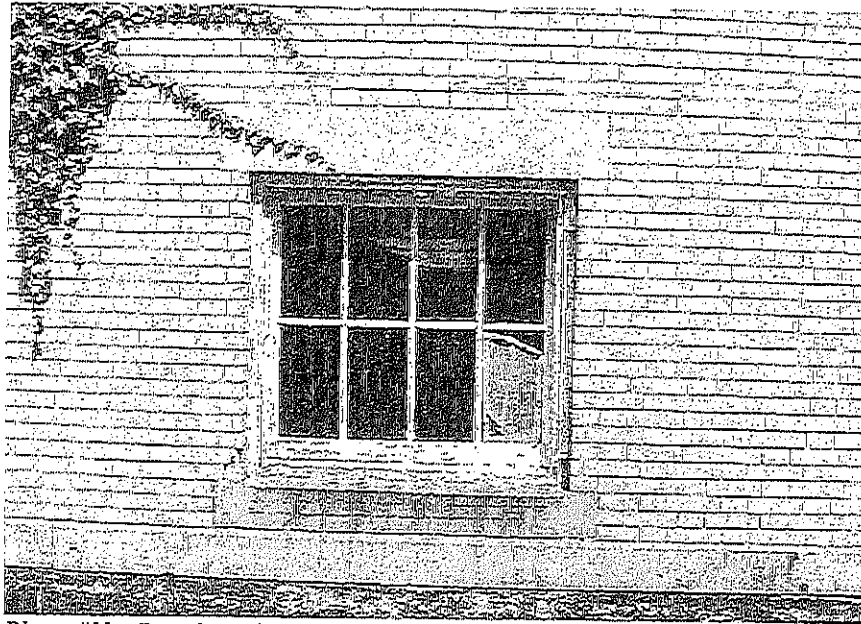
- Mortar joints are deteriorated, missing and have been improperly repointed.
- All masonry surfaces are generally dirty.
- Some bricks are spalled and missing along the molded brick course.
- The bluestone band below the basement windows is exfoliated in areas. Rust from iron window grilles has stained window sill sections. (*Photo #11*)

Photo #11 - Rust from the iron window security grille, since removed, has caused rust staining on the bluestone sill and watertable. Vine growth is destructive to the masonry wall and dislodged and missing brick in the corner of the opening allows water infiltration. Paint coatings have failed, typically on window sash and frames, exposing the wood to ultraviolet light and moisture.
