# Elizabethtown, NC Safe Streets and Roads for All (SS4A) Safety Action Plan

## Steering Committee Meeting #3

December 12, 2024

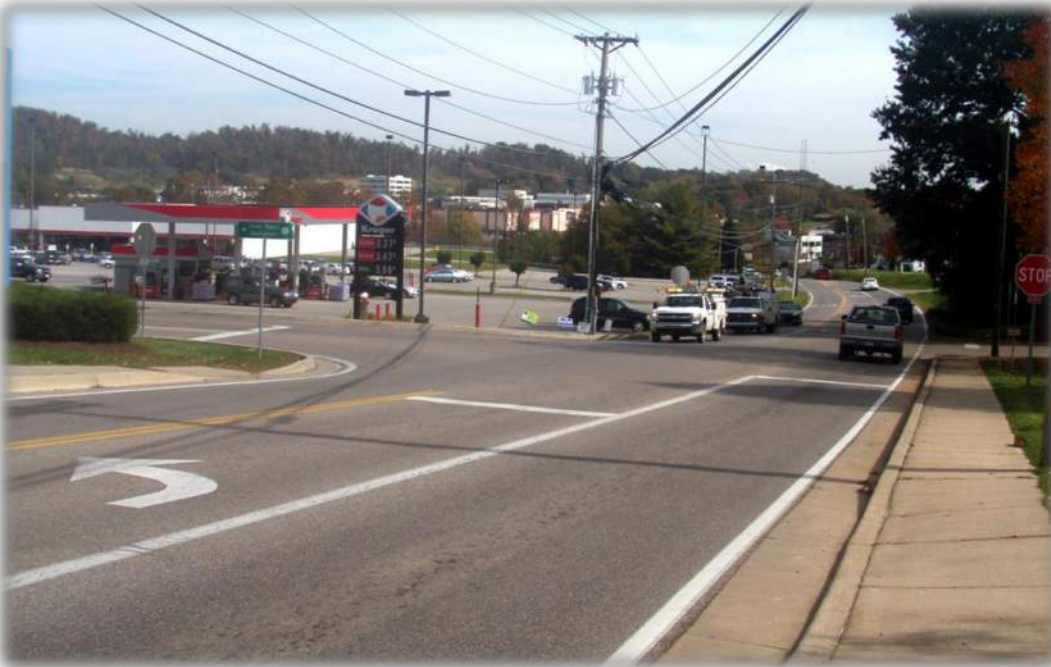
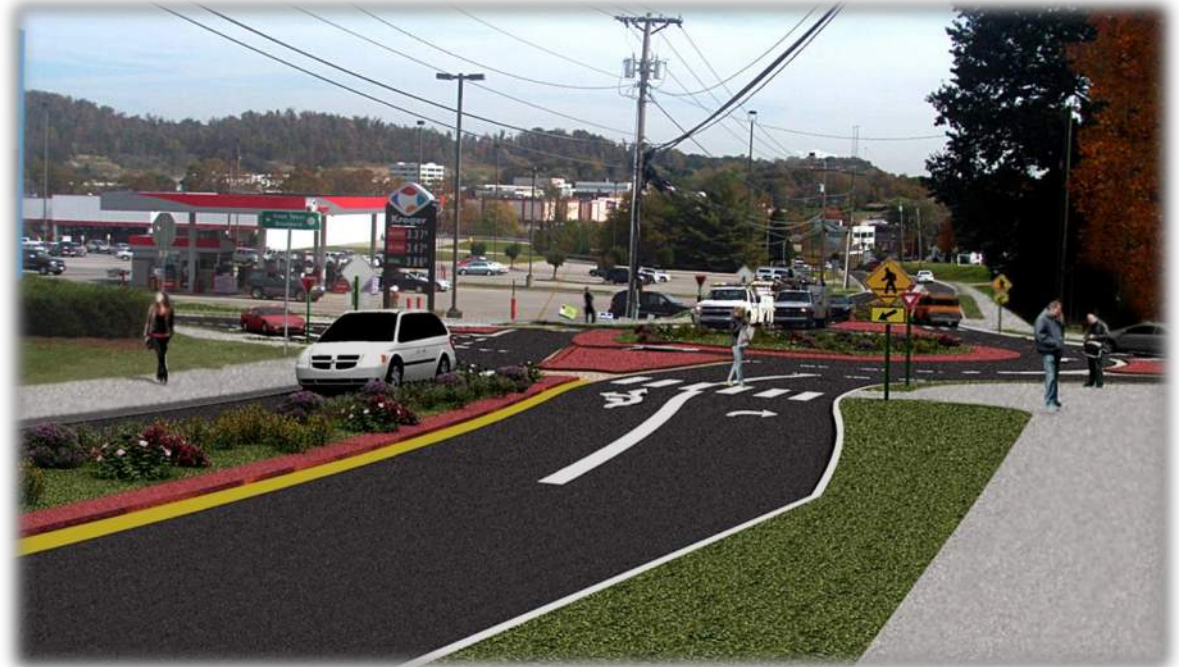
# Roundabout Intersection

- Install, Retime, or Remove a Traffic Signal
- Install a Roundabout

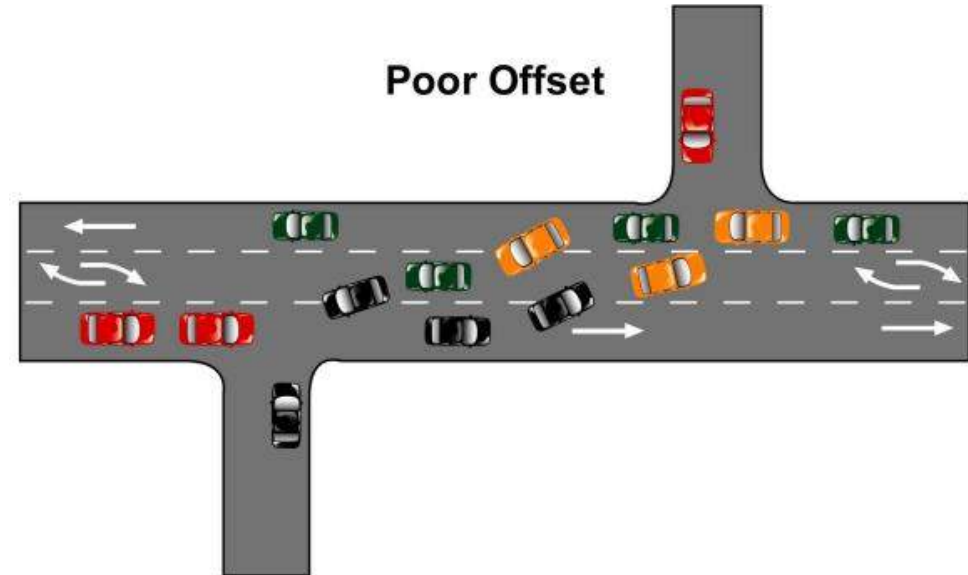
Encourage Joint & Cross Access

# Access Management

- Access Management

- Driveways are too close to intersections and cross traffic
- Consider right-in/right-out driveways
- Consolidate driveways to safer locations away from intersection

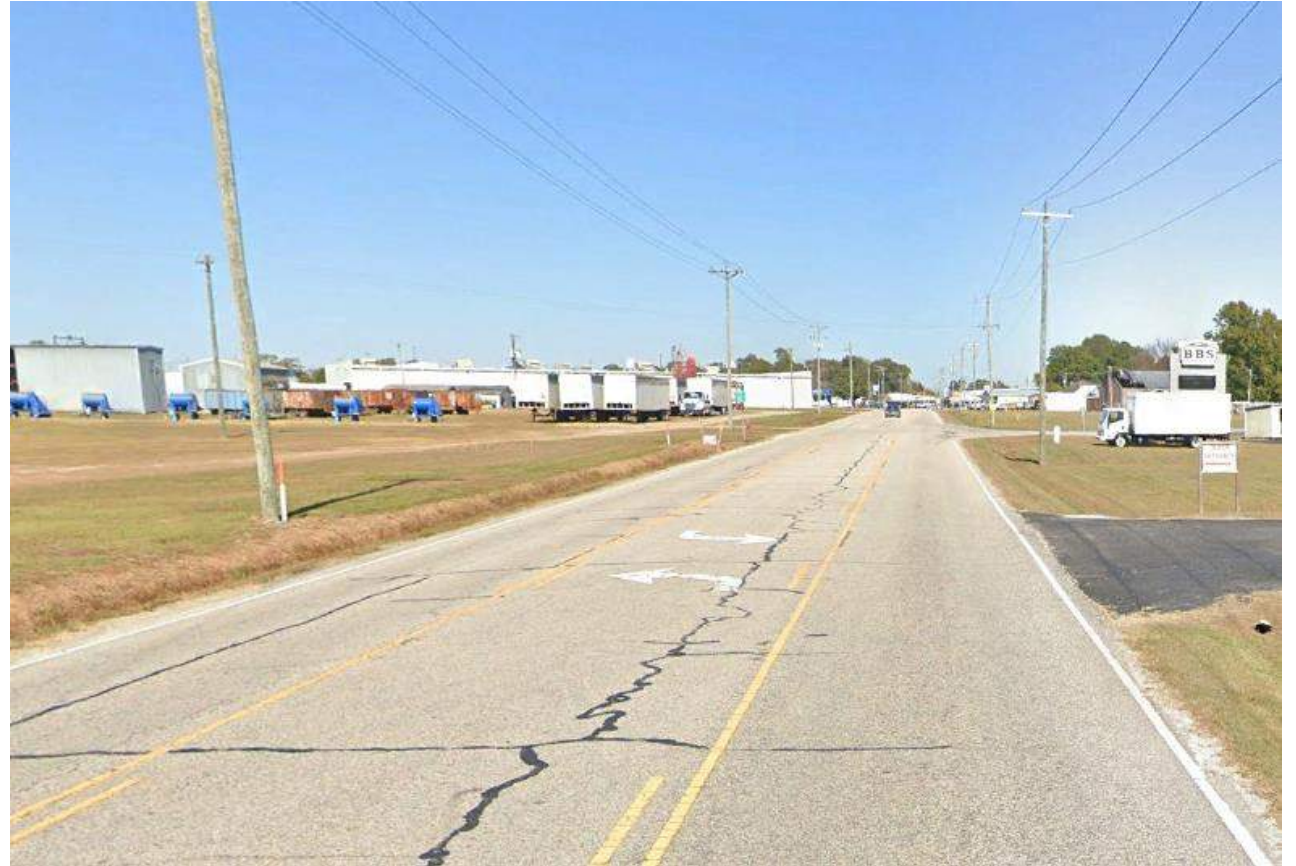
# Corridor – Peanut Plant Road

- **Location:** Broad Street to Route 87
- **Observed Safety Concerns:**
  - Pedestrian activity
  - No sidewalks, no shoulders
  - Seldom used center turning lane
  - Dark nighttime conditions
  - Crash history and near misses
  - Lacking signage
  - Flooding on Richardson
- **Suggested Countermeasures:**
  -

Intersection realignment to reduce skew and form 90-degree T-intersections at Quail and Swanzy Streets
  -

Improved wayfinding signage at Route 87

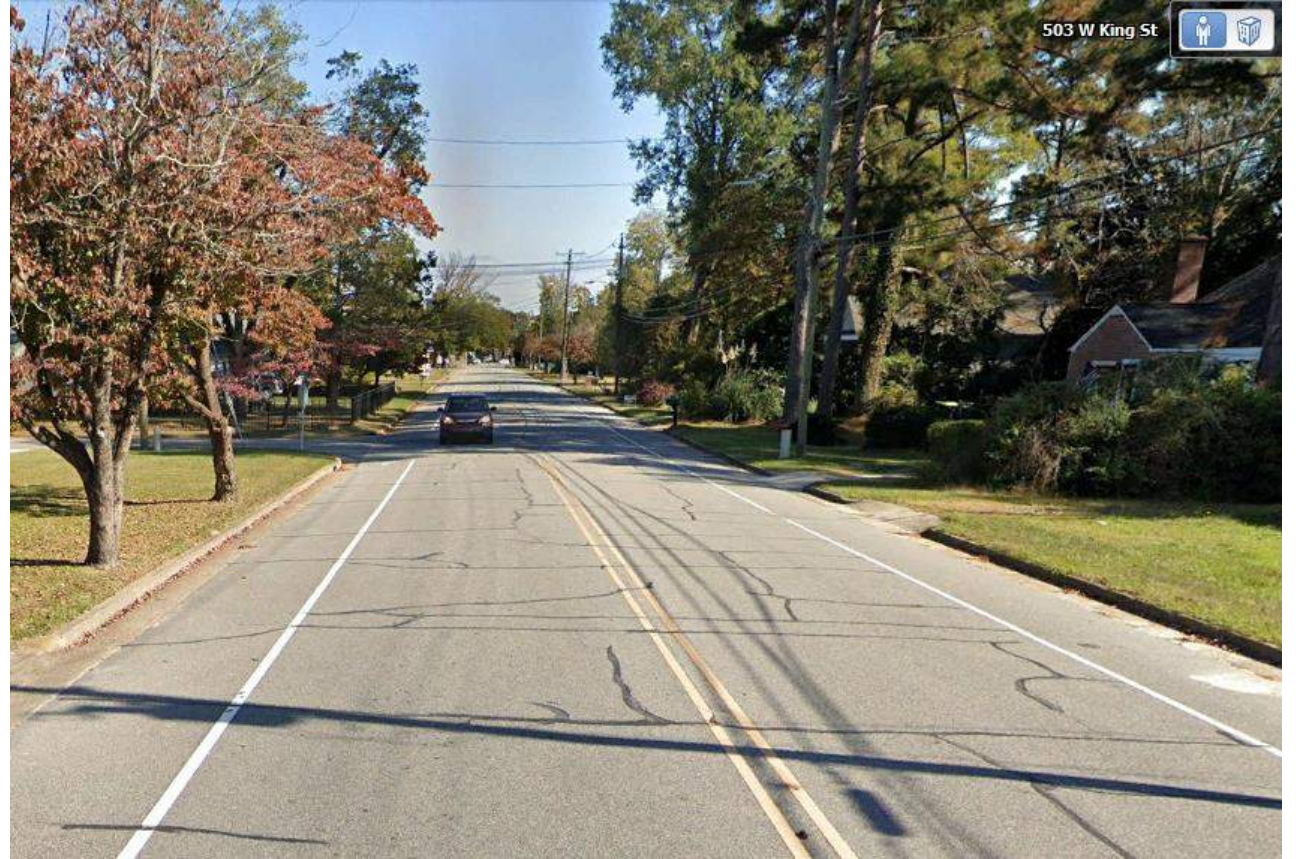
# Corridor – Swanzy Street

- **Location:** Peanut Plant Road to David Street
- **Observed Safety Concerns:**
  - Pedestrian activity
  - Apartments, senior living, key east-west route
  - No sidewalks, narrow shoulders
  - Dark nighttime conditions
  - Crash history and near misses
  - Lacking signage
  - Signs for flooding
- **Suggested Countermeasures:**

Sidewalk & Pedestrian Crossing Installation

Lighting Installation
