HISTORY OF SIGNIFICANT MAD RIVER FLOOD EVENTS

A LOOK AT FLOODING IN THE MAD RIVER VALLEY
AND THE EVOLUTION OF RIVER MANAGEMENT

It's a 'MAD' RIVER

A look at flooding in the Mad River Valley
& the evolution of river management

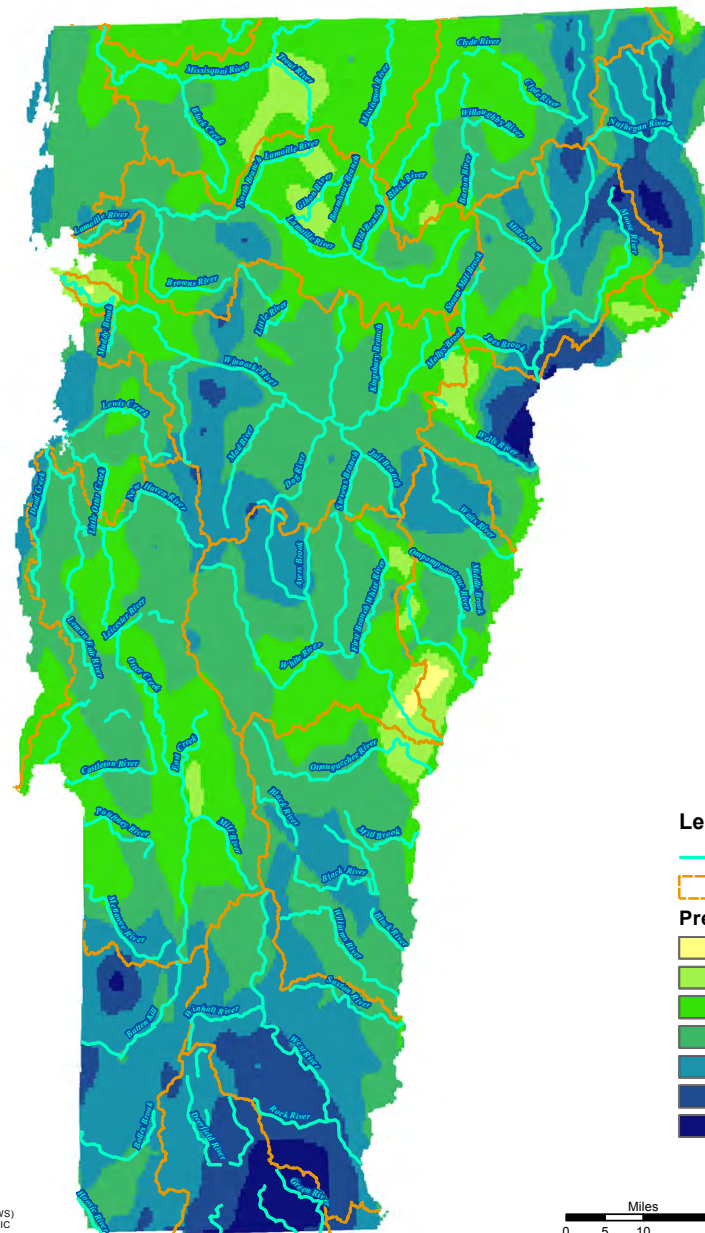
FEMA-4022-DR-VT TROPICAL STORM IRENE

Total Rainfall in Inches 27 August - 1 September 2011

SOURCE - NATIONAL
WEATHER SERVICE (NWS)
ADVANCED HYDROLOGIC
PREDICTION SERVICE
GRIDDED RAINFALL DATA

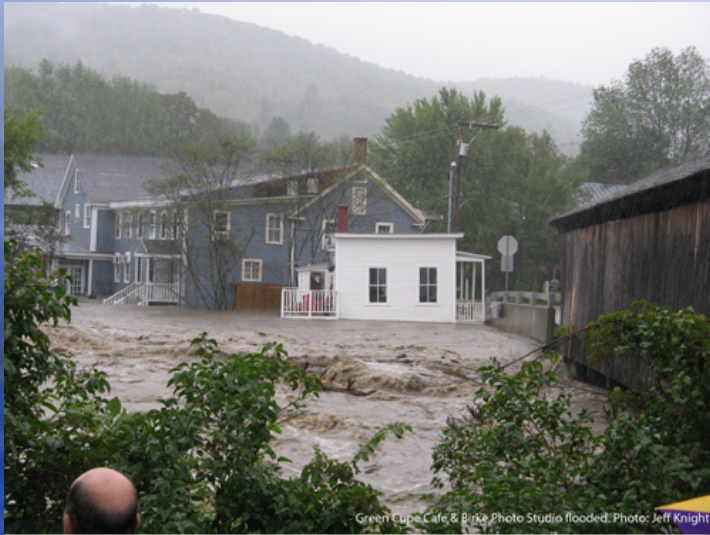
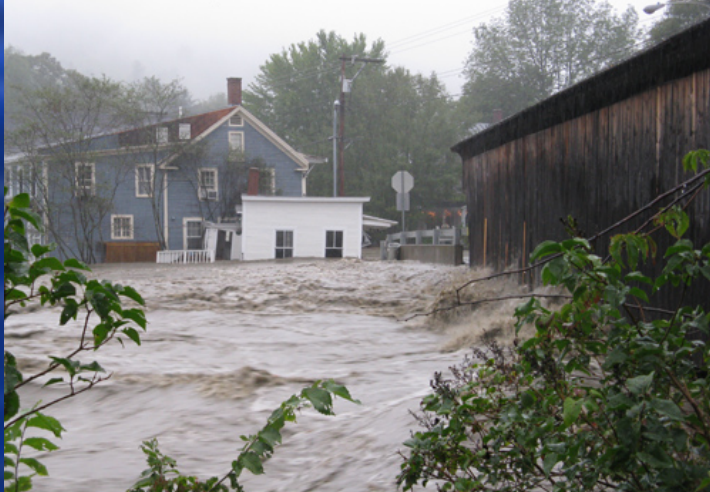
Above: about 3:30 pm. Below: water level around 530pm

- ◆ 19.40 ft¹--November 1927
- ◆ 19.06 ft--August 2011
- ◆ 16.34 ft--September 1938
- ◆ 14.45 ft--February 1981
- ◆ 14.13 ft--June 1998

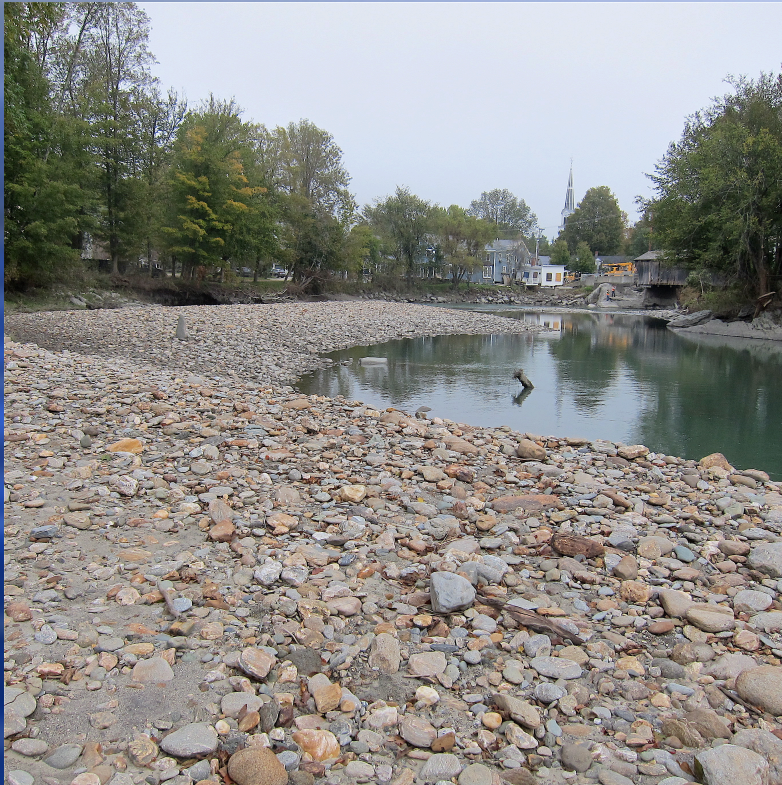
Left: New gravel bar formation, Bridge Street, Waitsfield

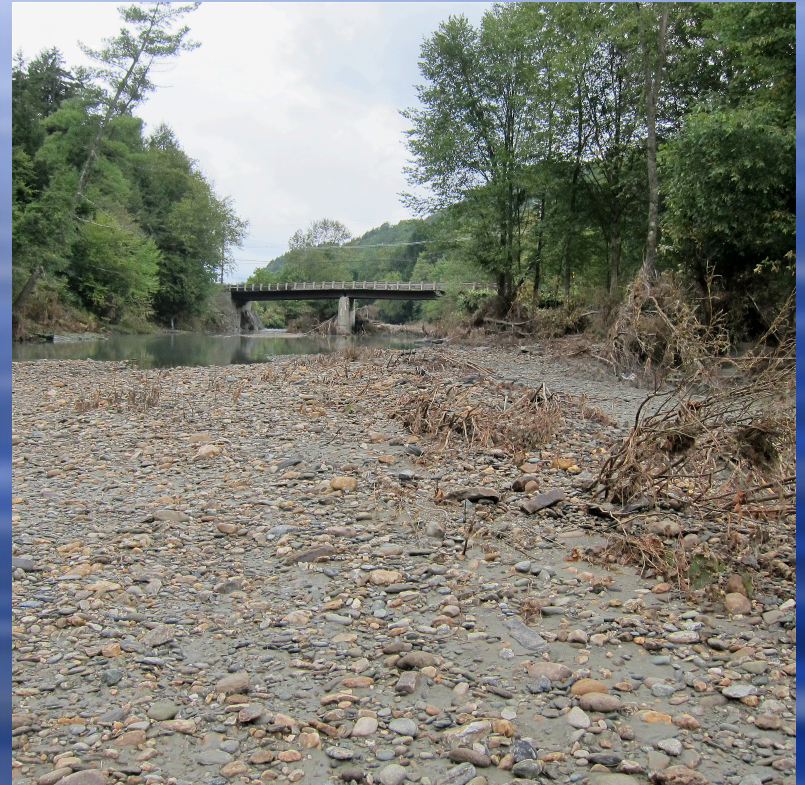
Right: Looking south from Lareau Park, Waitsfield

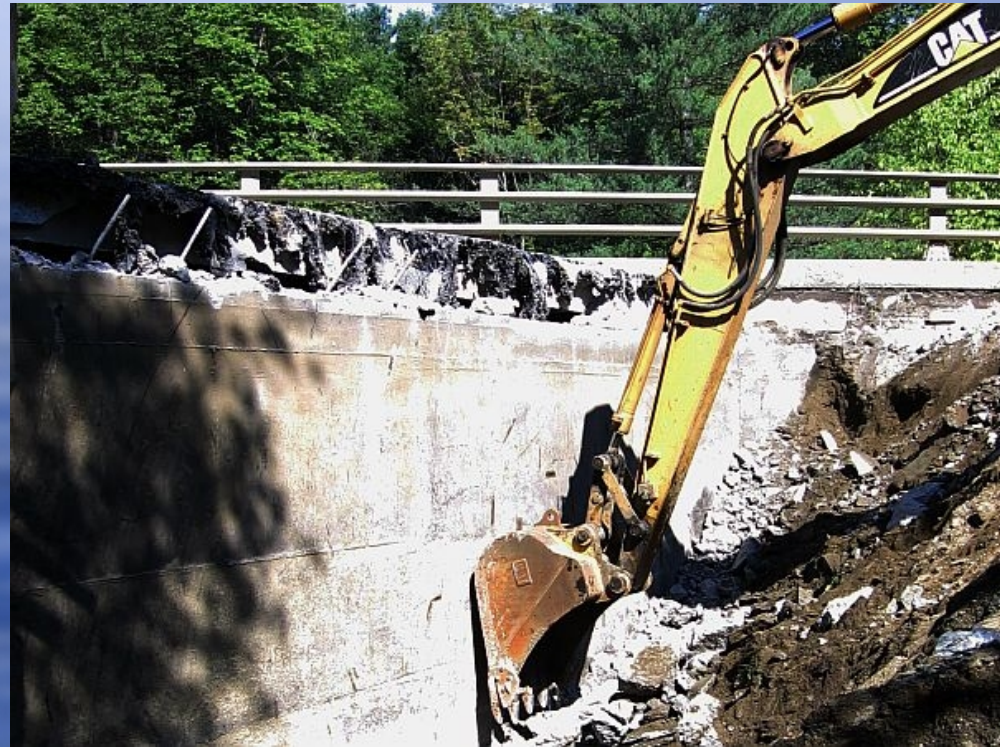
An excavator finishes work on one of the Route 100B bridges in Moretown that was damaged by the floods

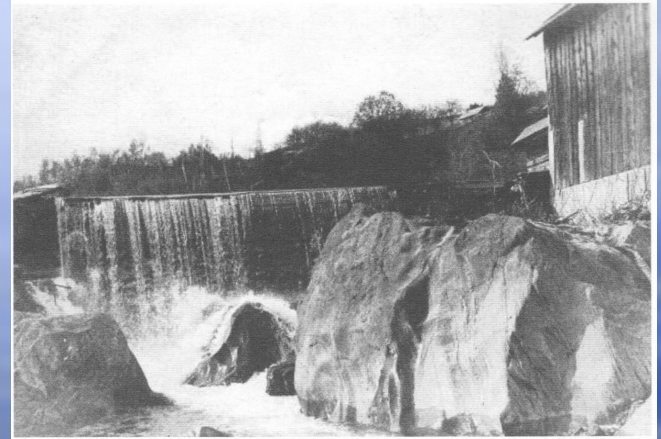
Pictured: Richardson Dam on lower Mill Brook. The dam was destroyed in 1858, 1869, 1906 (fire), 1927 and 1938.

Richardson Mill Dam and corner of the Mill Prior to 1907

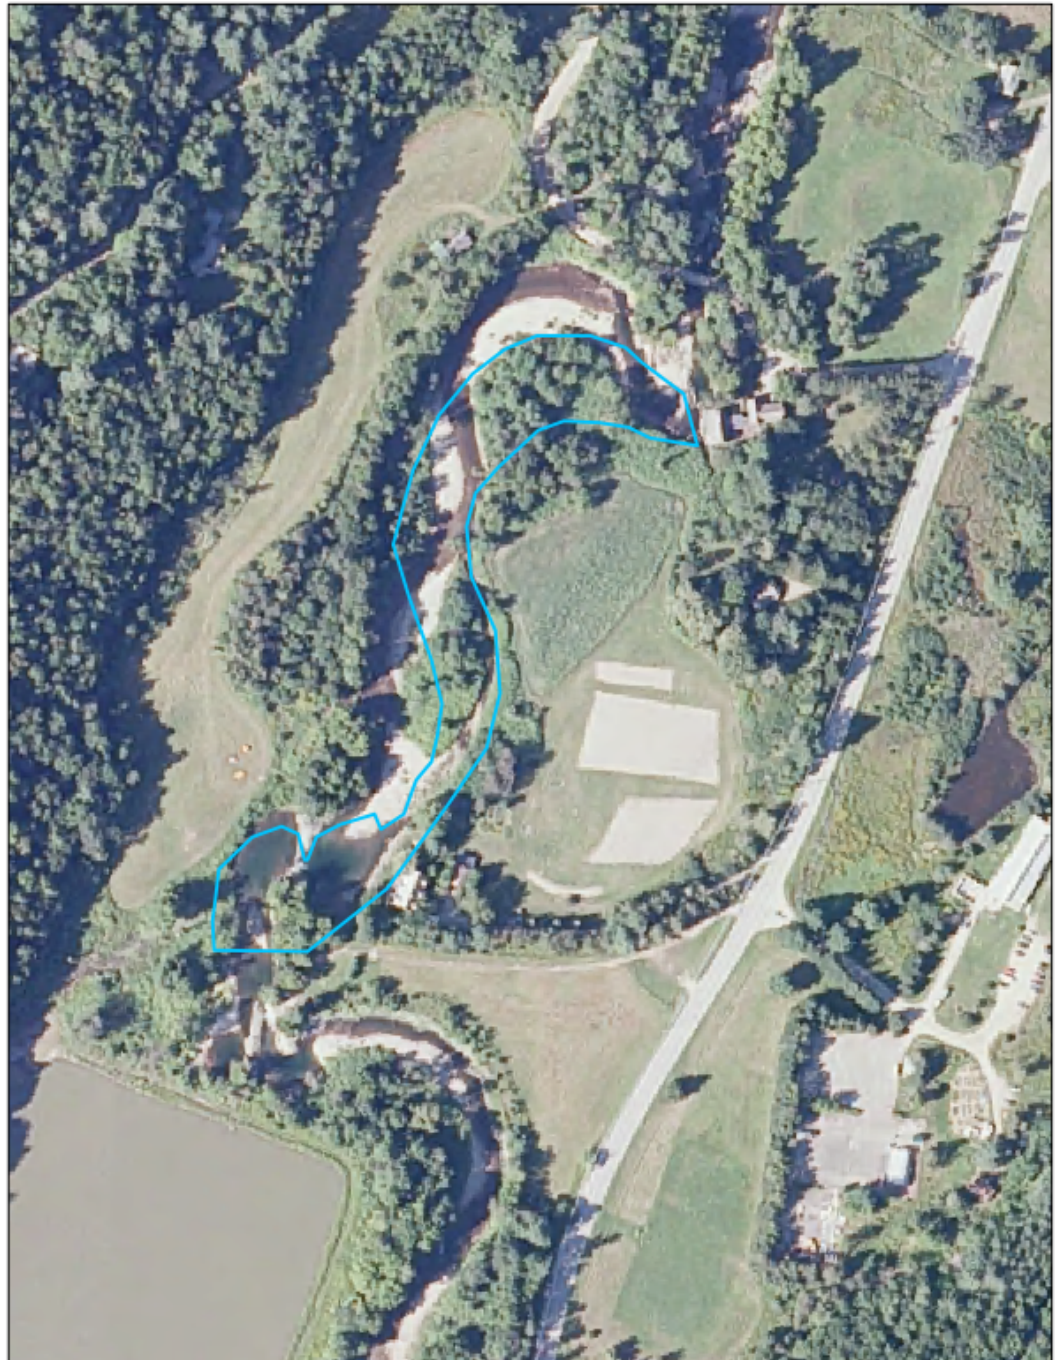
Southern Waitsfield

- ◆ 2004
- ◆ 1973 (blue)

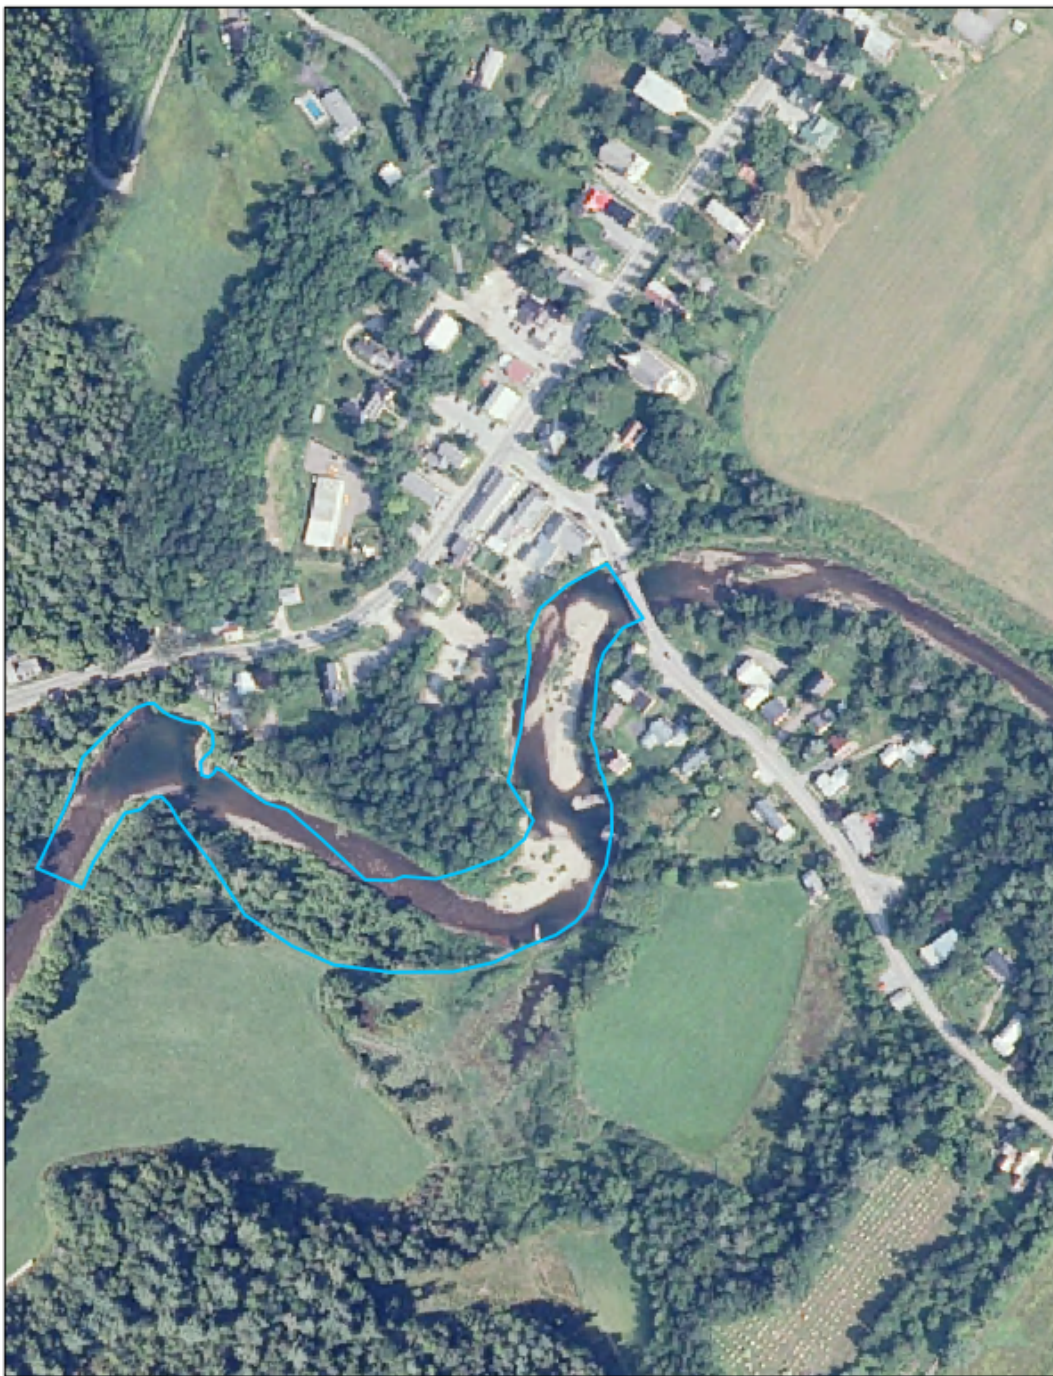
Waitsfield Village

- ◆ 2004 (photo)
- ◆ 1973 (blue)

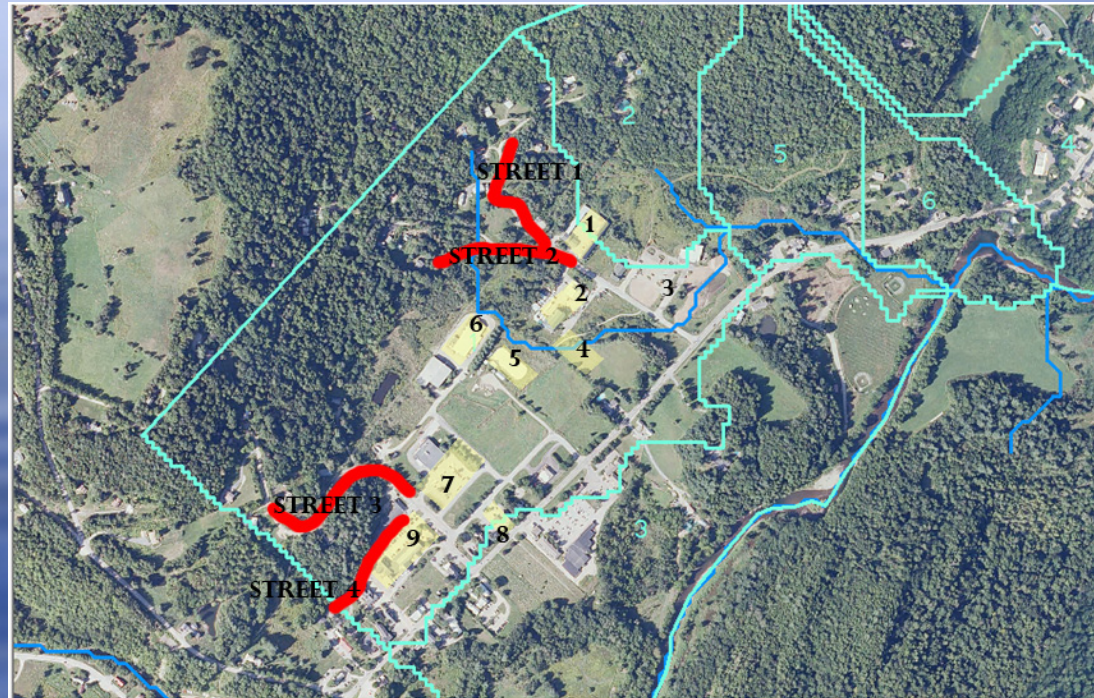
UVM Stormwater Planning Project:
Analysis of sub-watersheds and impervious
surface, Irasville.

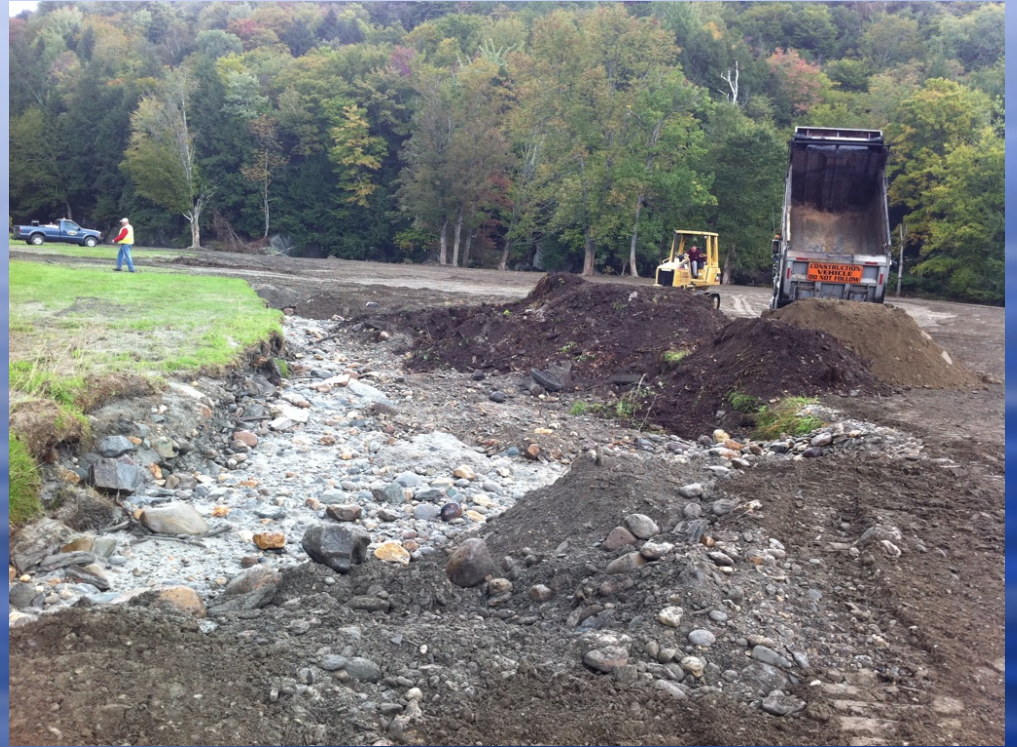
Damage to Riverside Park, owned by the Town of Warren, is repaired after Irene.

Homes were destroyed at this site during the 1998 flood, but were not rebuilt, lessening future impacts.
