# RICE LAKE, BARRON COUNTY

## 2026-30 AQUATIC PLANT MANAGEMENT PLAN

WDNR WBIC: 2103900

August 2025

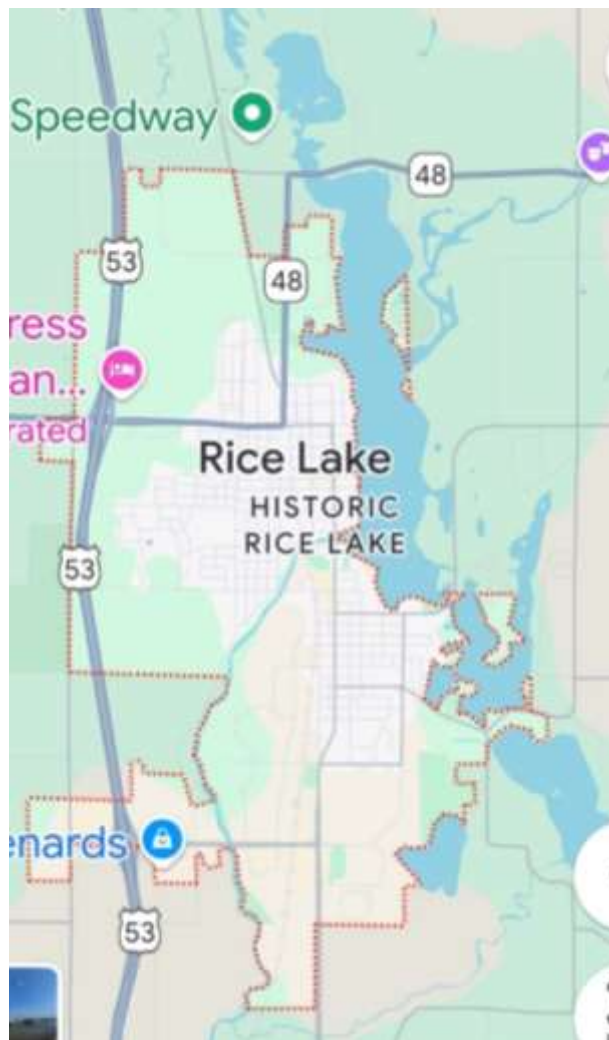
Figure 3: Rice Lake City Limits (dotted line)

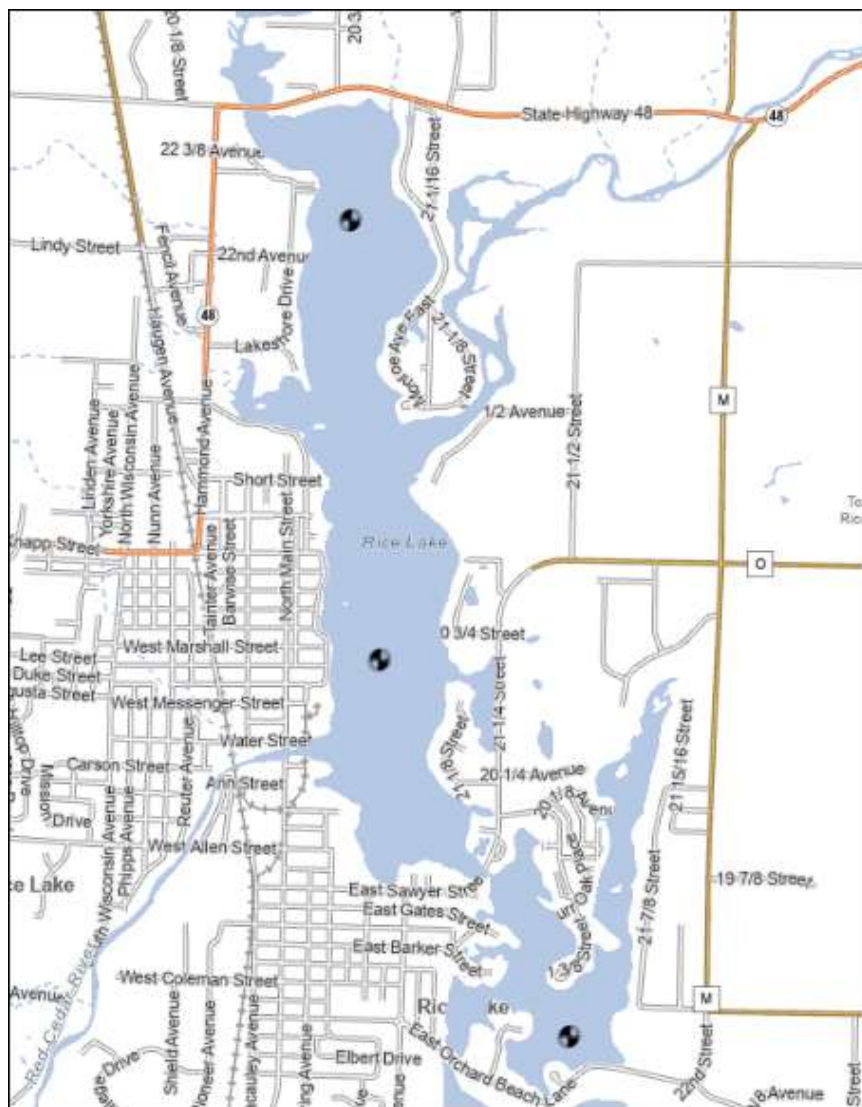
Figure 7: Citizen Lake Monitoring Network Water Quality Monitoring Sites – Rice Lake

Within Rice Lake, there are three main basins where water quality data is collected (Figure 7). North Basin data primarily consists of Secchi disk readings of water clarity. Central Basin data includes water clarity, total phosphorus, chlorophyll-a, and temperature/dissolved oxygen profiles. South Basin data has the most data of all three sites and consists of water clarity, total phosphorus, chlorophyll-a, and temperature/dissolved oxygen profiles.

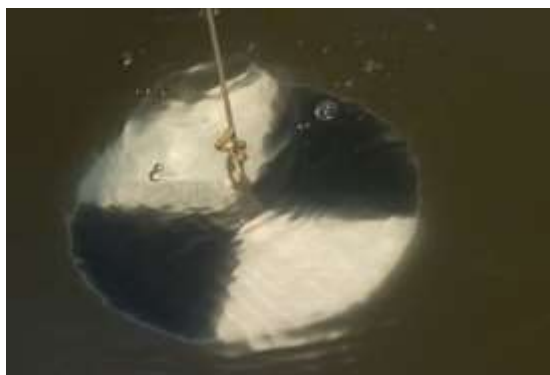
Water clarity is a measurement of how deep sunlight can penetrate the waters of a lake. It can be measured in several ways, the most common being an 8" disk divided into four sections, two black and two white, lowered into the lake water from the surface by a rope marked in measurable increments (Figure 8). The water clarity reading is the point at which the Secchi disk, when lowered into the water, can no longer be seen from the surface of the lake. Water color (like dark water stained by tannins from nearby bogs and wetlands), particles suspended in the water column (like sediment or algae), and weather conditions (cloudy, windy, or sunlight) can impact how far a Secchi disk can be seen down in the water. Some lakes have Secchi disk readings of water clarity of just a few inches, while other lakes have conditions that allow the Secchi disk to be seen for dozens of feet before it disappears.

**Figure 8: Black and white Secchi disk**

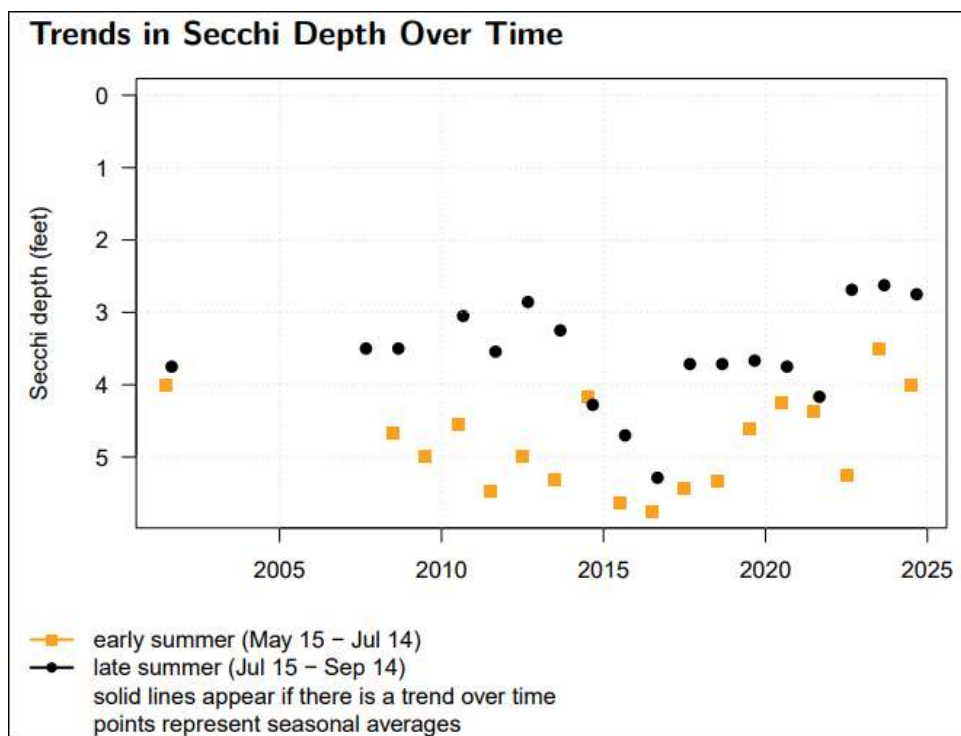
Figure 11: Rice Lake – North Basin water clarity data (WEx, 2024)

2020 with TSI values hovering just above 60 indicating hypereutrophic conditions (Figure 12). Water clarity in the North Basin is slightly worse than average when compared to data collected from similar reservoirs (Figure 13).

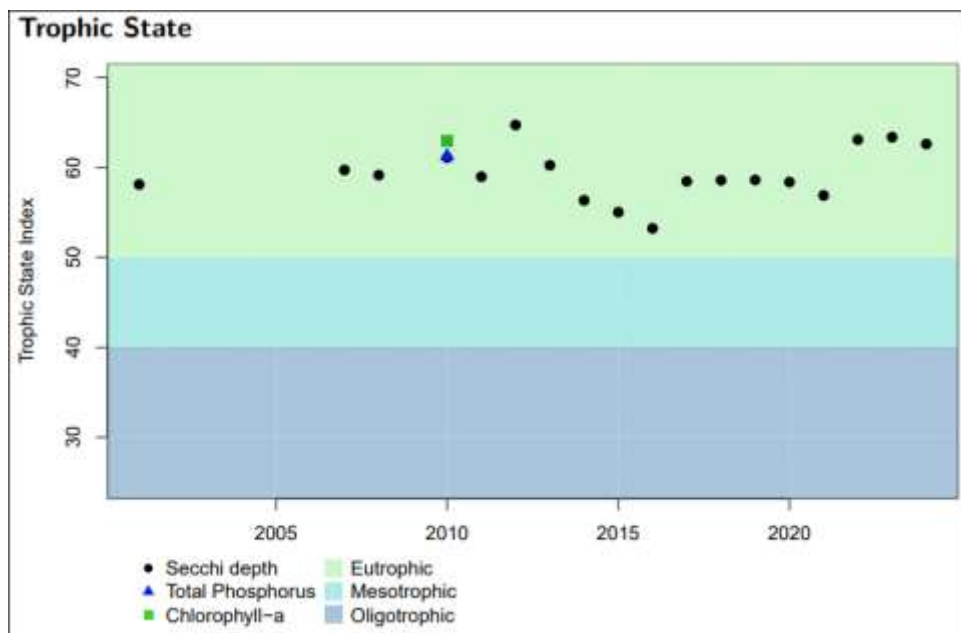
Figure 12: Trophic status – North Basin of Rice Lake (WEx, 2024)

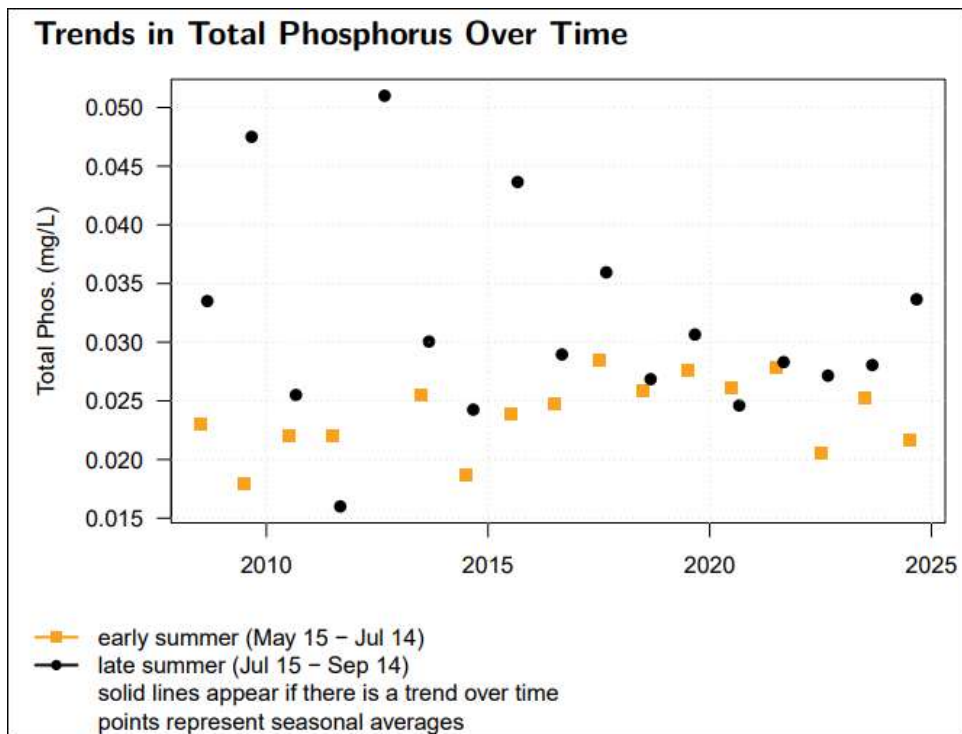
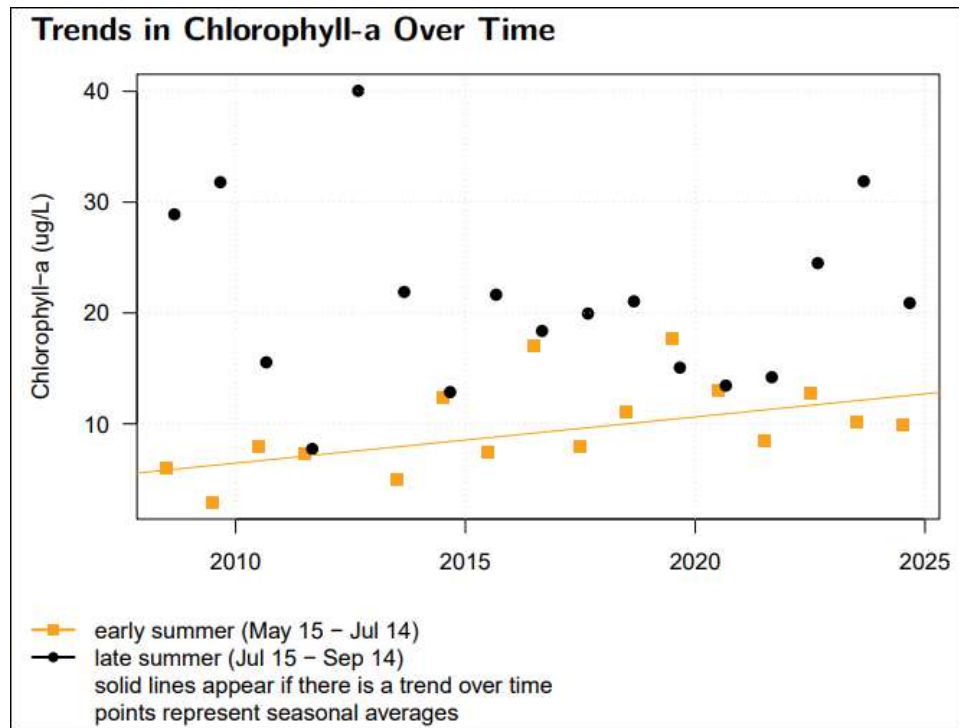
Water clarity and Chla exhibit a worsening trend in the early summer (Figures 21&22). TP exhibits no trend (Figure 23). Overall, there appears to be a slight trend toward worsening water quality over the last 10 years (Figure 24). When compared to data from other reservoirs, water clarity and TP are slightly better than average with Chla being slightly worse (Figure 25). However, being separated from the North and Central Basins by the narrows, the South Basin does not have all the characteristics of a reservoir, it acts more like a seepage lake, without the flushing that a reservoir or drainage lake gets.

Figure 21: South Basin Secchi (WEx, 2024)

Figure 22: South Basin Total Phosphorus (WEx, 2024)

Figure 23: South Basin Chlorophyll-a (WEx, 2024)

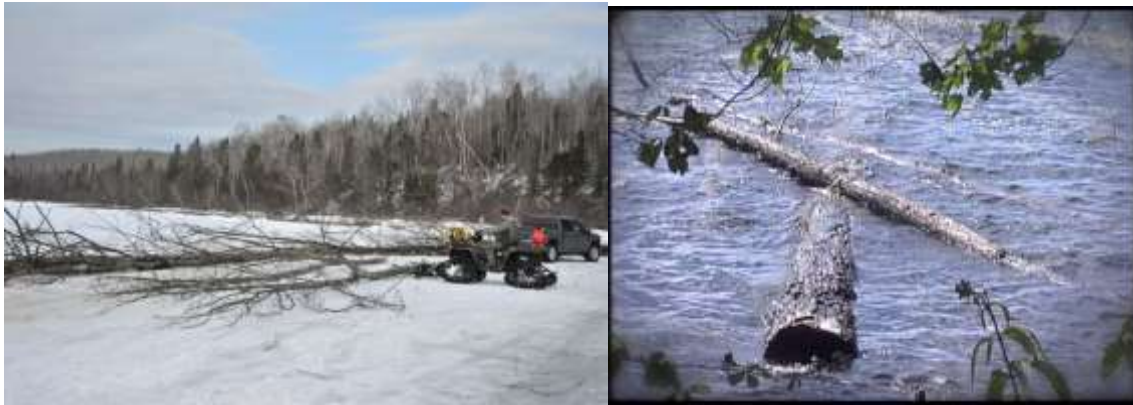
**Figure 29: Coarse woody habitat-Fishsticks projects**

on this process visit: <http://dnr.wi.gov/topic/fishing/outreach/fishsticks.html> (last accessed on 1-4-2018). These types of projects are more formally called “tree drops” but are popularly called “fish sticks” (Figure 29).

The woody habitat within Rice Lake has not been quantified but interested property owners are still able to install fish sticks projects in the lake adjacent to their property if they follow the proper channels for permitting and obtaining the trees.

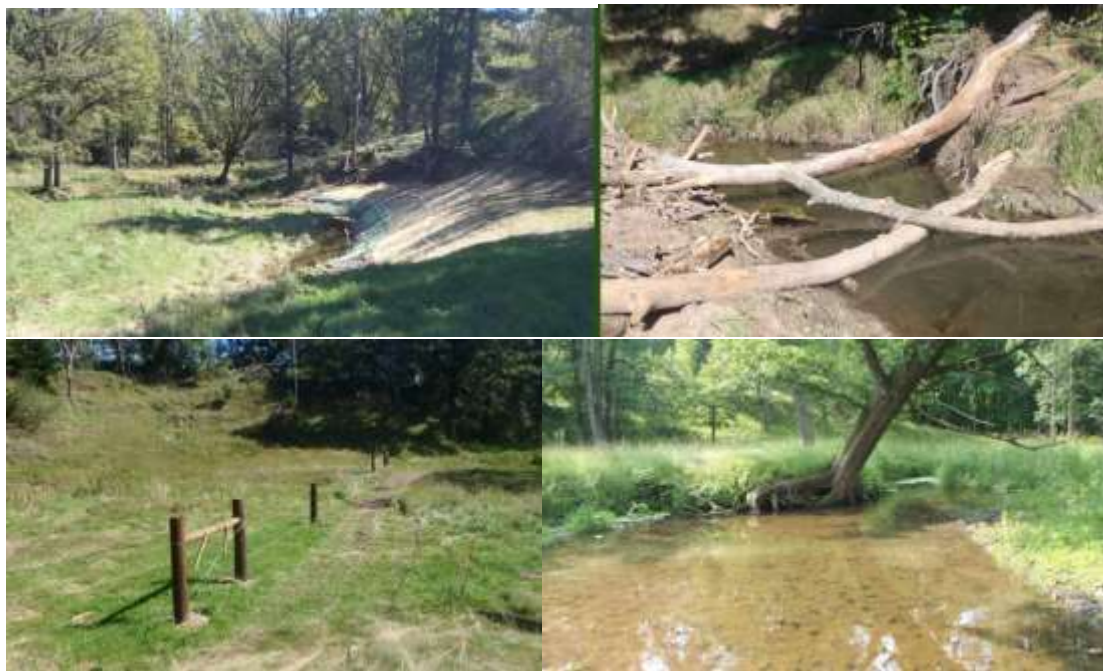
A trout stream that is the headwaters of Tuscobia Creek which feeds Tuscobia Lake and moving water into Bear Creek, Stump Lake, and Rice Lake was rehabilitated. This project cleaned out a fouled area of the stream, stabilized stream banks that were suffering major erosion, and removed cattle access to the stream (Figure 31).

**Figure 31 – Mlejnek Tuscobia Creek Headwaters Project (Barron County, 2015)**

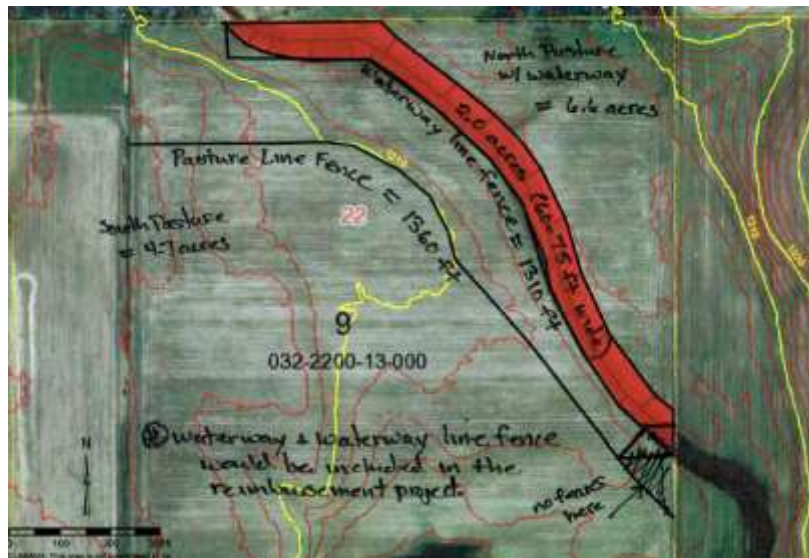
This project was in the northern portion of the watershed between 25<sup>th</sup> and 26<sup>th</sup> Street. It included a grassed waterway to be used for light pasturing of dairy cattle. To prevent significant damage to the grassed waterway, fencing was installed to control cattle movement on the site. Several conditions were placed on the pasturing

area including the requirement that the farmer maintain it in good condition for a minimum of 10 years (Figure 32).

Figure 32 – Mullen Grassed Waterway Project (LEAPS, 2015)

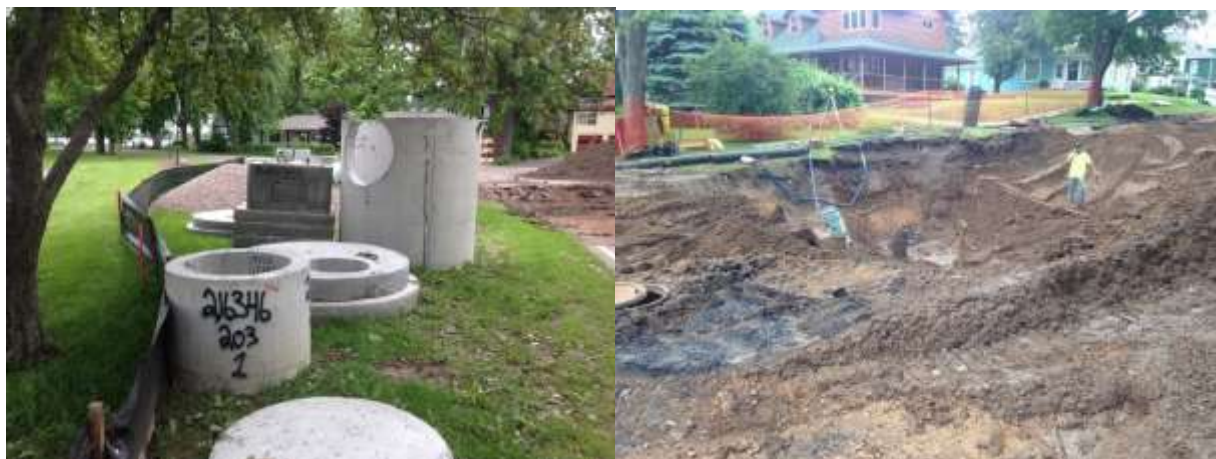
The City of Rice Lake redid a stretch of Humbird Street between Main Street and Lakeshore Drive in 2016. This project included the installation of a grit chamber at the lake side of the storm water sewer system. The actual grit chamber was paid for by the Lake District to the sum of \$15,000.00. Design work and installation was completed by the City of Rice Lake. The Humbird St. project was already planned by the city, but it originally did not include a grit chamber. With the settlement money, the installation of a grit chamber was approved and added to the original project. This project was completed over the summer (Figure 33). The City of Rice Lake continues to maintain the grit chamber to this day.

Figure 33: Humbird Street Grit Chamber Installation

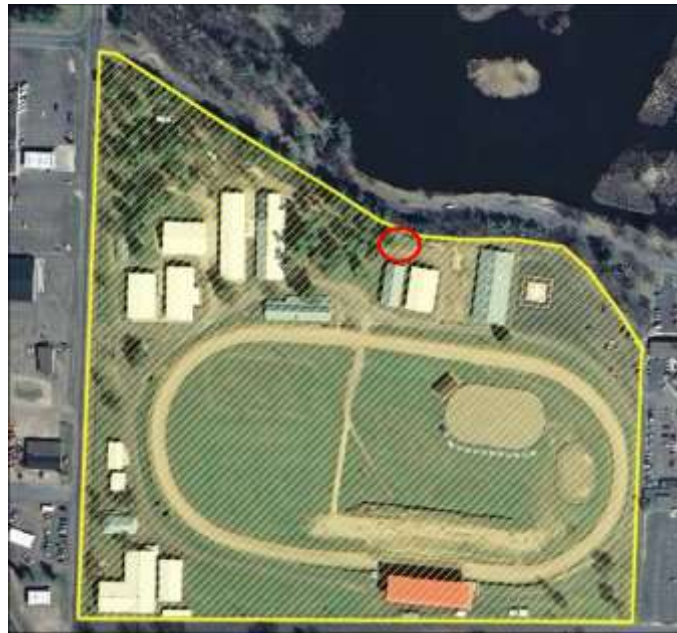
**Figure 34: Location of the rain garden installed at the Barron County Fairgrounds**

The Barron County Fairgrounds in Rice Lake have been a source of sediment and nutrient loading into Rice Lake for years. While several projects have been completed including reshaping the clay harness racing track, installing grassed waterways and rock drainage basins, a rain garden had never been installed. In cooperation with the City of Rice Lake, Barron County Fair Board, and the Barron County Land and Water Conservation Department, the Lake District funded much of the cost to install a large catch basin/rain garden behind the large animal show barns on the northern edge of the Fairgrounds up above the lake (Figures 34 and 35). This project was completed in November 2017 under the direction of the Barron County Soil and Water Conservation Department. Since that time, both Barron County and the Lake District have maintained it, including redoing it a few years later when it stopped working the way it was originally supposed to.

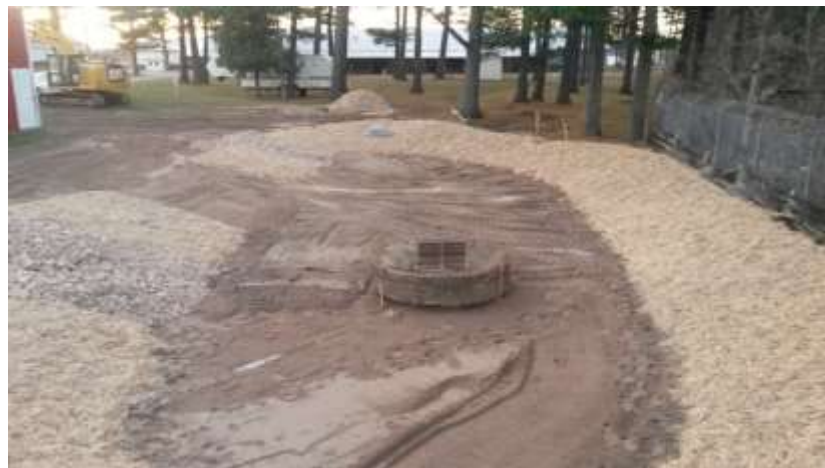
**Figure 35: Original construction of the rain garden at the Barron County Fairgrounds**

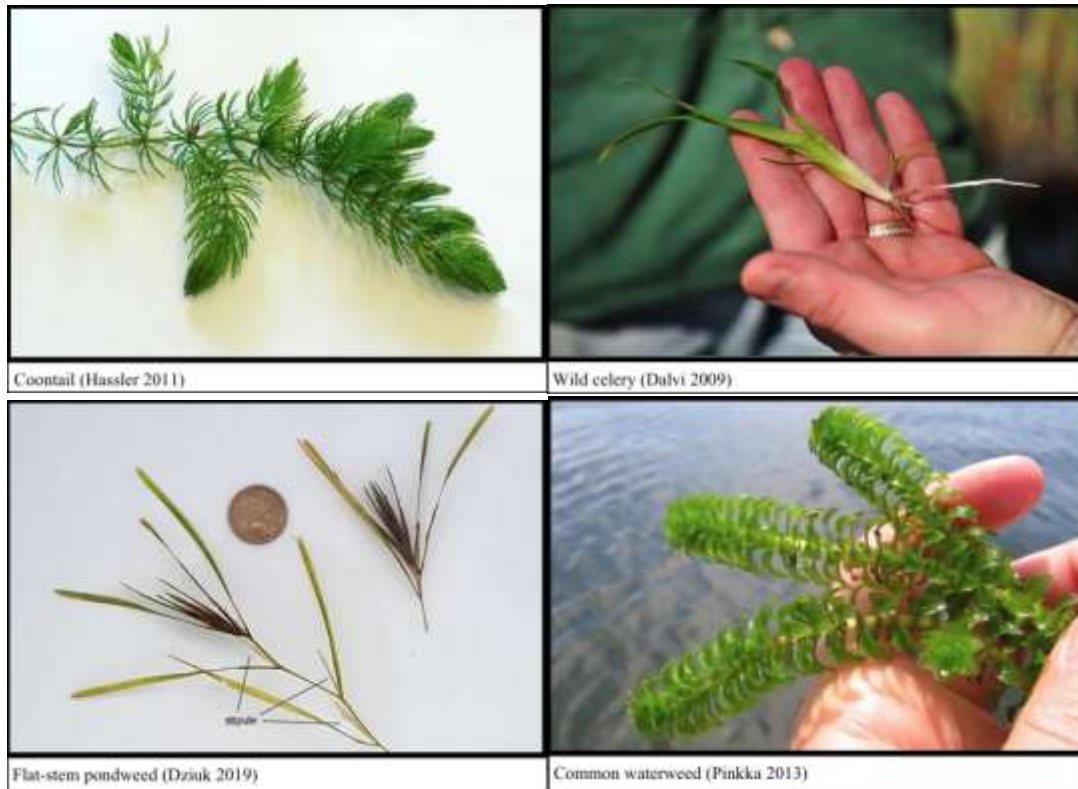
In August 2018, EIS biologists found Coontail, Wild celery, Flat-stem pondweed, and Common waterweed were the most common macrophyte species (Figure 40). They were present at 80.39%, 31.37%, 29.41%, and 15.03% of survey points with vegetation respectively, and, collectively, they accounted for 56.50% of the total relative frequency. Relative frequency shows a species' frequency relative to all other species. It is expressed as a percentage, and the total of all species' relative frequency will add up to 100%. Organizing species from highest to lowest relative frequency value gives an idea of which species are most important within the macrophyte community. White water lily (5.32%), Fern pondweed (4.14%), and Forked duckweed (4.02%) also had relative frequencies over 4.00%.

**Figure 40: 2018 and 2024 most common species in Rice Lake**

In 2024, Coontail, Flat-stem pondweed, Common waterweed, and Wild celery were again the most common macrophyte species (Figures 40 & 41). They were found at 72.97%, 43.54%, 37.54%, and 28.83% of sites with vegetation, and they captured 44.85% of the total relative frequency. Small pondweed (6.26%), White water lily (5.96%), Large duckweed (4.93%), Small duckweed (4.64%), Common watermeal (4.49%), and Fern pondweed (4.42%) also had relative frequencies over 4.00% (See the 2024 Summer PI Report from ERS for photos of these and other plants found in Rice Lake).

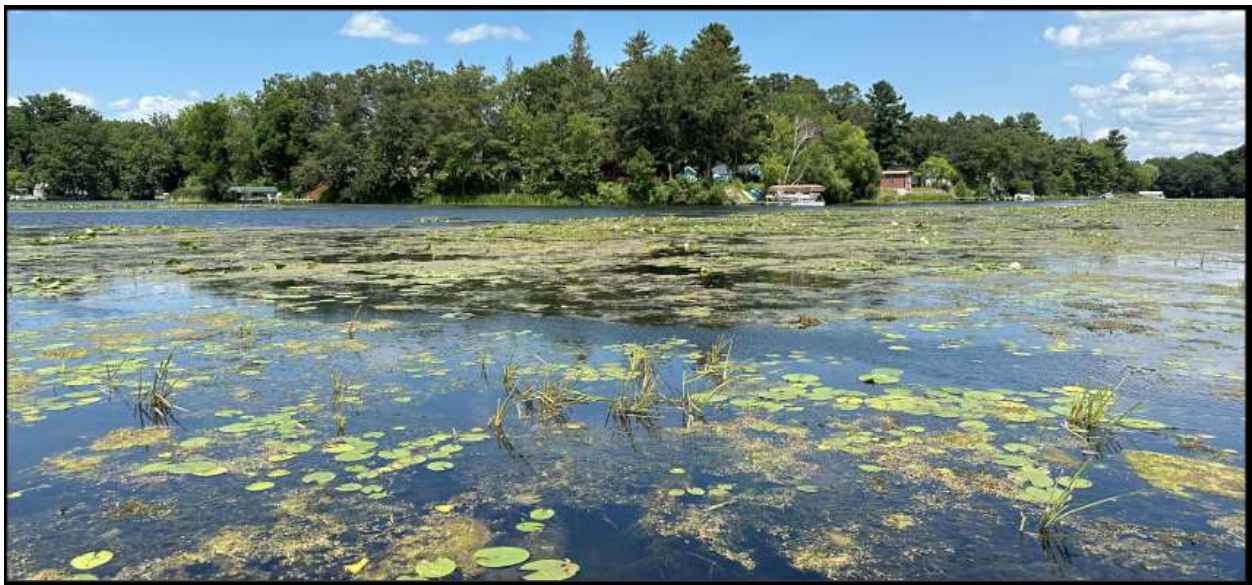
**Figure 42: 2024 Wild Rice near the Red Cedar River Inlet (Photo from ERS)**

In 2024, wild rice was limited to a few 100 goose-cropped blades in and adjacent to the Red Cedar River Inlet, and no areas even approached levels that would provide human harvest potential (Figure 42). The 2018 survey found rice in the rake at two points with a mean rake fullness of 1 and recorded it as a visual at a single point. In 2024, it was found in the rake at a single point which had a rake fullness of 1 with two additional visual sightings (Figure 43). Neither surveyor headed upstream in the Red Cedar River to check on wild rice.

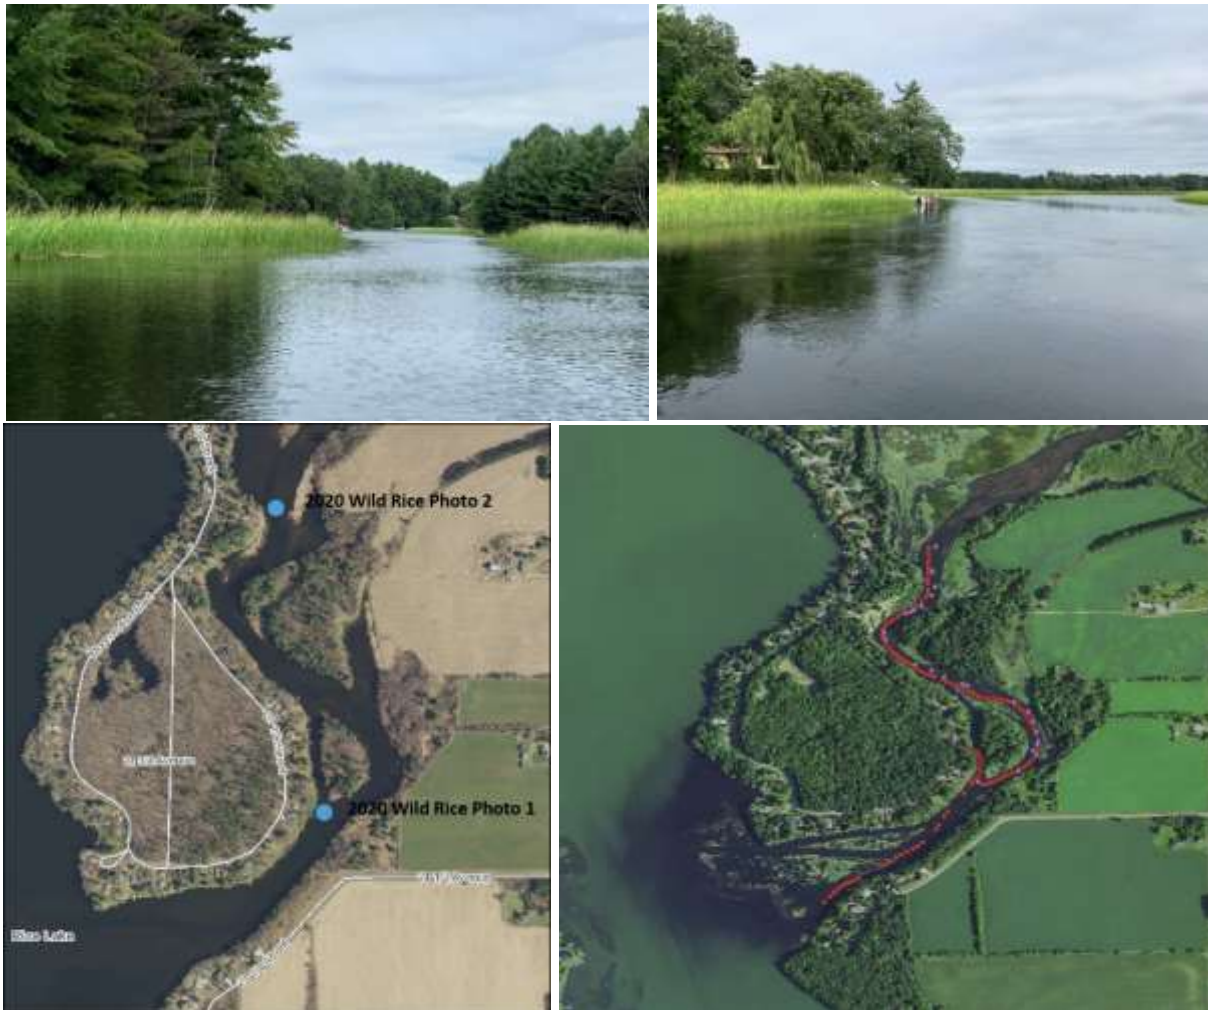
**Figure 44: August 13, 2020 Wild rice in the Red Cedar River just upstream of Rice Lake. Purple dots indicate all the places where sizable beds were located. Photos and Maps from LEAPS**

Wild rice flourished in 2020 with sizable beds along both sides of the river for at least a quarter mile upstream from the lake delta. The author of this Plan has been working on Rice Lake for better than 15 years and this is the first time he has seen wild rice with this amount of density. Photos of the rice were sent to Peter David, Manoomin Biologist with the Great Lakes Indian Fish and Wildlife Commission (Figure 44). His comment was “You rock my world! It does seem more abundant than my past impressions.” This was the first time wild rice in this area produced some potential for harvest. Anecdotally though, one person who attempted harvest said that actual rice was spotty with much of it being consumed by wildlife.

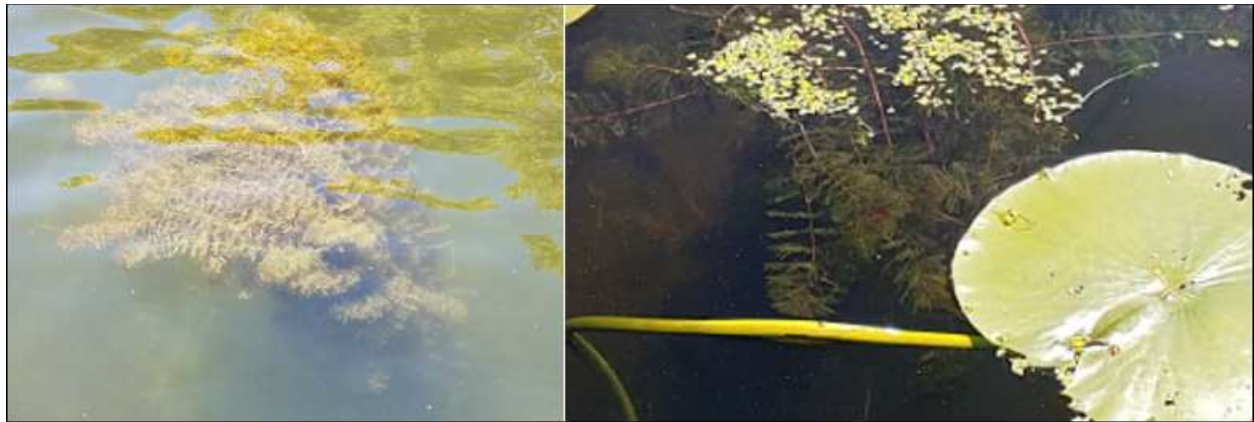
**Figure 47: HWM in Rice Lake, June 2018. Photos from LEAPS**

In June of 2018, hybrid watermilfoil (HWM) was discovered in Clearwater Bay in the south basin of Rice Lake (Figure 47). The Lake District took an aggressive, integrated approach to management which included rake removal, diver removal, and chemical control followed by multiple recon and mapping surveys with rake removal.

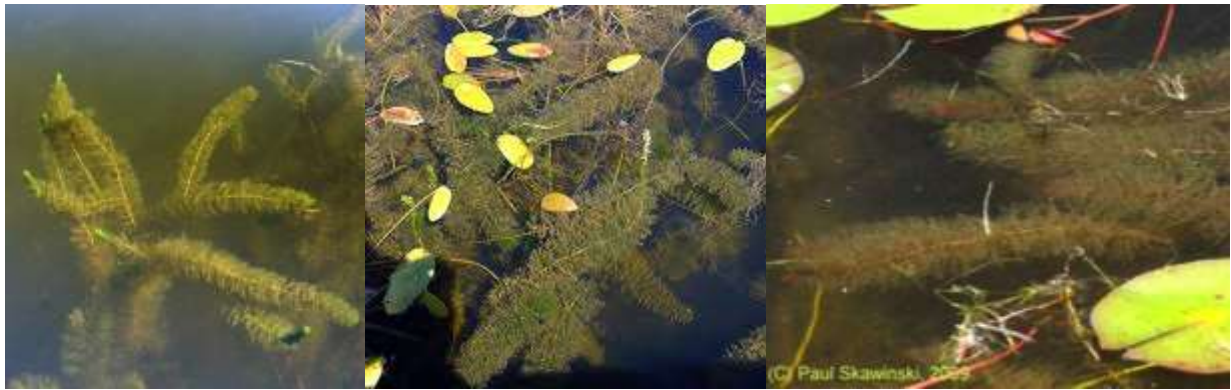
**Figure 51: Northern watermilfoil (left), Whorled watermilfoil (middle), Farwell's watermilfoil (right)**

Rice Lake provides habitat for several native milfoils Northern watermilfoil (*Myriophyllum sibiricum*), Whorled watermilfoil (*Myriophyllum verticillatum*), and Farwell's watermilfoil (*Myriophyllum farwellii*) (Figure 51). HWM is a cross between Northern watermilfoil (native) and Eurasian watermilfoil (non-native) (*Myriophyllum spicatum*) (Figure 52). Management of HWM in Rice Lake using what is generally considered appropriate is complicated by the Lake District's use of mechanical harvesters to remove CLP and nuisance native vegetation. The current integrated approach of herbicide treatments coupled with mechanical harvesting may be counterproductive as the harvester is clearly fragmenting plants and leading to HWM's spread and re-establishment in areas where herbicide treatments recently occurred. If harvesting continues in areas with HWM, these herbicide treatments may be a waste of resources. However, if the goal of lowering HWM levels supersedes mechanical harvesting of other vegetation, treating HWM chemically may remain a management option. Ultimately, the amount of HWM growth the Lake District is comfortable with will determine how much, if any, focused management occurs in the future.

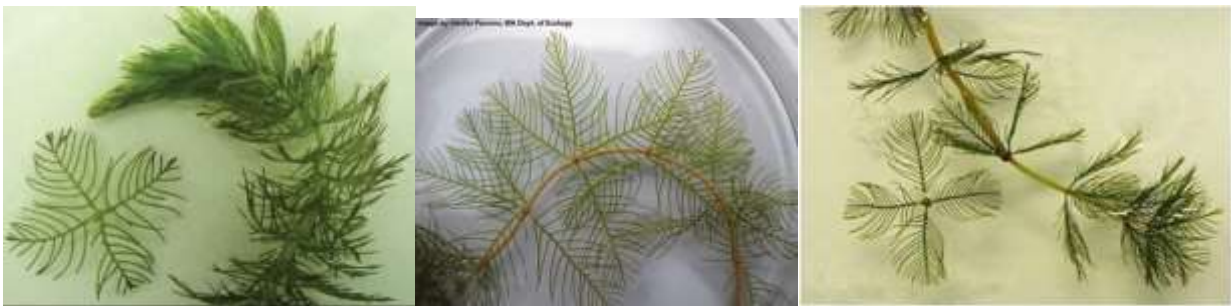
**Figure 52: Northern watermilfoil (left), Hybrid watermilfoil (middle), Eurasian watermilfoil (right)**

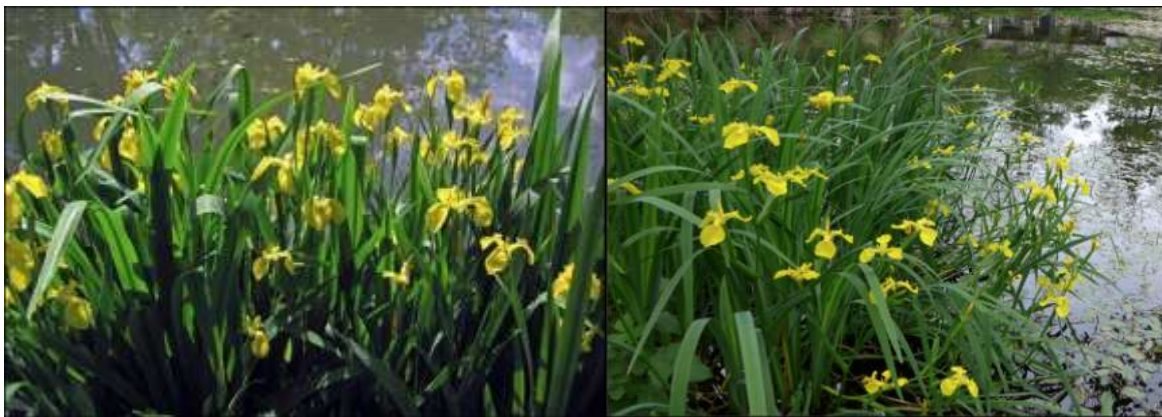
**Figure 53: Yellow Flag Iris**

Yellow iris has broad, sword-shaped leaves that grow upright, tall and stiff. They are green with a slight blue-grey tint and are very difficult to distinguish from other ornamental or native iris species. Flowers are produced on a stem that can grow 3-4 feet tall among leaves that are usually as tall or taller. Its flowers are showy and variable in color from almost white to vibrant dark yellow. Flowers are 3-4 inches wide and bloom from April to June. Three upright petals are less showy than the larger three downward pointing sepals, which may have brown to purple-colored streaks. Seeds are produced in fruits that are 6-angled capsules, 2-4 inches long. Each fruit may have over 100 seeds that start pale before turning dark brown. Each seed has a hard outer casing with a small air space underneath, which allows the seeds to float. The plant has thick, fleshy, pink-colored rhizomes or roots that spread extensively in good conditions, forming thick mats that can float on the water's surface.

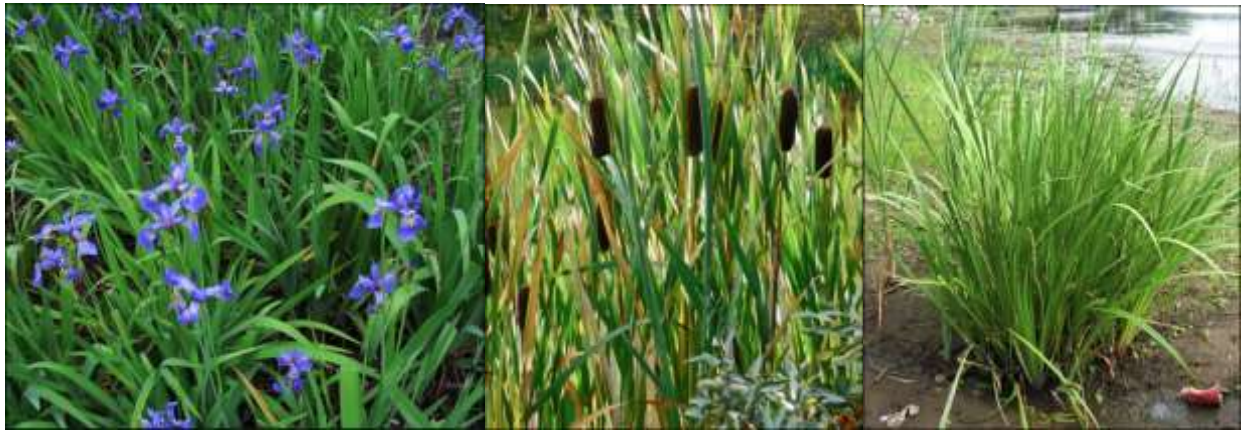
**Figure 54: Blue Flag Iris (left), Cattails (middle), Sweet Flag (right)**

When not flowering, the yellow flag iris can be easily confused with the native blue flag iris (*Iris versicolor*) as well as other ornamental irises that are not invasive (Figure 50). The blue flag iris is usually more miniature and does not tend to form as dense clumps or floating mats. When not flowering or showing fruiting bodies, the yellow flag iris may be confused with other wetland plants such as cattails (*Typha* spp.) or sweet flag (*Acorus* spp.) species (Figure 54).

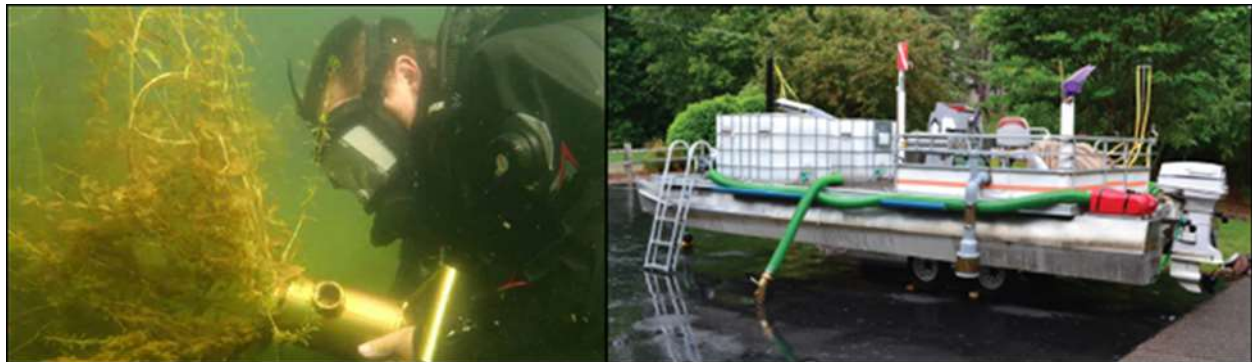
**Figure 62: DASH – Feeding EWM into the underwater Suction Hose (Marinette Co.); and a sample DASH Pontoon Boat (Beaver Dam Lake Management District)**

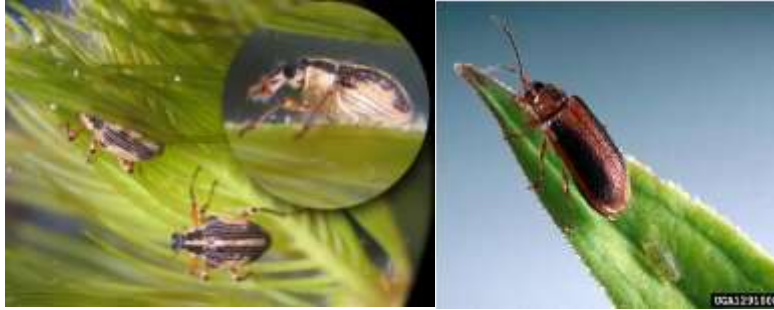
**Figure 64: Milfoil weevil (left) and purple loosestrife beetle (right)**

Biological controls do exist for EWM and purple loosestrife. The milfoil weevil (*Eubrychiopsis lecontei*) is a small, herbivorous aquatic beetle that is native to North America (Figure 64). It is a watermilfoil specialist, meaning that it feeds and develops only on plants in this genus. Its original host before the introduction of EWM was the native northern watermilfoil. The weevil completes all life stages fully submersed, feeding and developing on milfoil, and the larvae are stem miners. These characteristics make it unique, as specialist herbivores are very rare among aquatic insects (Newman, 2020). These characteristics are why the milfoil weevil has shown the most promise as a potential biocontrol agent for EWM and why it has been the subject of much research. Unfortunately, though these insects have been used in WI, the process of rearing and distributing them is very difficult and time consuming involving harvest of EWM from the lake the weevils are to be put in, setting up of rearing stations that consist of large water tanks and live EWM, tending and refreshing the tanks, collecting weevils in the field, and distributing them once they have propagated. This consultant is also not aware of any research that has been done to test the effectiveness of the weevils on hybrid watermilfoil.

To control purple loosestrife, the WDNR has been using four of its insect enemies, also from Europe, since 1994. Careful research has shown that all four control species depend only on loosestrife and do not threaten native plants. This is classic biocontrol, and it is likely the best long-term control for loosestrife, reducing the need for other more costly and disruptive controls, such as herbicides. Two beetle species (*Galerucella californiensis* and *pusilla*) have proven extremely effective at control (Figure 64). Both species of beetles feed almost exclusively on leaves, shoots, and stems of purple loosestrife during all their life stages. *Galerucella* beetles monitored in the state and elsewhere have decreased the vigor, size and seed output of purple loosestrife, allowing native plants to survive and increase naturally by competing better against smaller loosestrife plants.

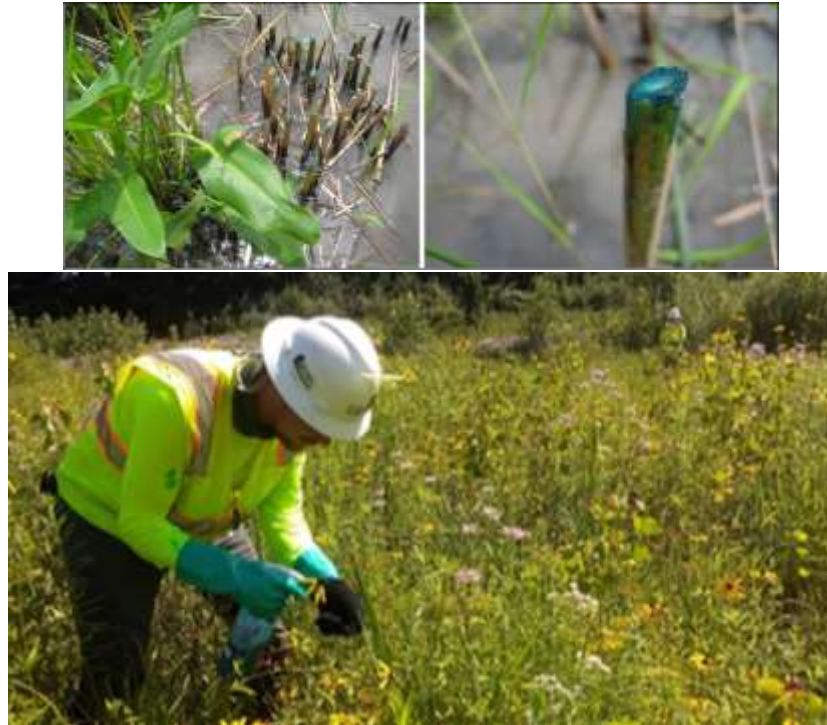
**Figure 65: Herbicide application using “Cut-stem dabbing” (top) and “wicking” (bottom)**

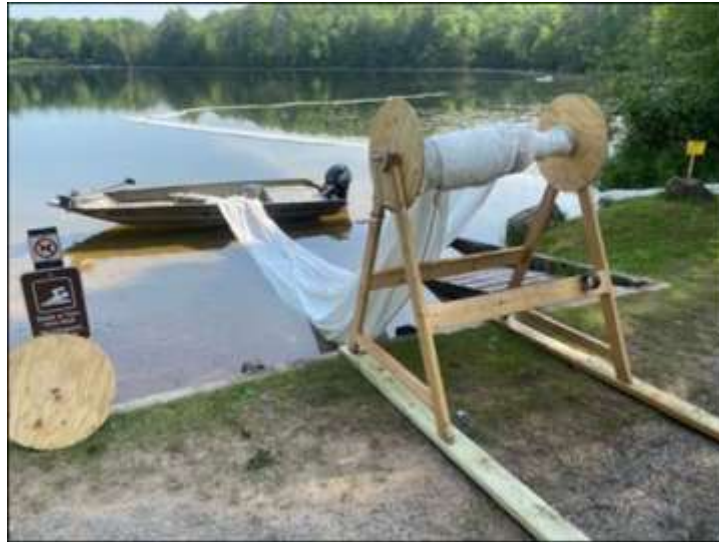
**Figure 66: Limno-curtain material on a roll before installation (photo from Marinette Co. LWCD)**

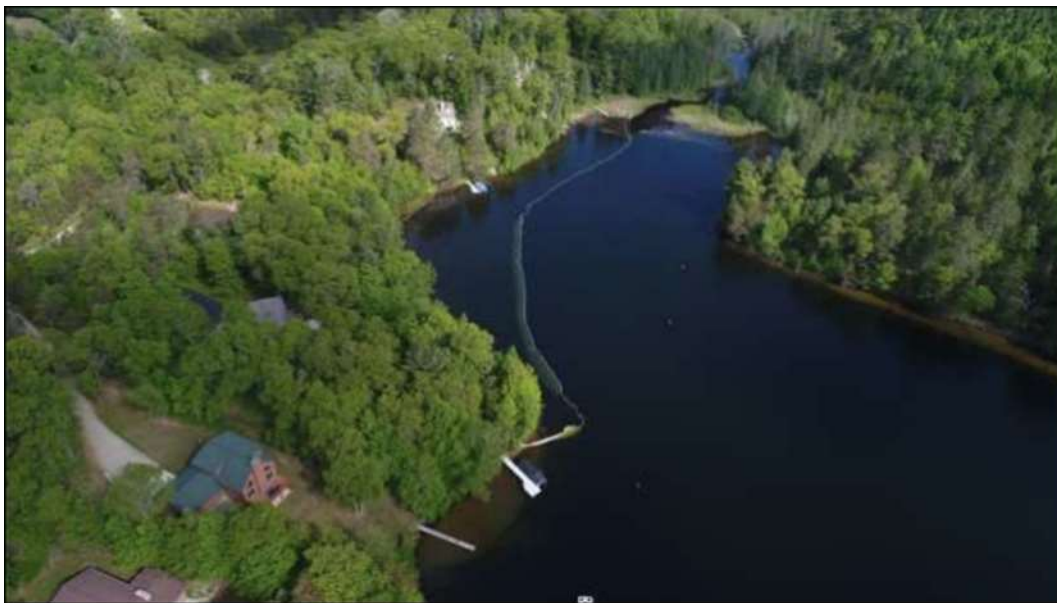
**Figure 67: Limno-curtain installed on Thunder Lake (photo from Marinette Co. LWCD)**
