State of the Lake

2018 Water Quality in Delavan Lake

Dale Robertson and Ben Siebers

U.S. Geological Survey, Upper Midwest Water Science Center

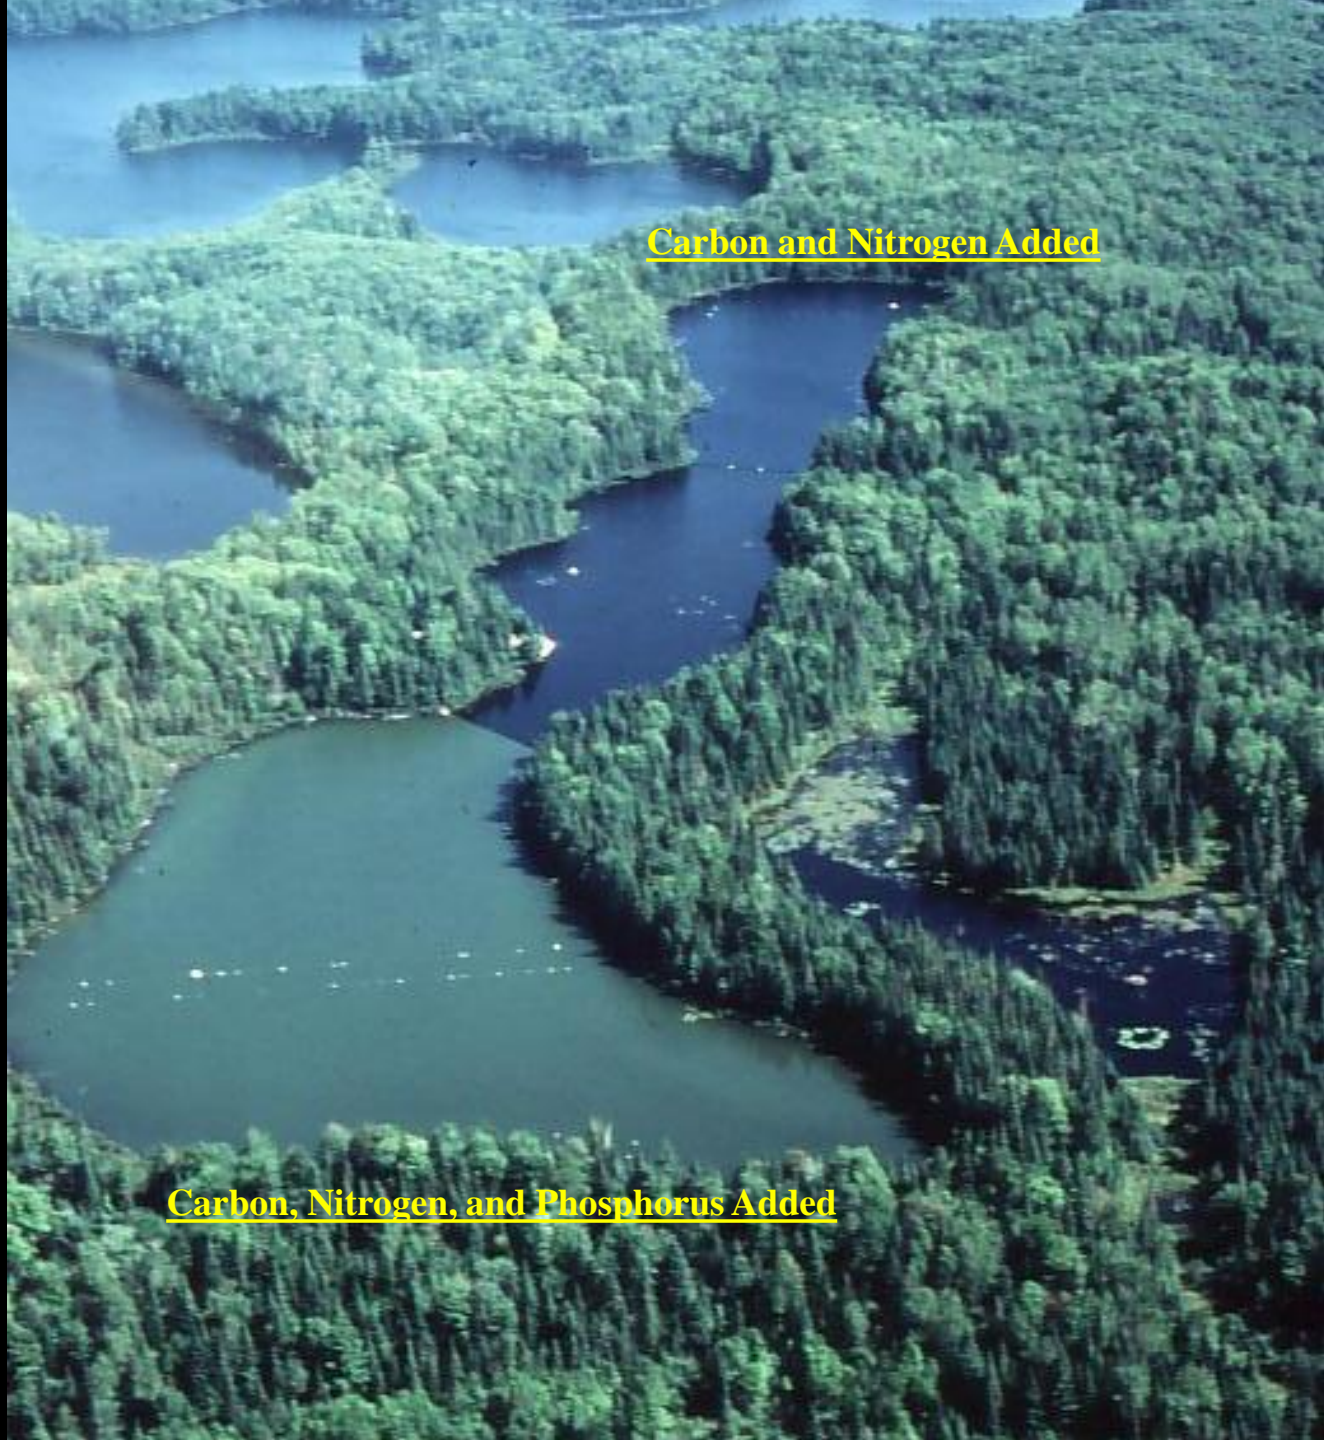
**Experimental Study
on Lake 226 in
Canada in the 1970s
demonstrated that
phosphorus was
usually the limiting
nutrient**

Carbon and Nitrogen Added

Carbon, Nitrogen, and Phosphorus Added

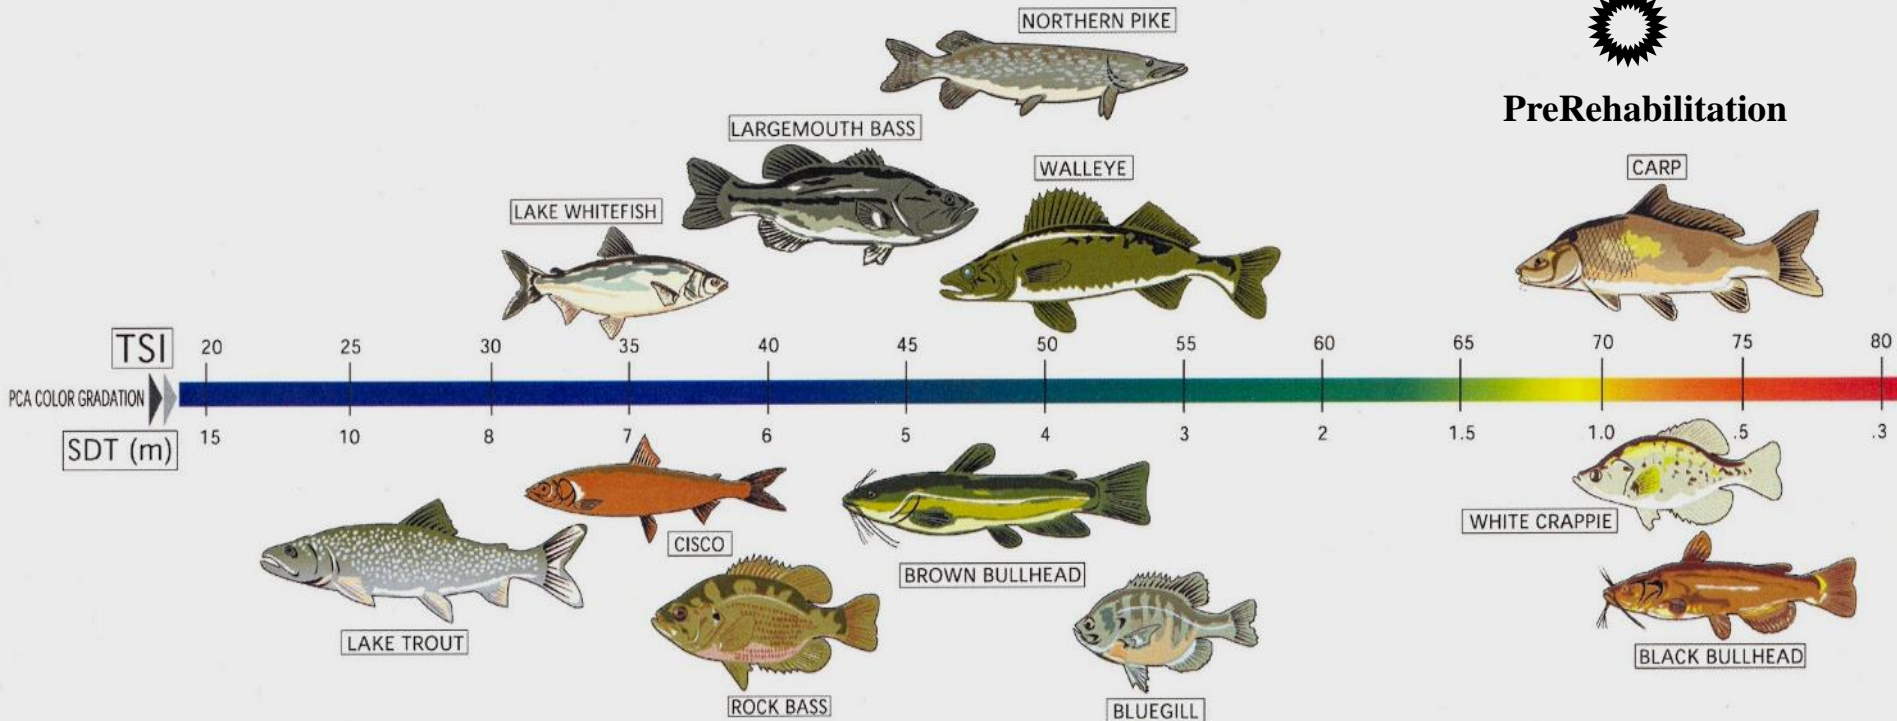
Typical conditions associated with trophic status

PreRehabilitation

Every change of 10 in the TSI corresponds to a doubling of a lake's algae biomass and a halving of water clarity.

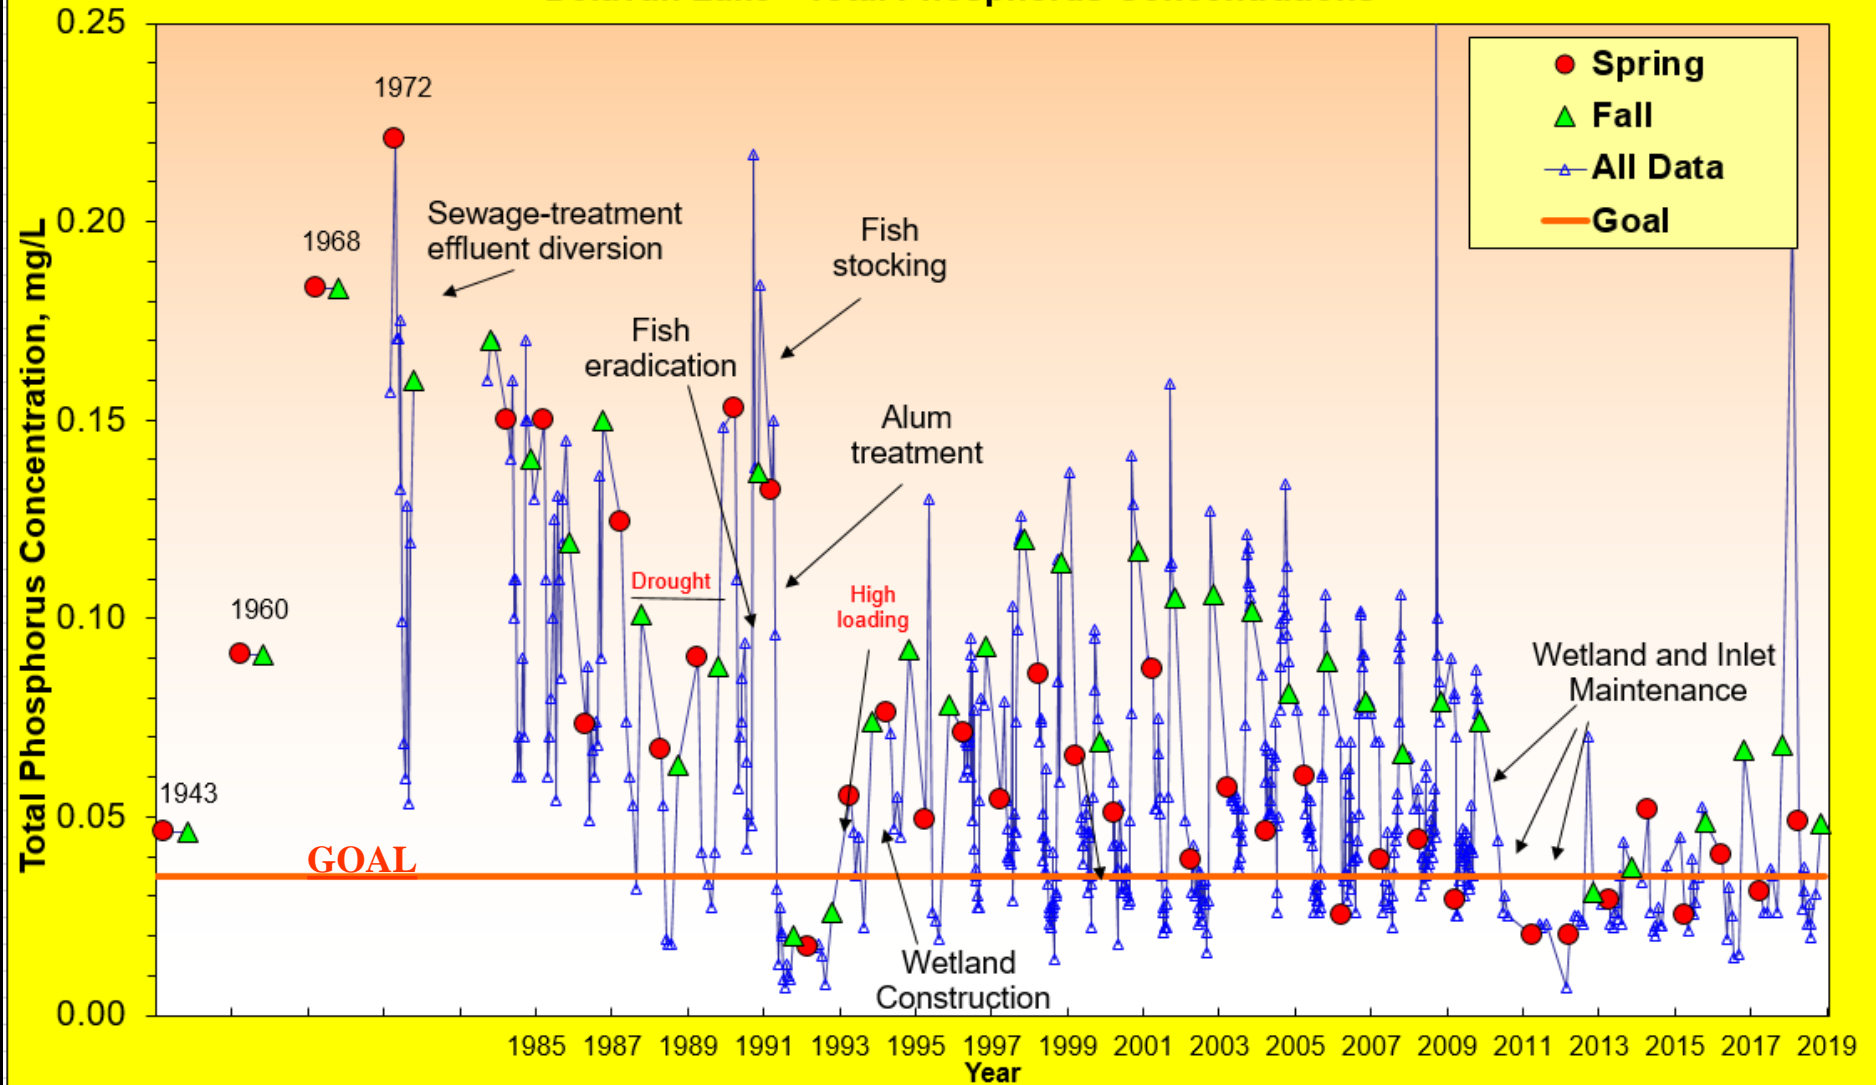
Delavan Lake - Total Phosphorus Concentrations

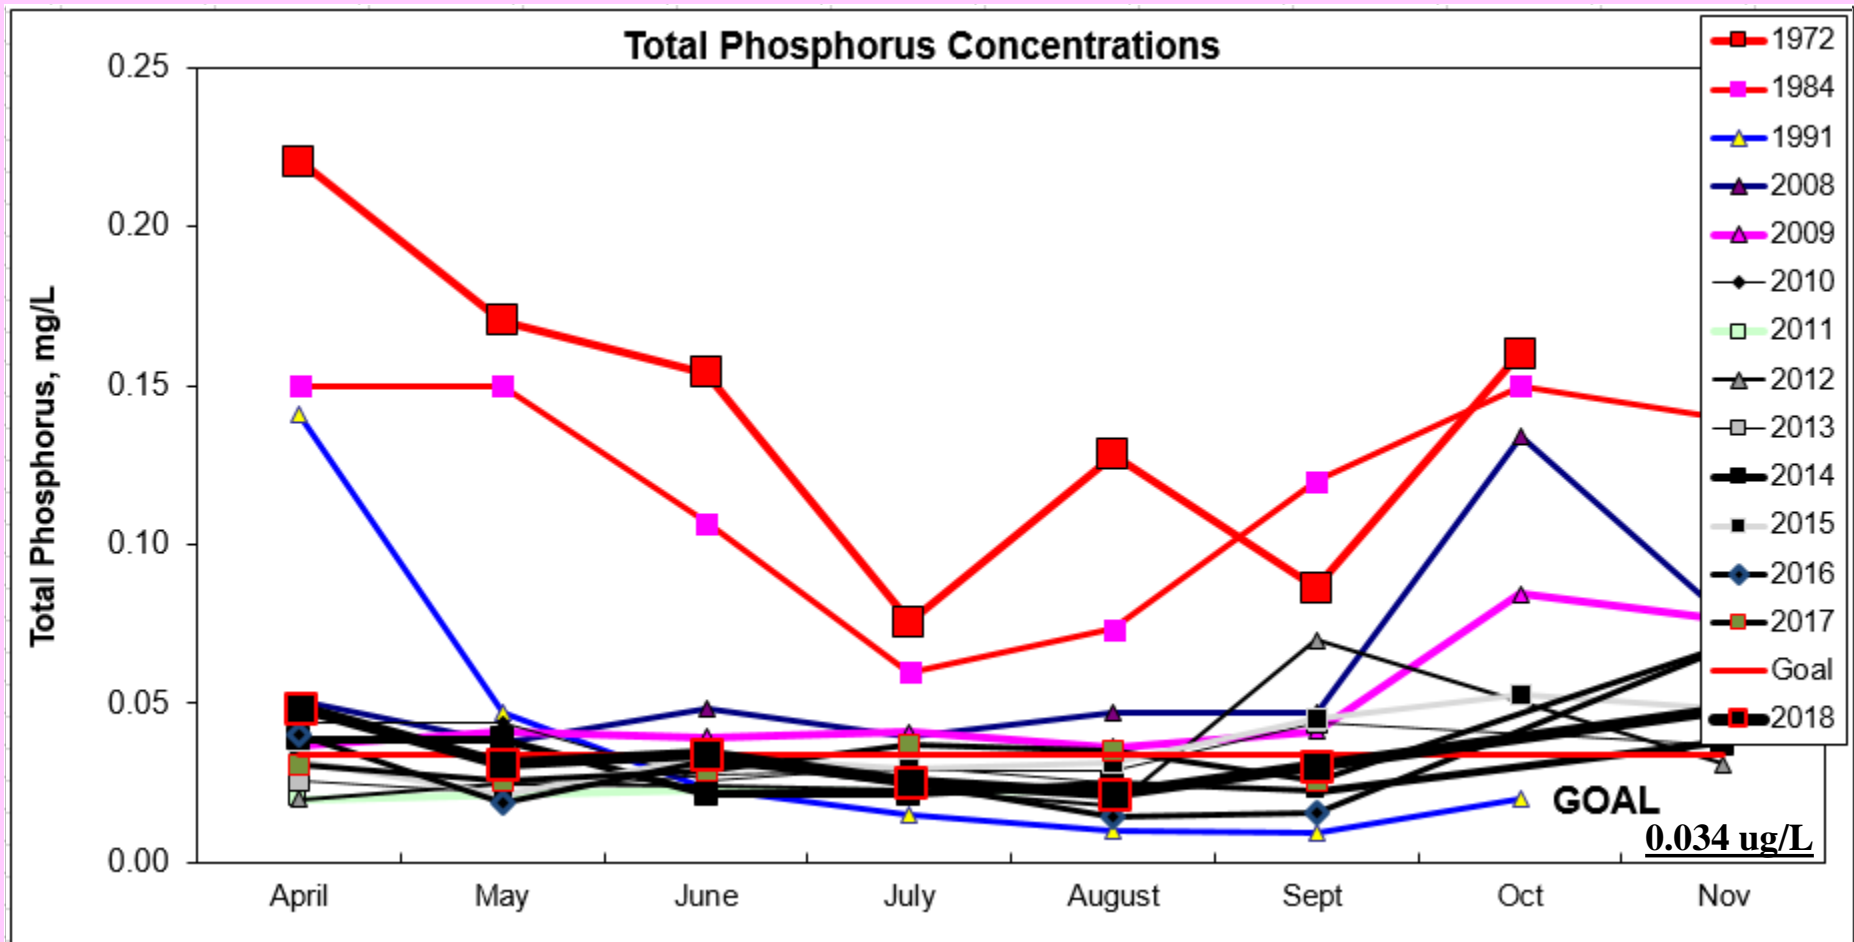
2018 Water Quality – Surface Phosphorus Concentrations

Indicator of the Source of the Potential Problems

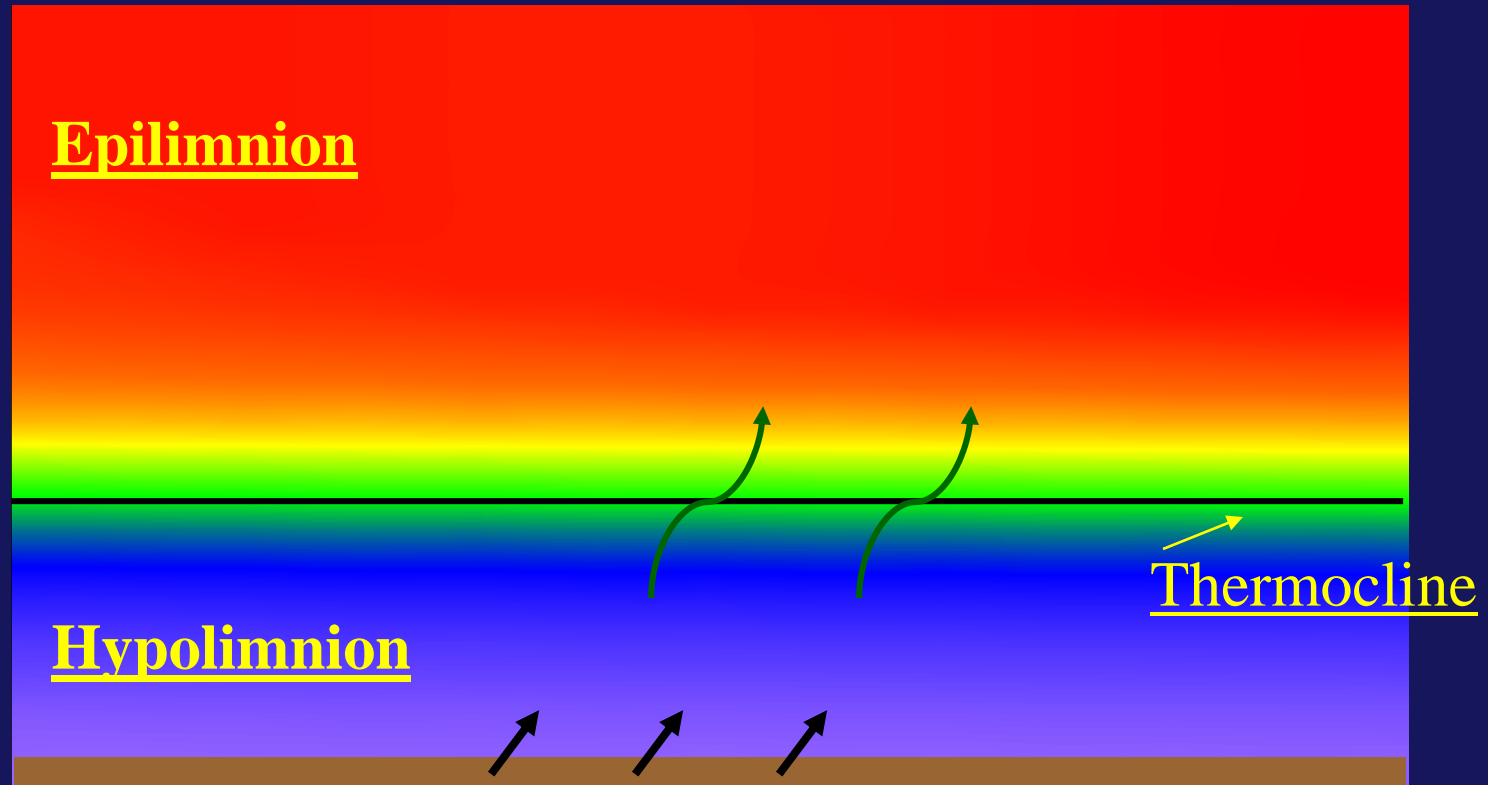
Internal Release of Phosphorus from Deep Sediment “Internal Loading”

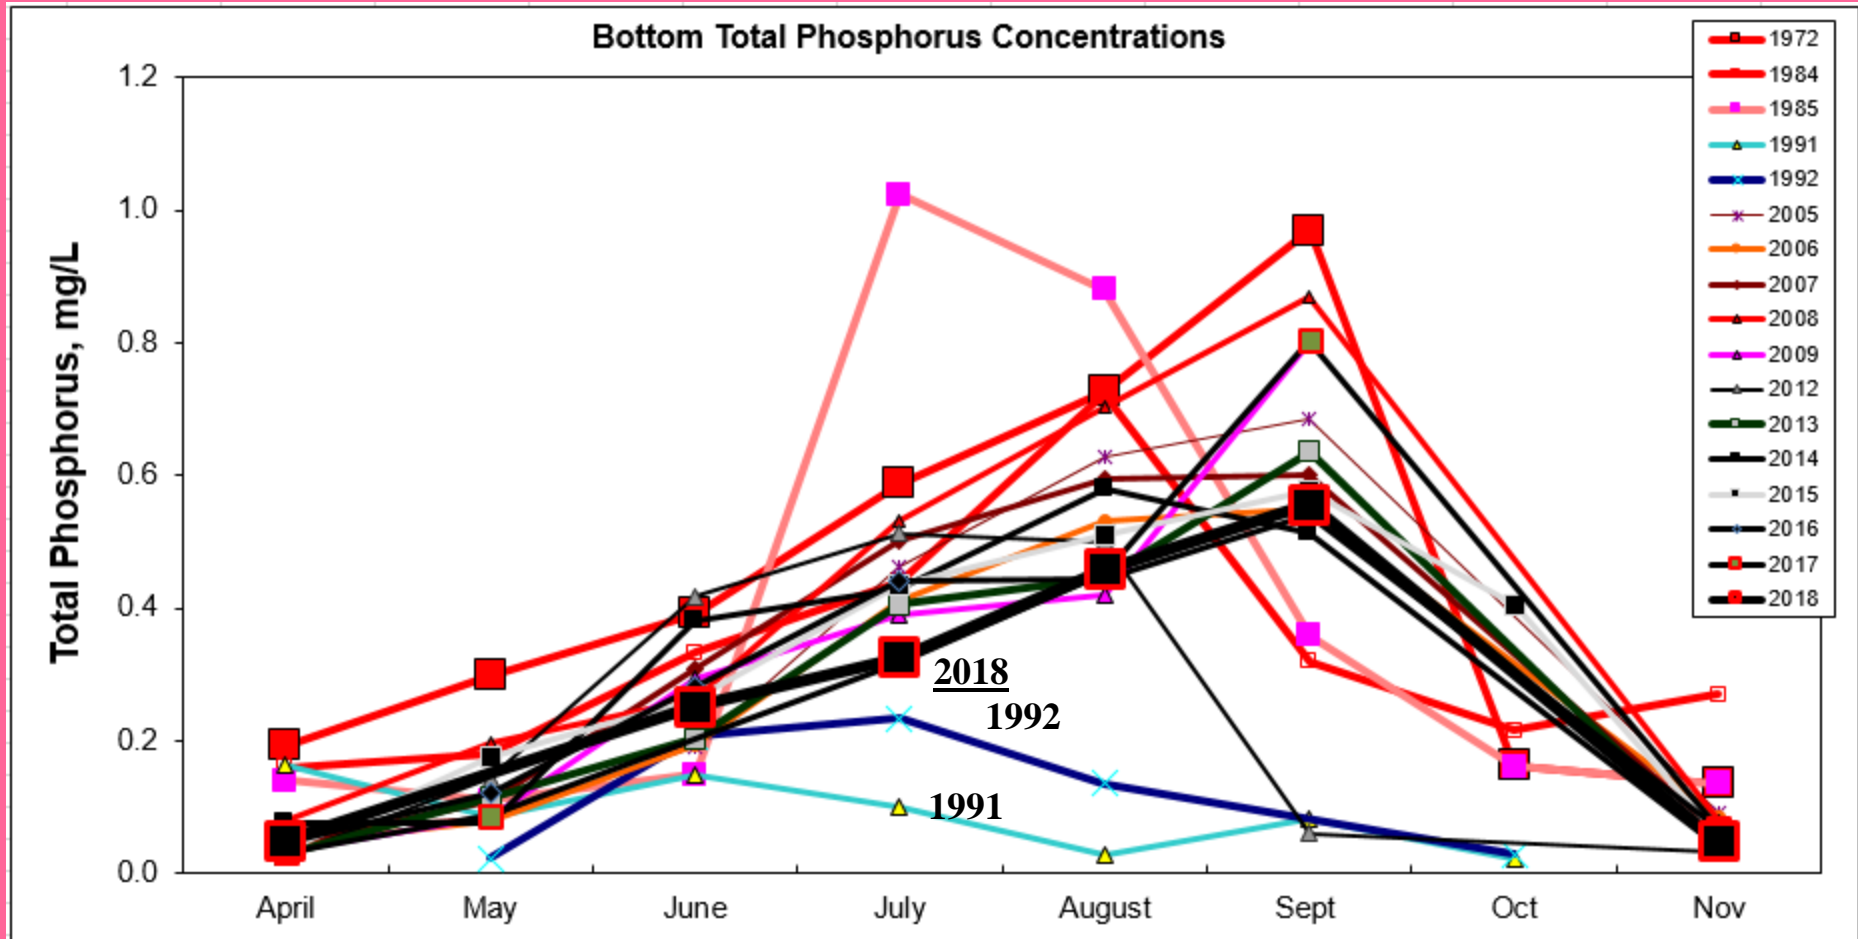
2018 Water Quality – Bottom Phosphorus Concentrations

Indicator of the amount of P coming in from lake sediments

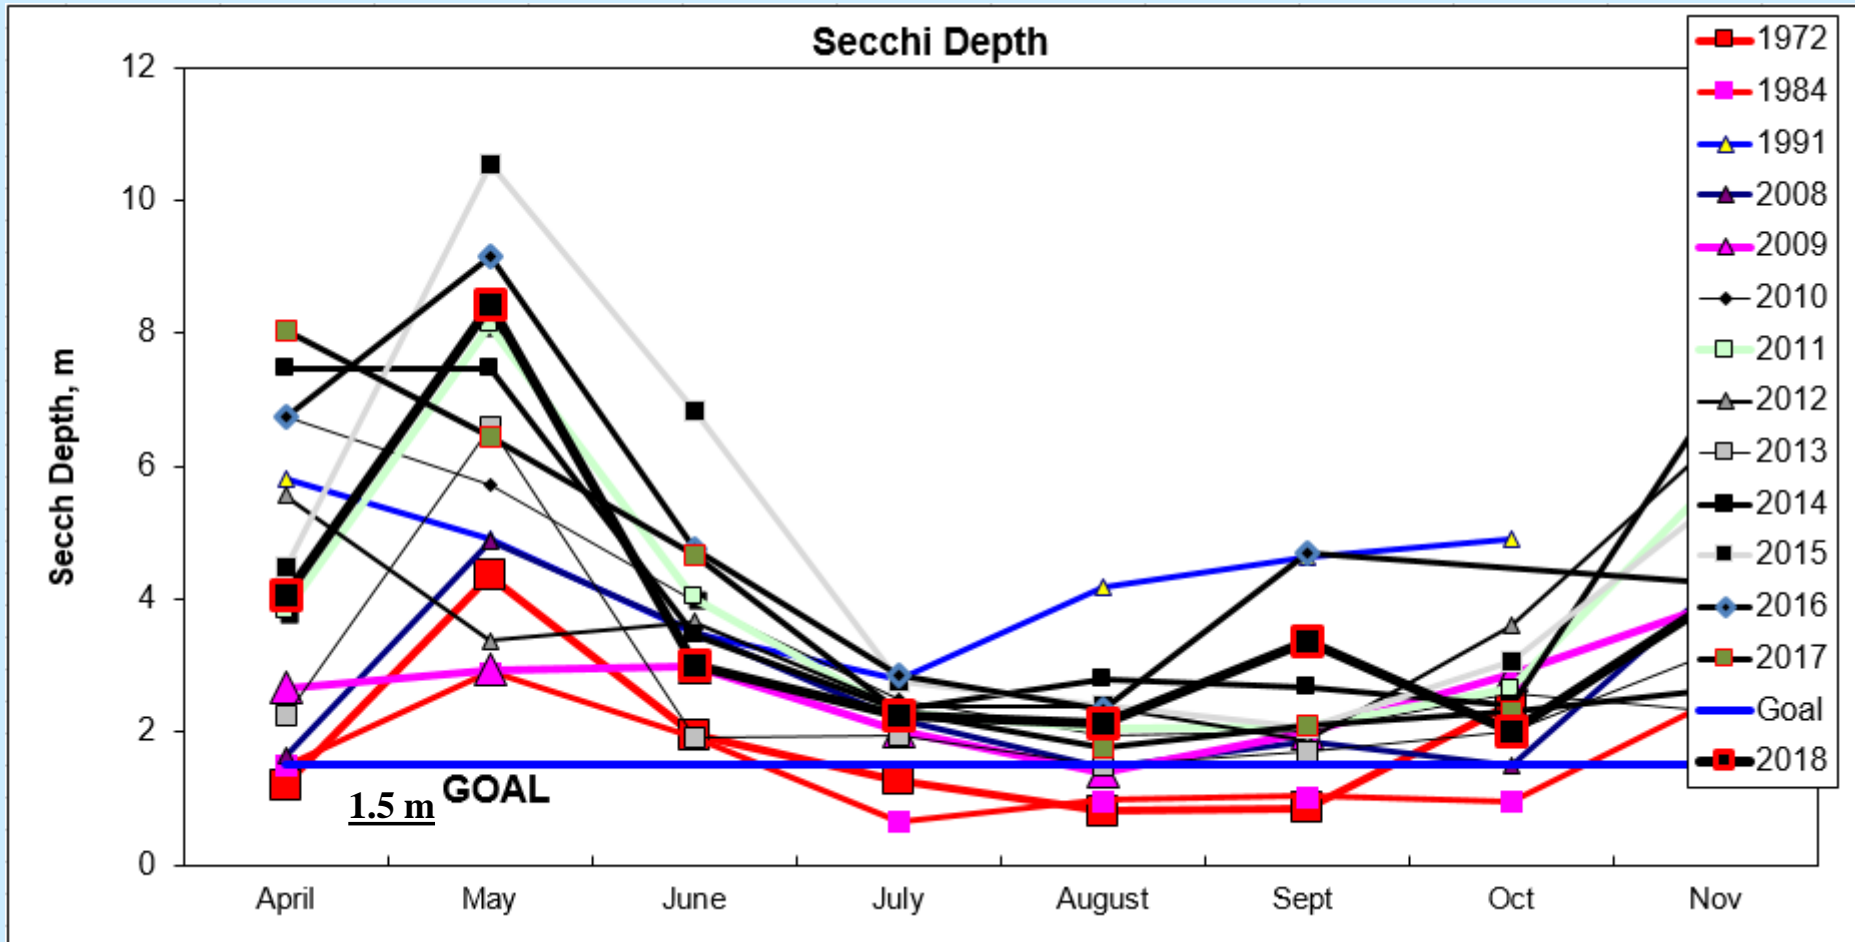
2018 Water Quality – Secchi Depth

Indicator of the water clarity in the lake

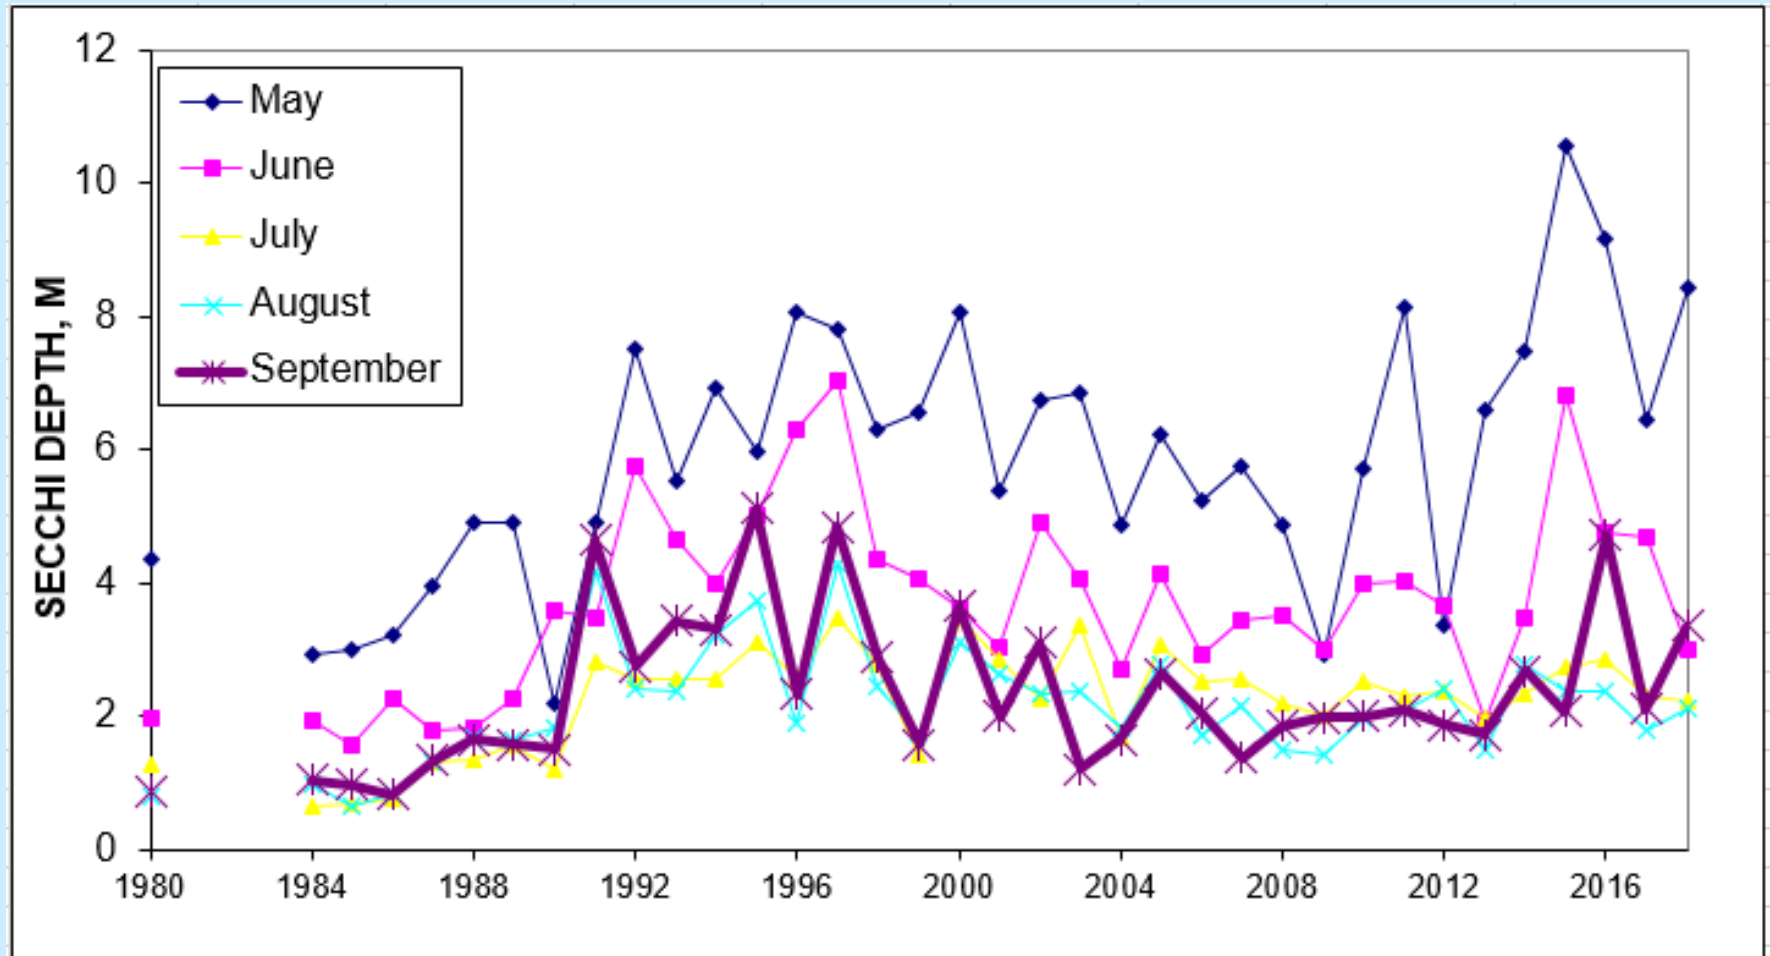
Monthly Changes in Water Clarity

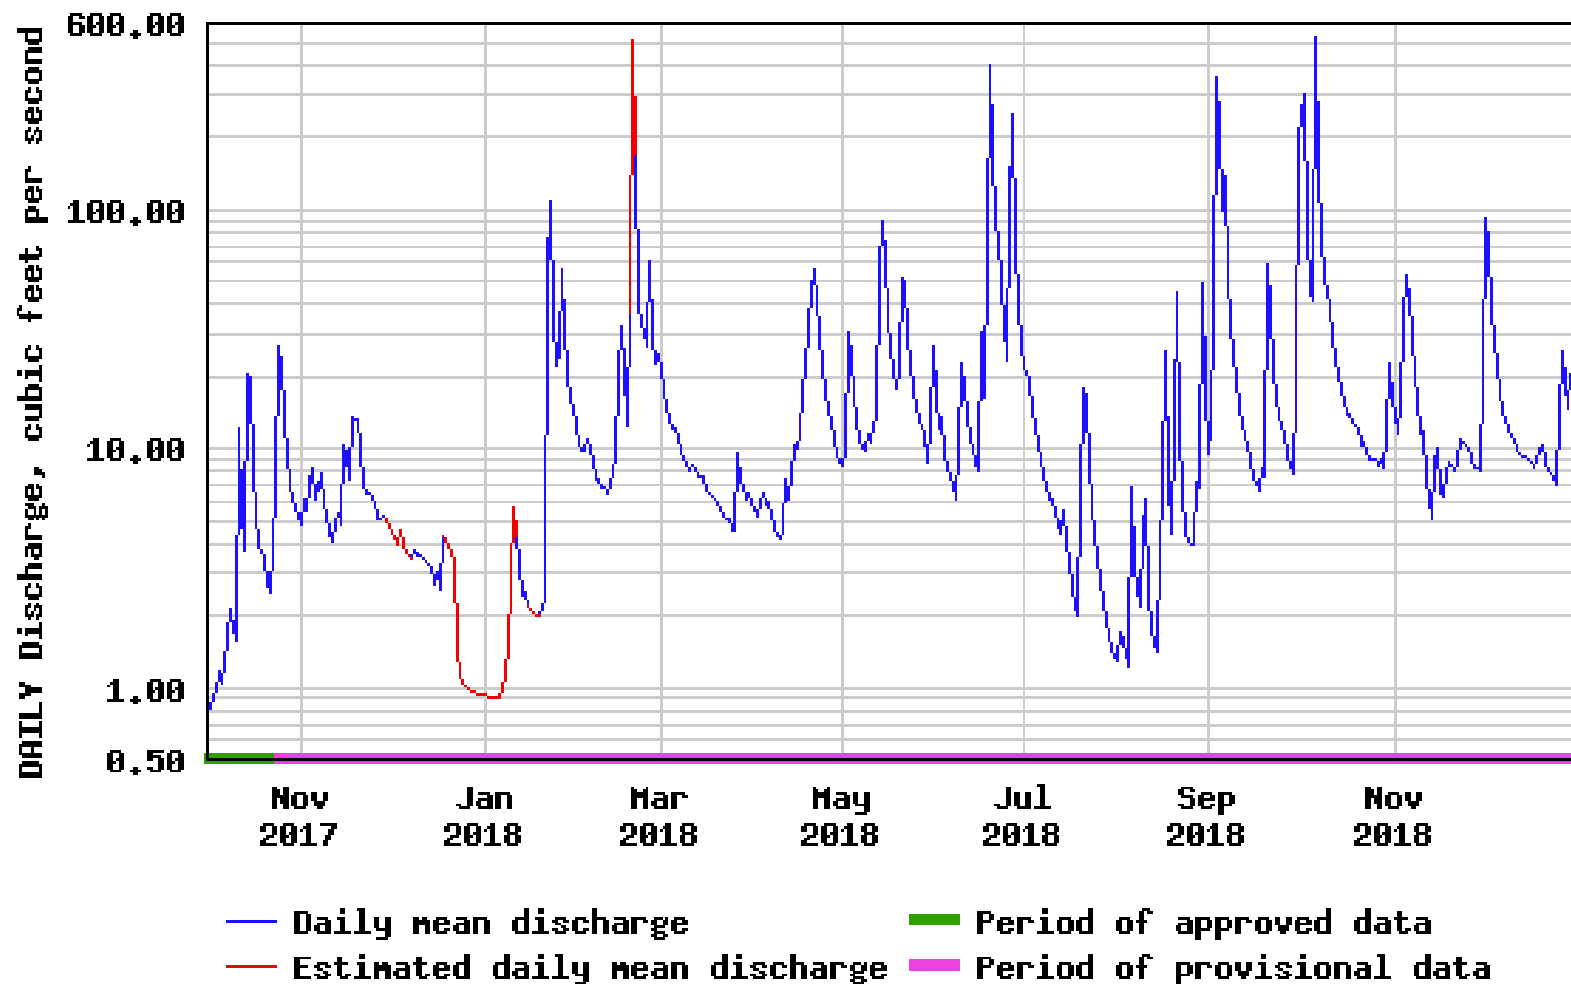
USGS 05431016 JACKSON CREEK AT MOUND ROAD NEAR ELKHORN, WI

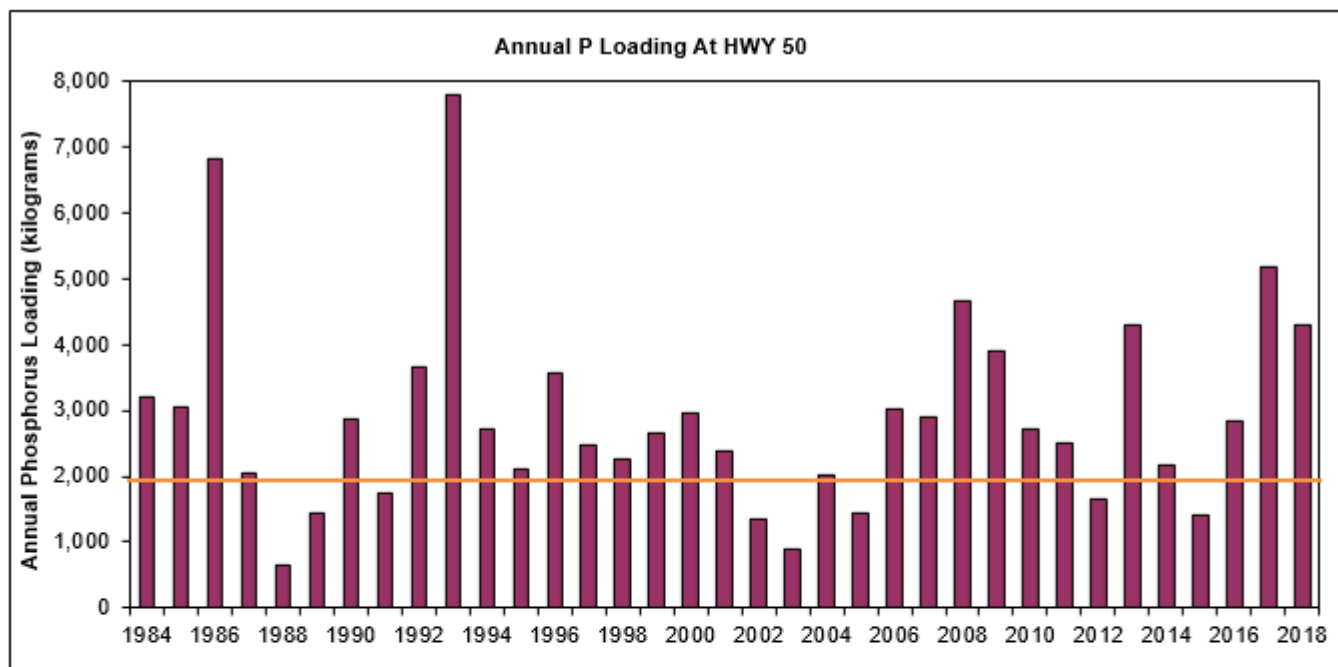
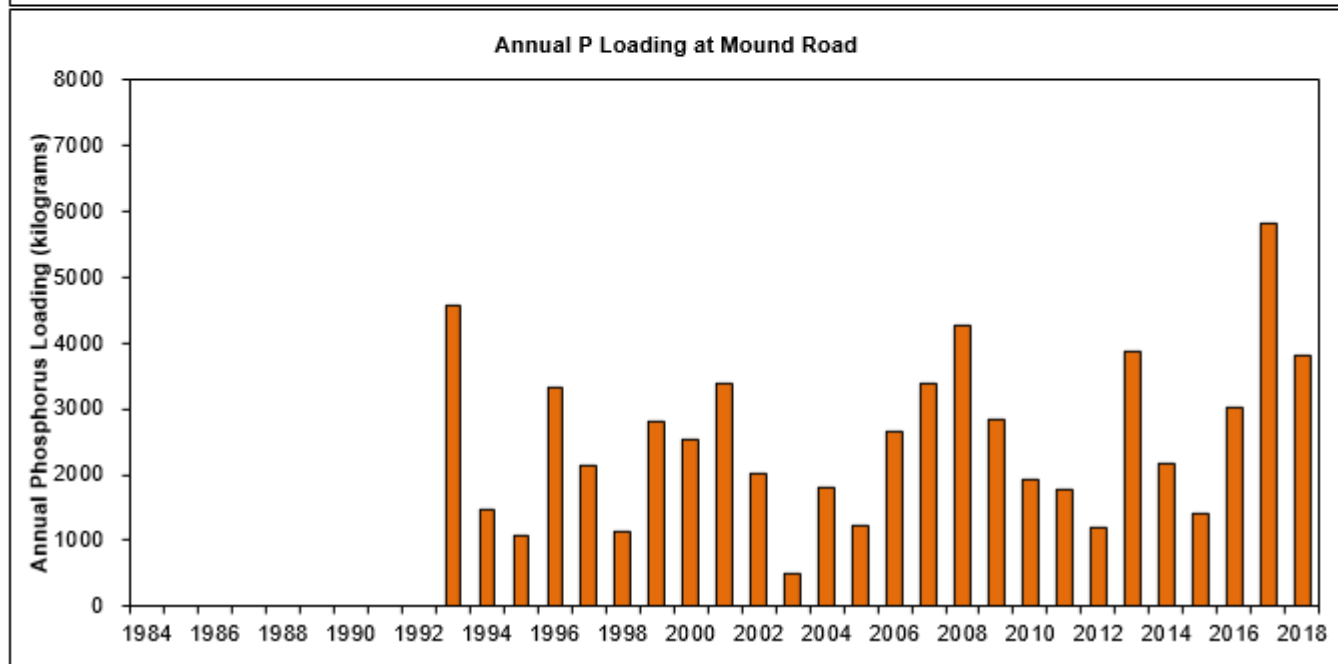
Phosphorus Loading to Delavan Lake from Jackson Creek

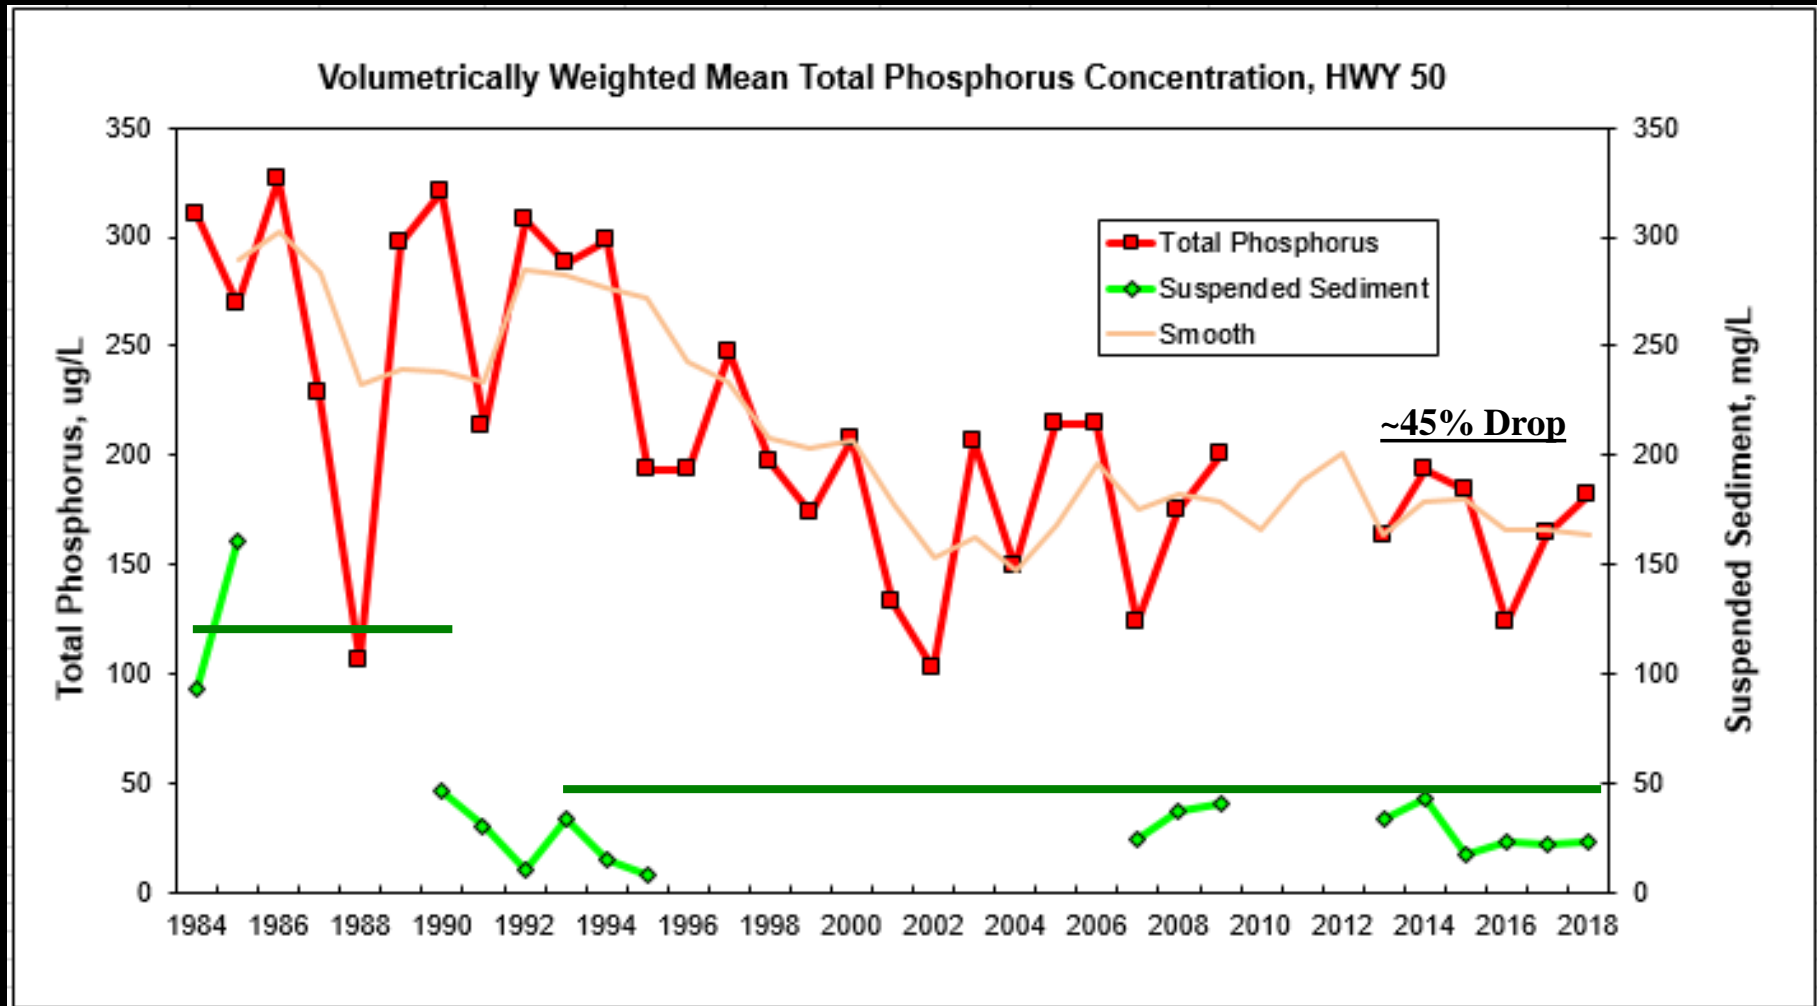
Changes in the Watershed Appear to Be Working After you remove the effects of differences in flow

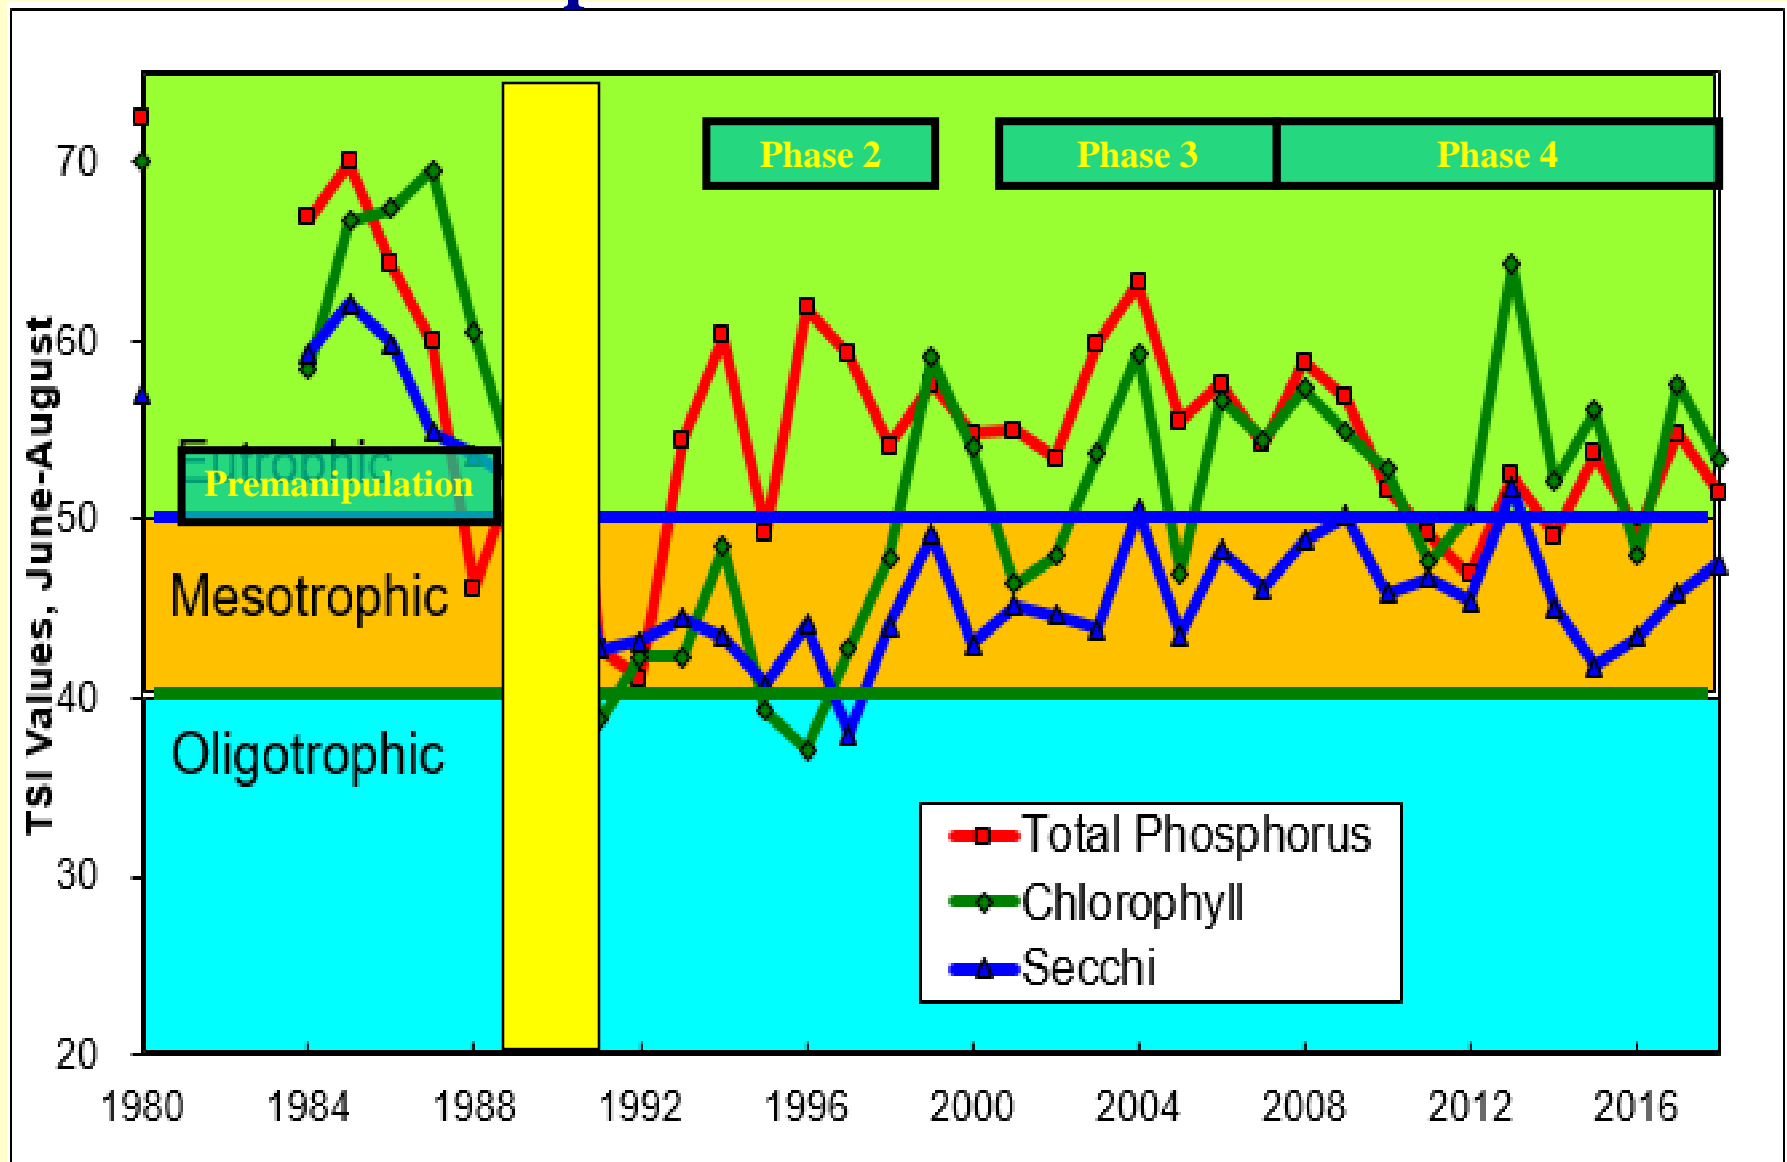
Trophic State of Delavan Lake

**The biology in the lake is affecting
the amount of algae and clarity in
the lake...**

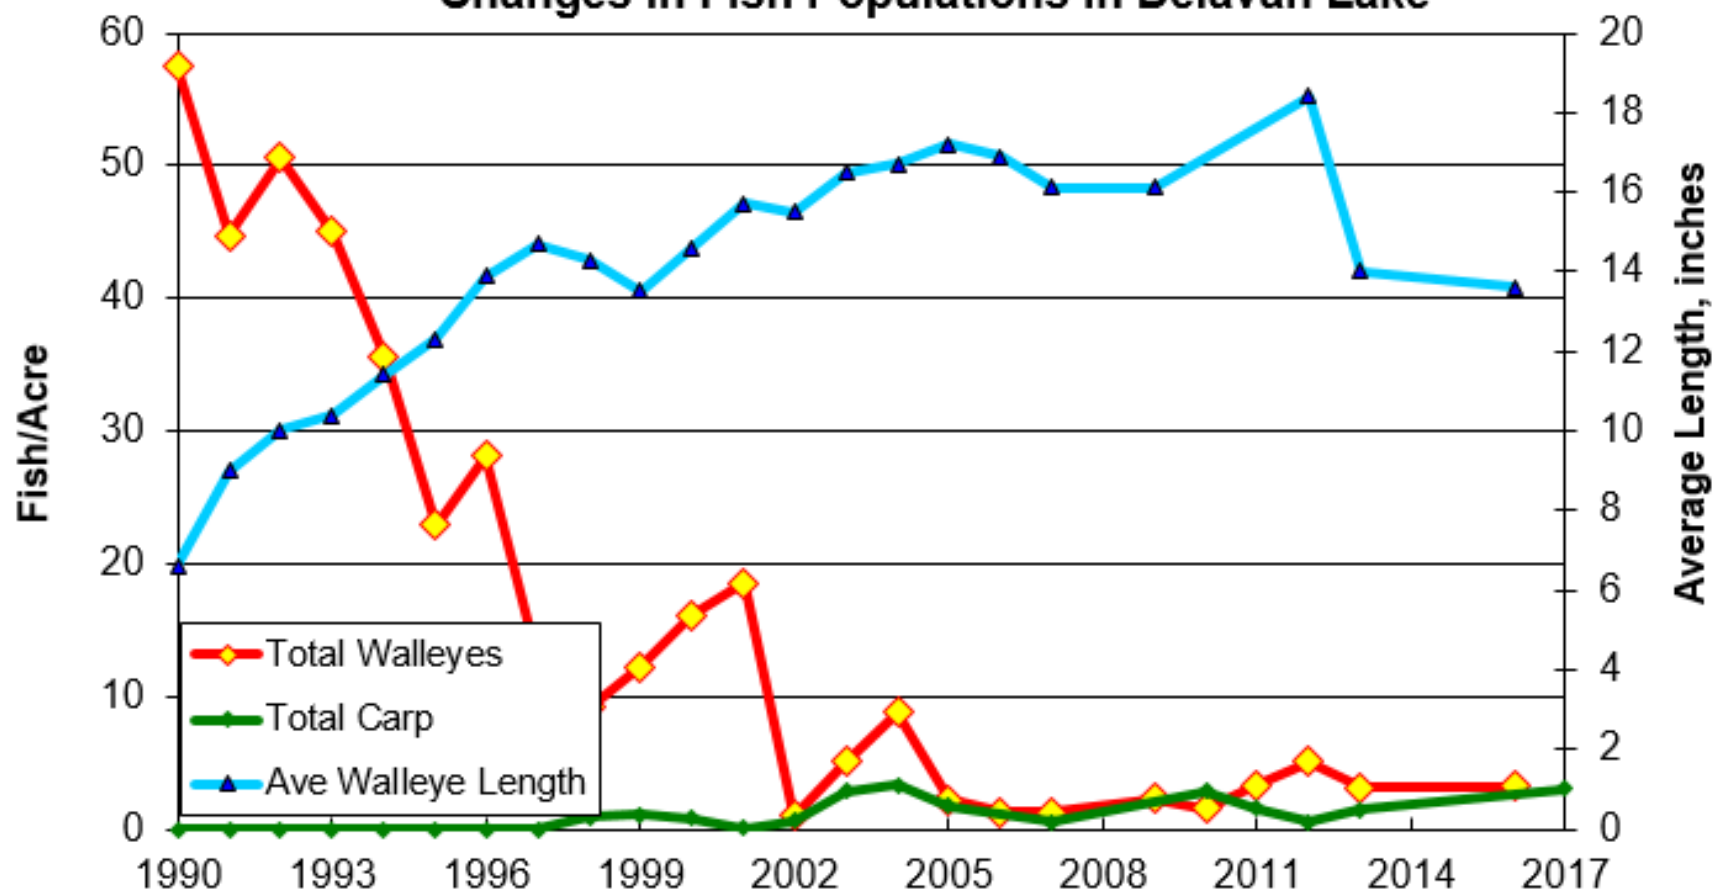
Changes in Fish Populations in Delavan Lake
