**Veteran Hill Road Solar Project**  
**Town of Veteran, Chemung County, New York**

**Project Narrative**

**April 2026**

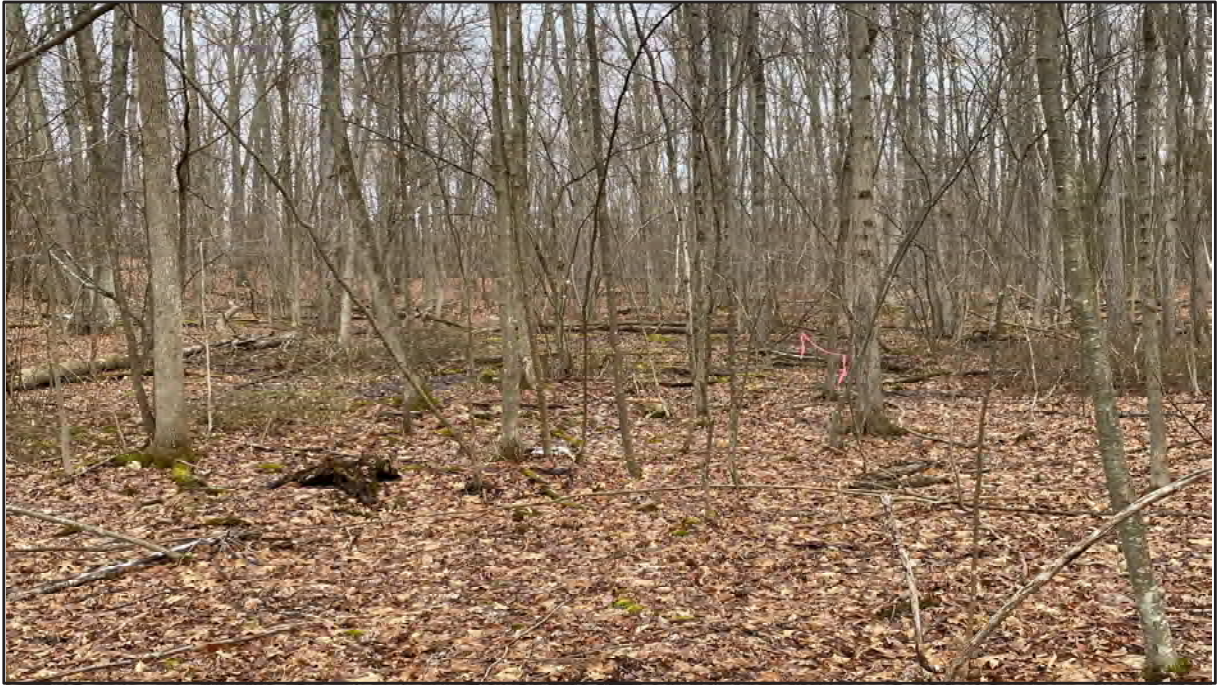
**Photo 3.** Photo view facing north with previously delineated wetland WD visible in the background. Photo taken from northwest corner of investigation area.

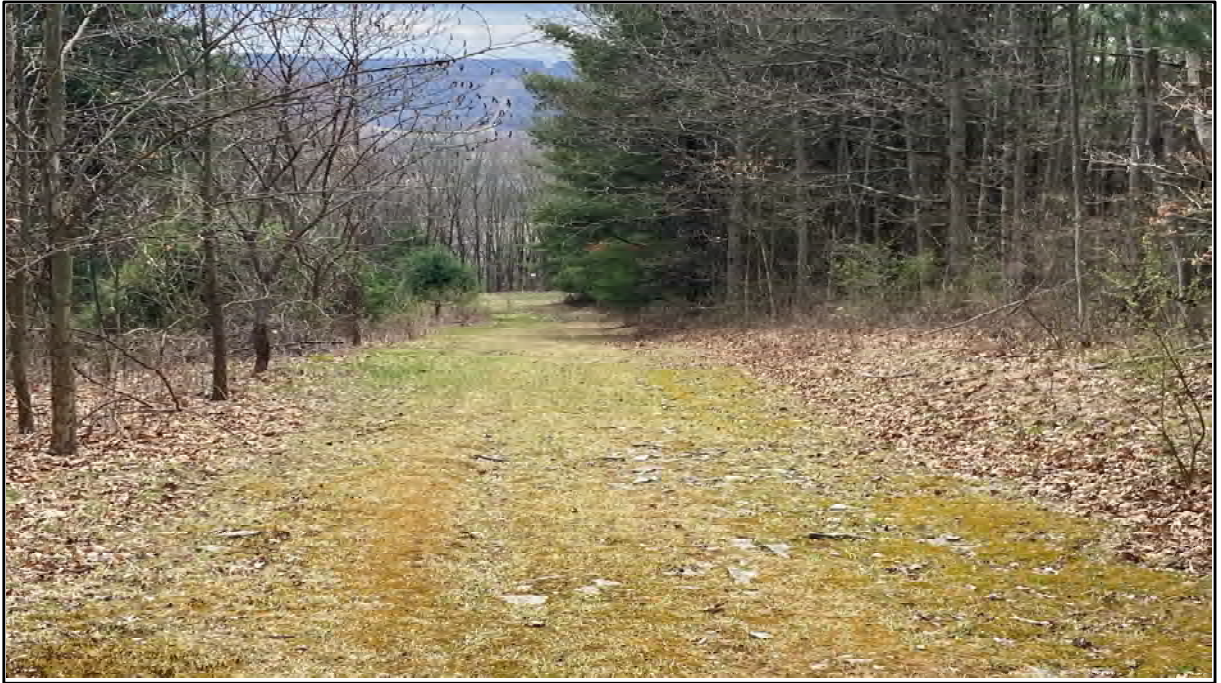
**Photo 21.** Photo view facing south, down gradient along proposed site access/project interconnection route. Photo taken from northeastern portion of proposed site access/project interconnection route.

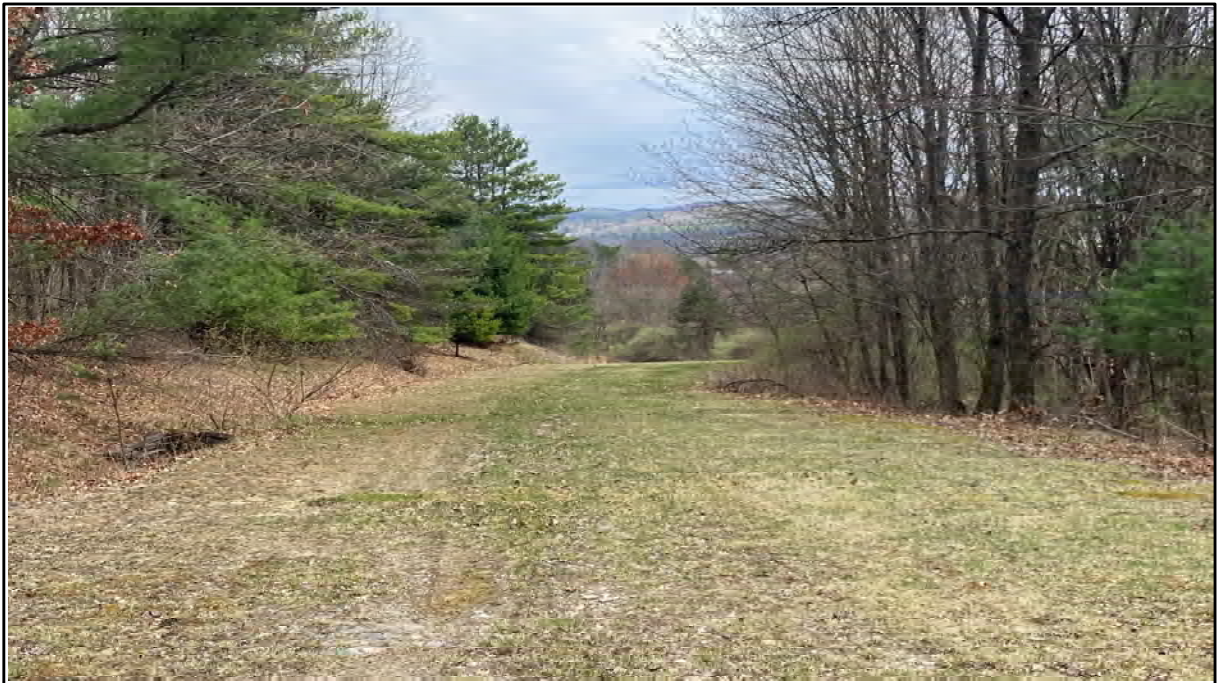
**Photo 22.** Photo view facing east, cross gradient along proposed site access/project interconnection route. Photo taken from northward turn on proposed site access/project interconnection route.

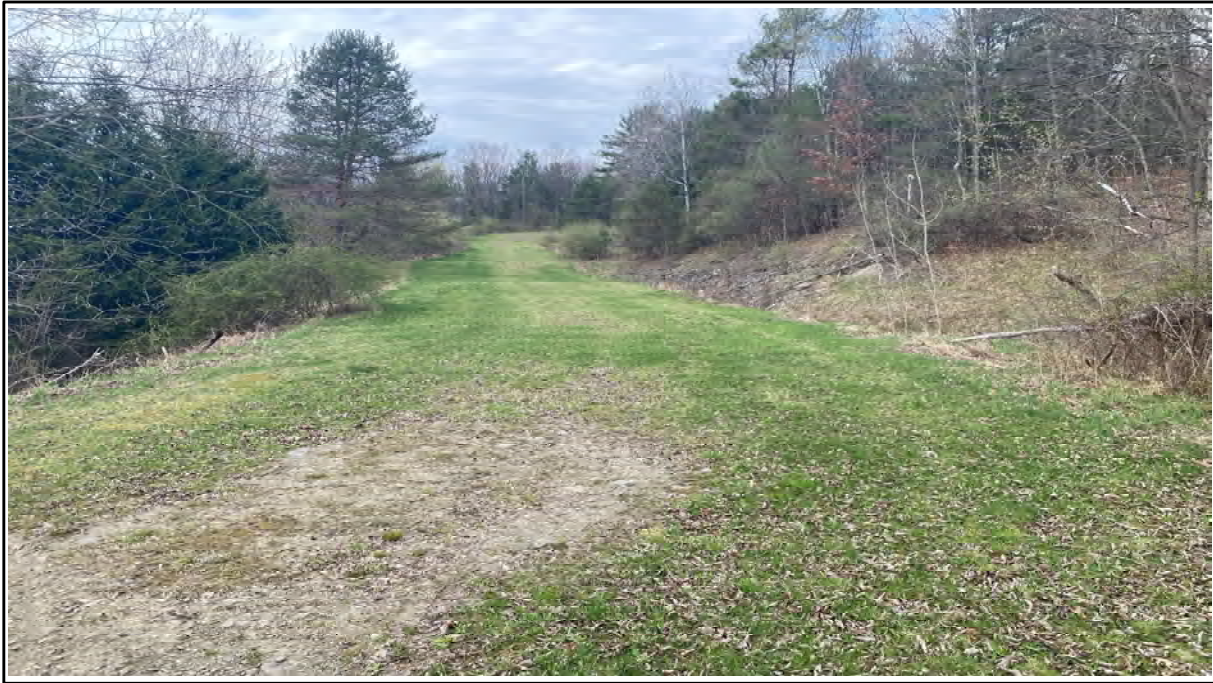
**Photo 23.** Photo view facing west, upgradient along proposed site access/project interconnection route. Photo taken from existing access road gate.

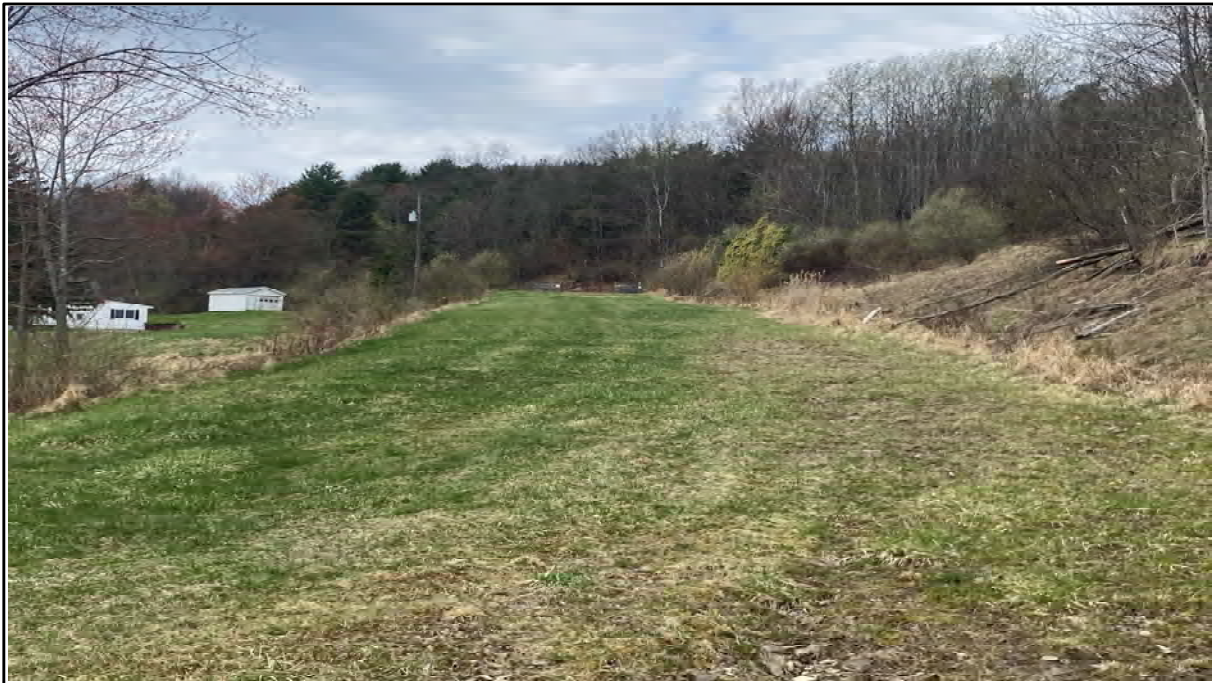
**Photo 24.** Photo facing west, upgradient along proposed site access/interconnection route. Photo taken from westward turn on existing access road, access road gate visible in distance.

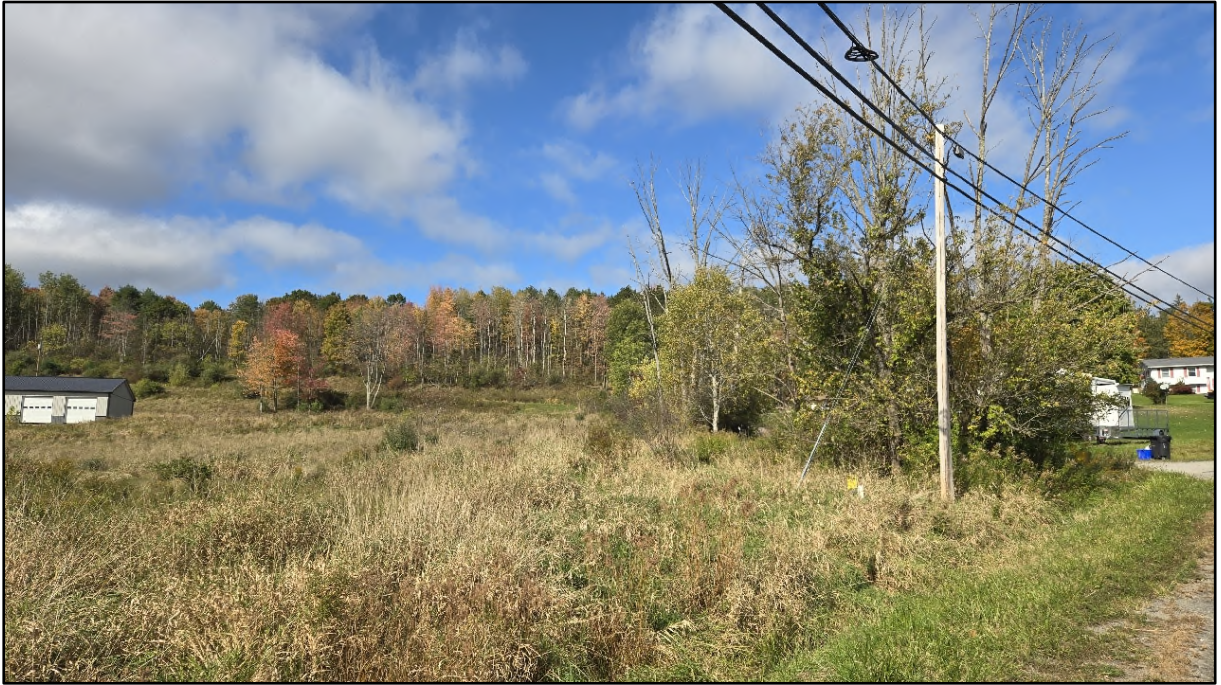
**Photo 1.** Photo facing north from Veteran Hill Road depicting the location of the proposed site access/project interconnection route.

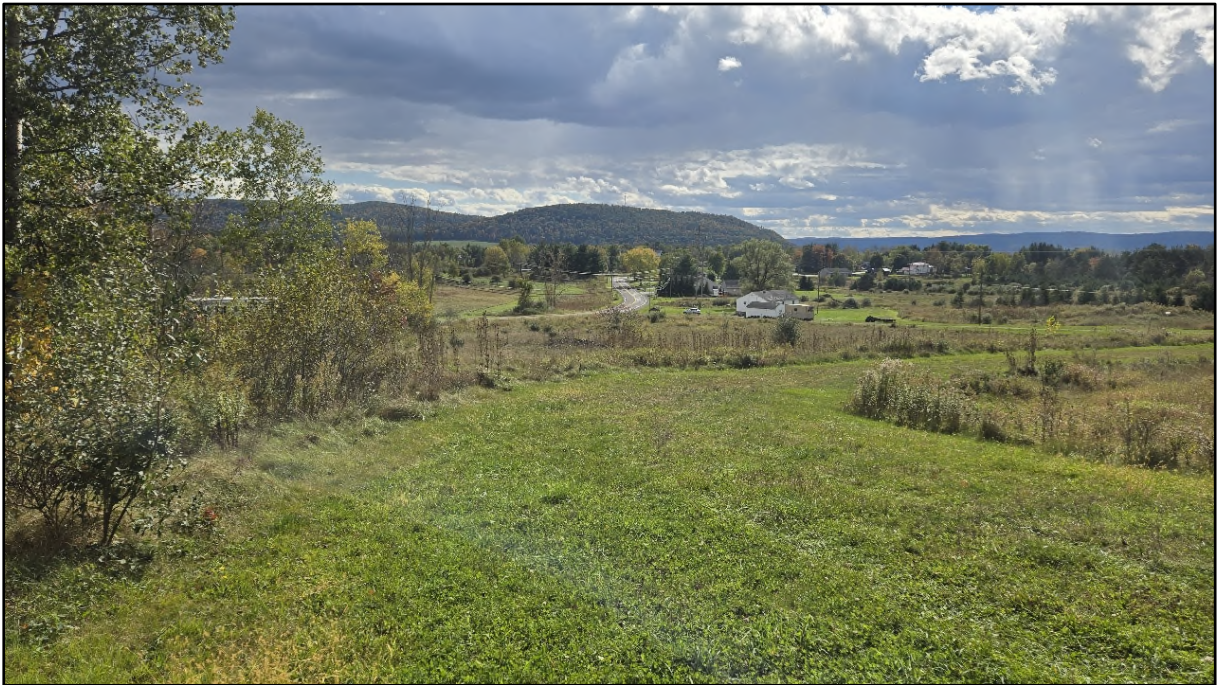
**Photo 2.** Photo facing south depicting the proposed route for site access and project interconnection to Veteran Hill Road (background).

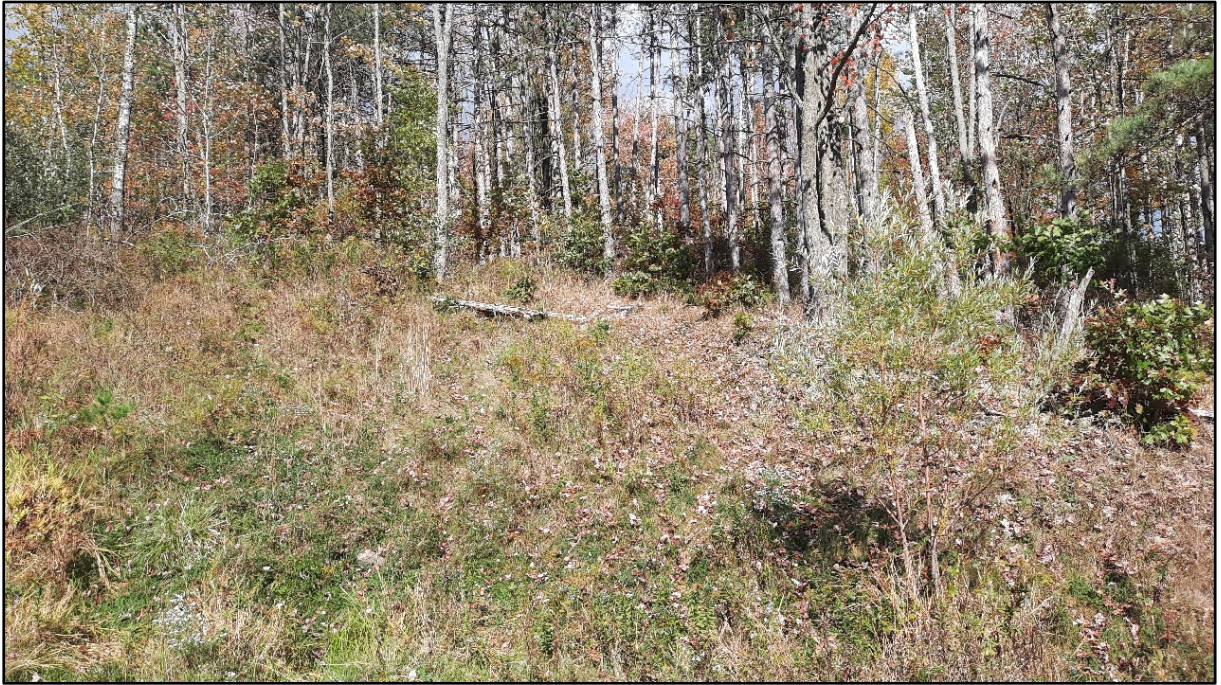
**Photo 3.** Photo facing north depicting the location where the proposed route for site access/interconnection enters old growth woodlands. Note the significant slopes present at this location.

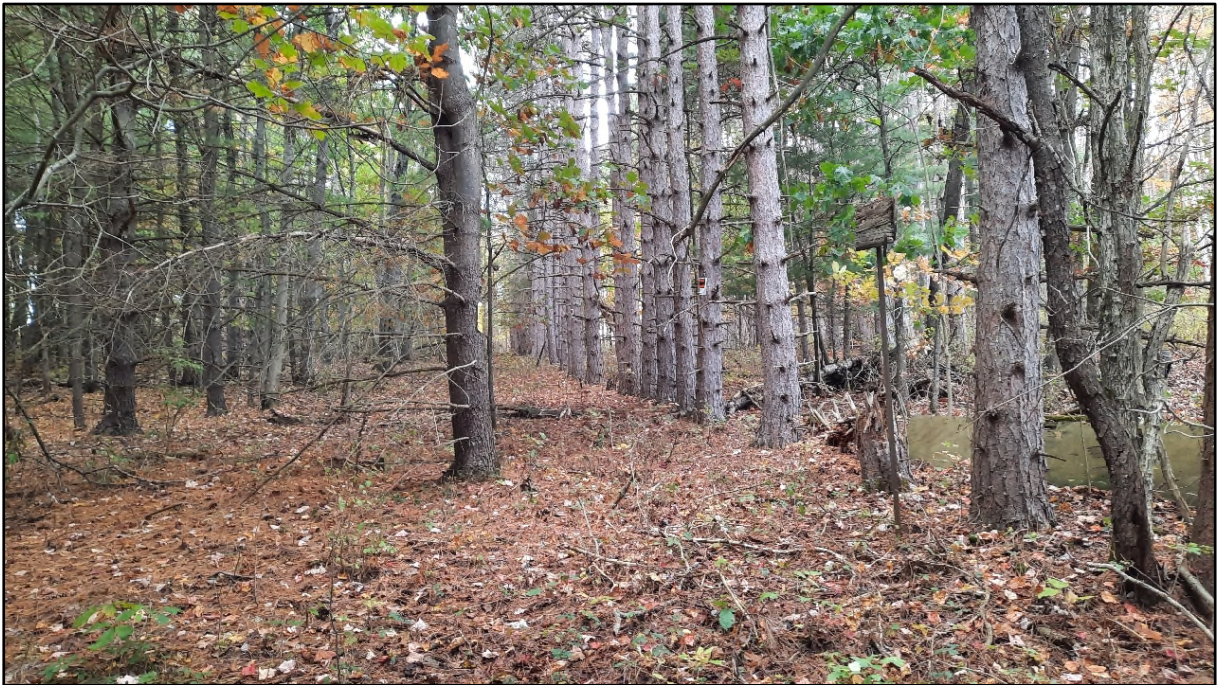
**Photo 4.** Photo facing north depicting the location of the proposed site access/interconnection route within the old growth woodlands. Note the property boundary and adjacent parcel to the east (right), identified by the linear tree line.

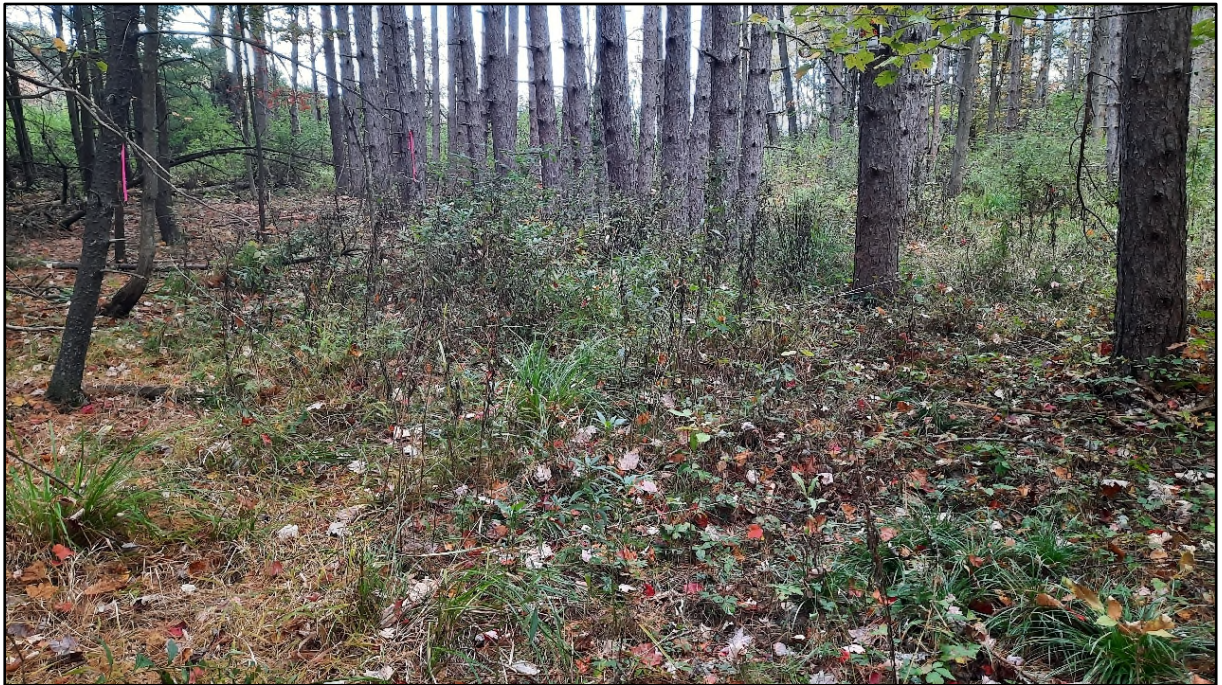
**Photo 5.** Photo facing northeast depicting wetland WA. This small wetland area is a localized depression and includes species such as fringed sedge (*Carex crinita*, OBL), giant goldenrod (*Solidago gigantea*, FACW), woolgrass (*Scirpus cyperinus*, OBL) and red maple (*Acer rubrum*, FAC)

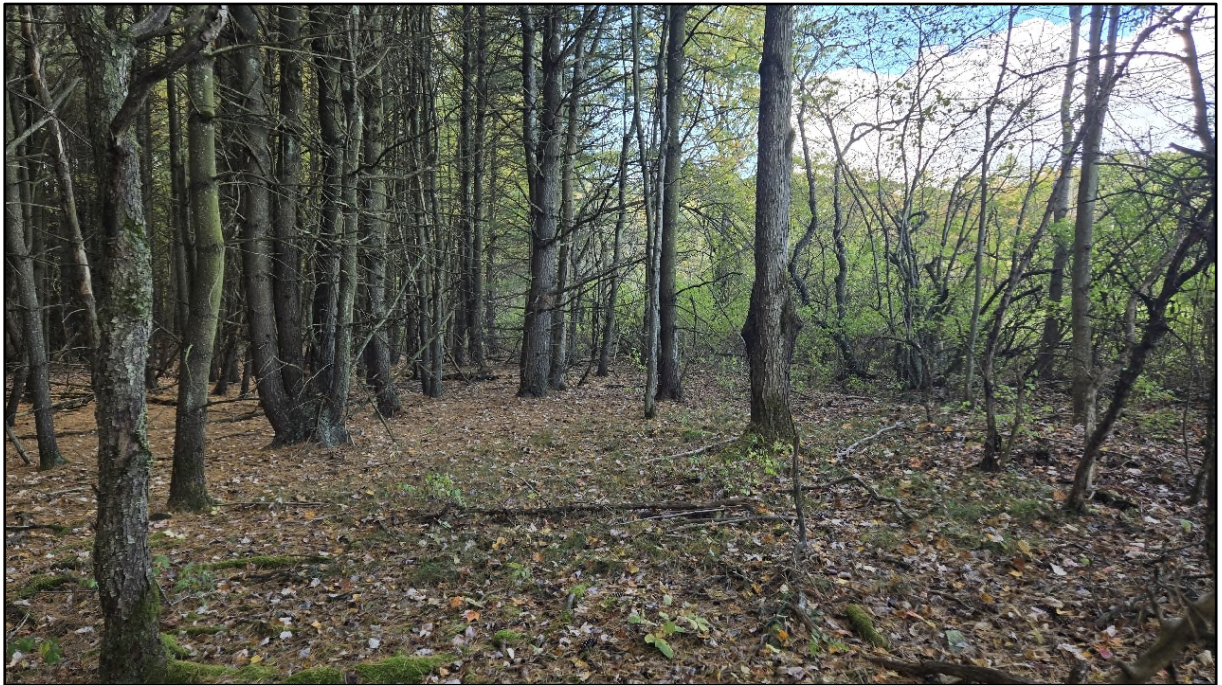
**Photo 7.** Photo facing west from the proposed site access/interconnection depicting typical upland conditions on the site. Uplands on the subject site can be typically characterized by white pine (*Pinus strobus*, UPL), pignut hickory (*Carya glabra*, FACU), American hornbeam (*Carpinus caroliniana*, FAC) and eastern cottonwood (*Populus deltoides*, FAC).

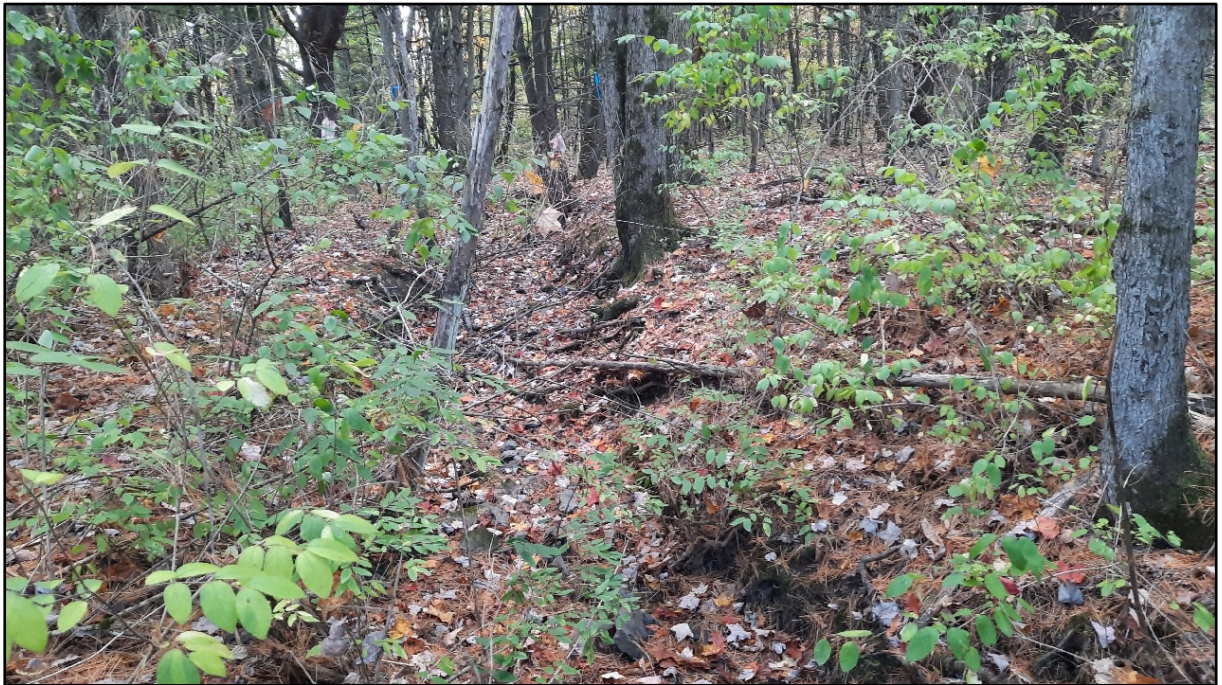
**Photo 8.** Photo facing south depicting the delineated ephemeral stream S2. This ephemeral stream is located adjacent to the southwest corner of the agricultural field by which it receives hydrologic input. This stream flows southwardly and bisects the proposed access/interconnection route.

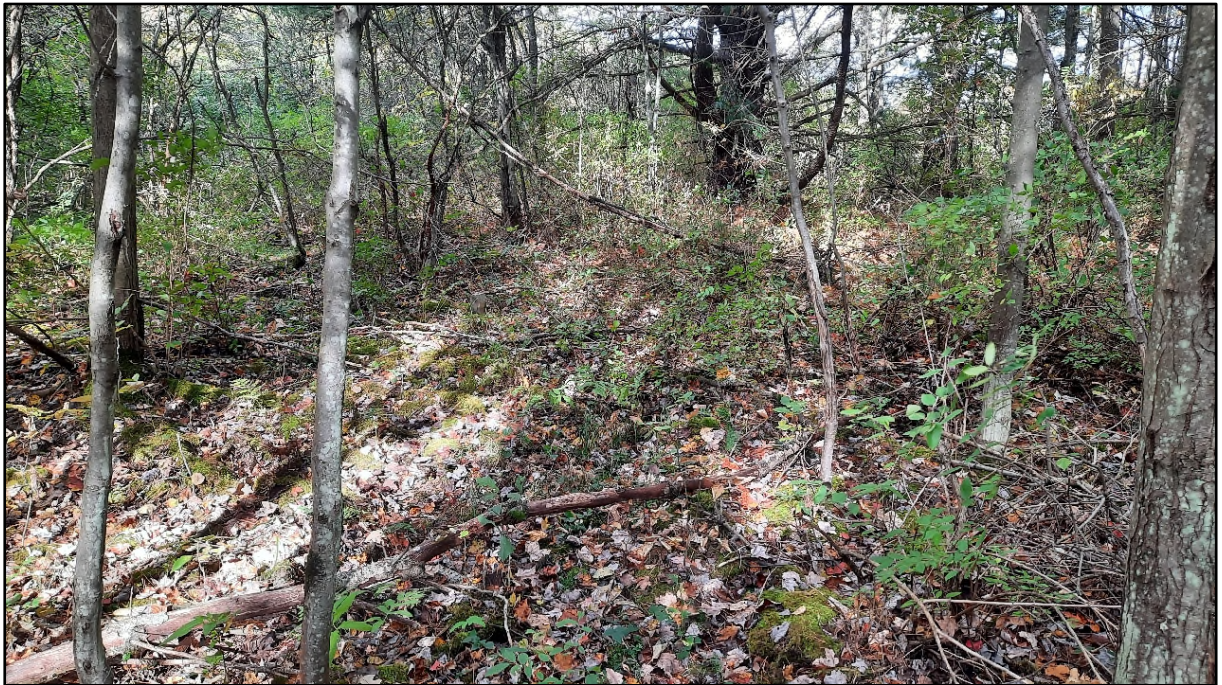
**Photo 9.** Photo facing north depicting wetland WB. This wetland area is a localized depression located to the east of stream S2, and is characterized by species such as sensitive fern (*Onoclea sensibilis*, FACW), New York fern (*Parathelypteris noveboracensis*, FAC) and shallow sedge (*Carex lurida*, OBL).

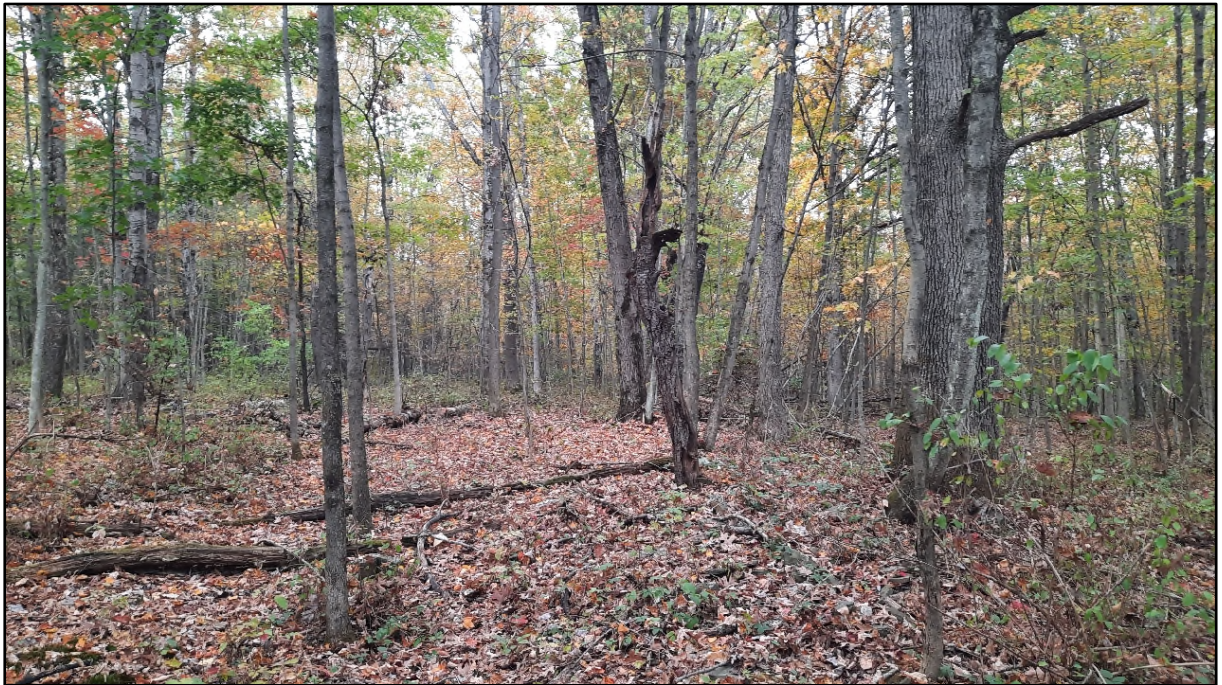
**Photo 10.** Photo facing north depicting the location where proposed site access/interconnection route turns north and typical uplands on the site.

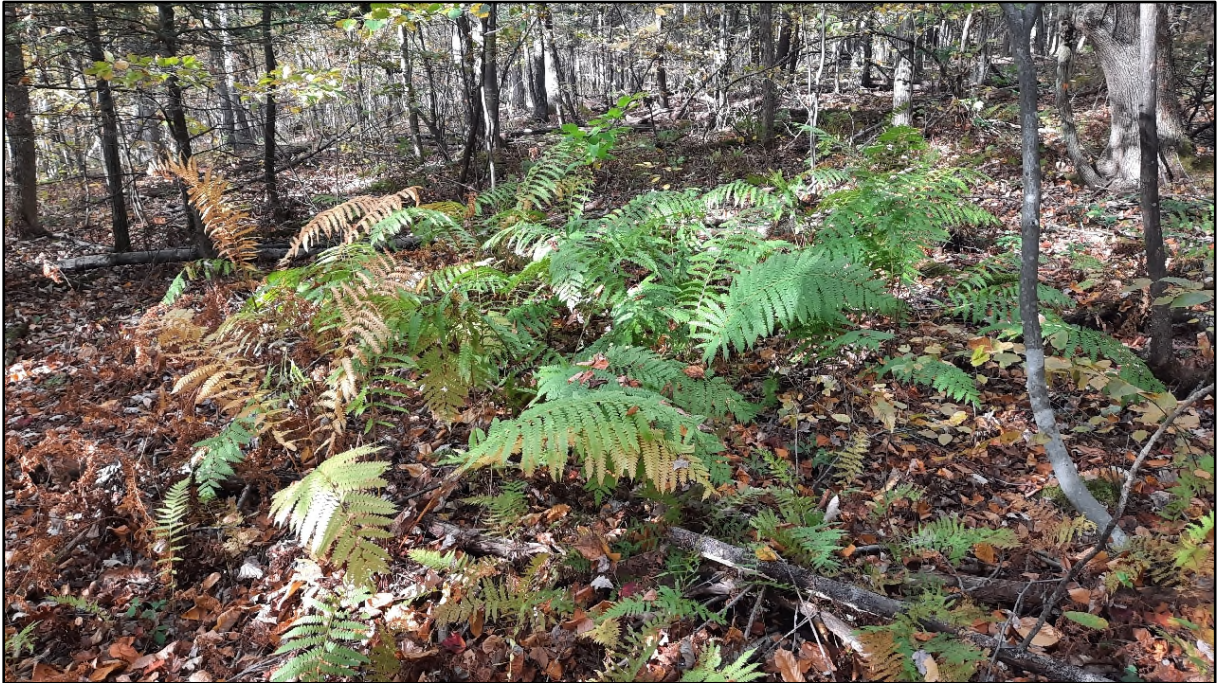
**Photo 13.** Photo facing west depicting wetland WC. This area of wetland WC contains a drainage corridor located on the hillside which drains into the larger WC wetland complex. This area of the site contains a high bedrock layer, at around 16 inches below the surface, which influences the hydrology and drainage patterns on the site.

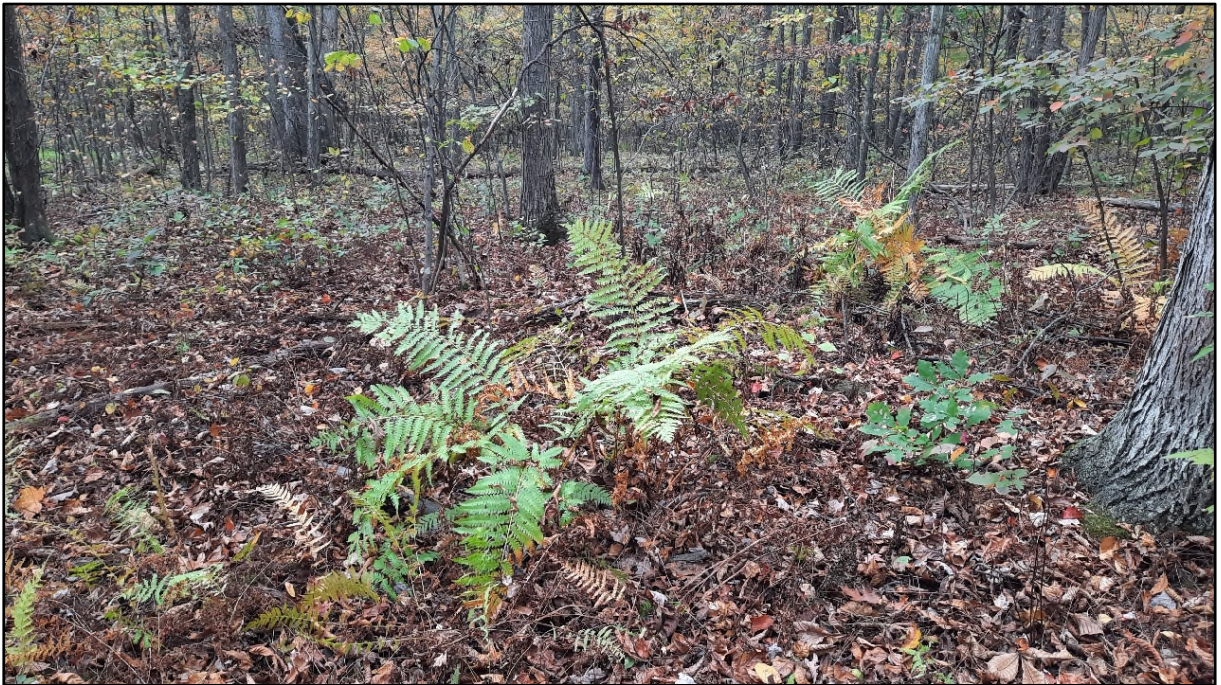
**Photo 14.** Photo facing west depicting a second hillside drainage corridor of wetland WC with characteristics similar to that of the drainage corridor depicted in photo 13. These areas of wetland WC are dominated by species including cinnamon fern (*Osmundastrum cinnamomeum*, FACW) and fowl manna grass (*Glyceria striata*, OBL).

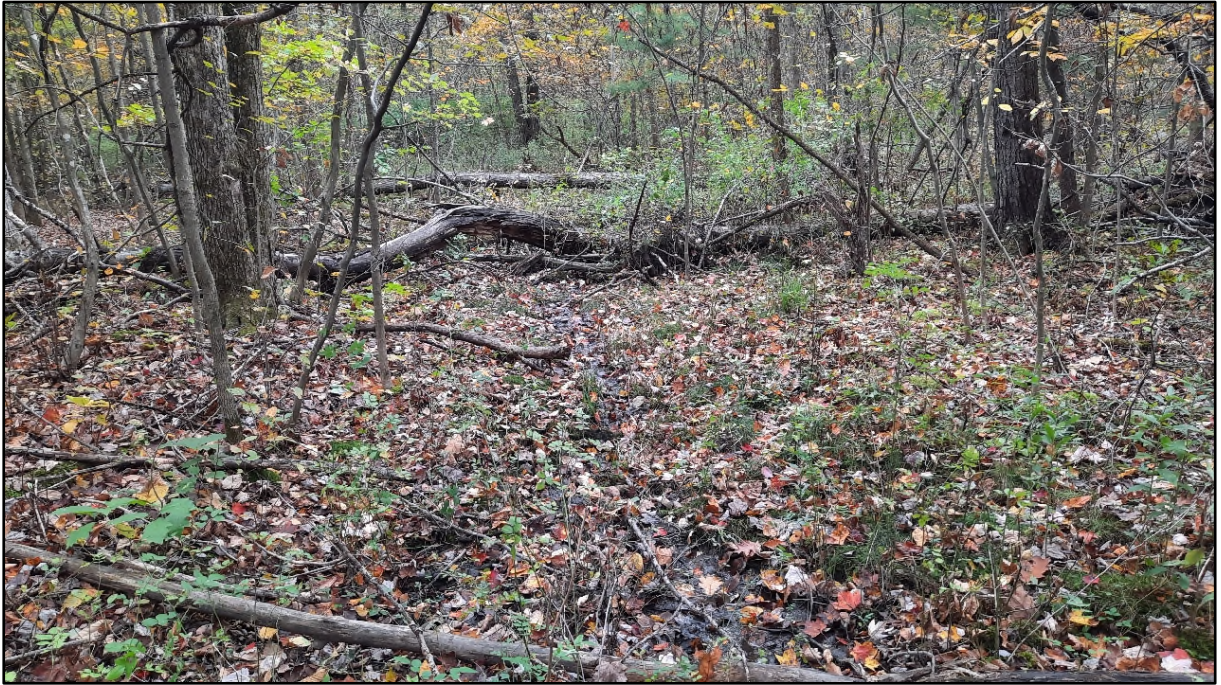
**Photo 15.** Photo facing west depicting a third hillside drainage corridor of wetland WC. This feature is more distinctly channelized than the drainage corridors depicting in photos 13 and 14.

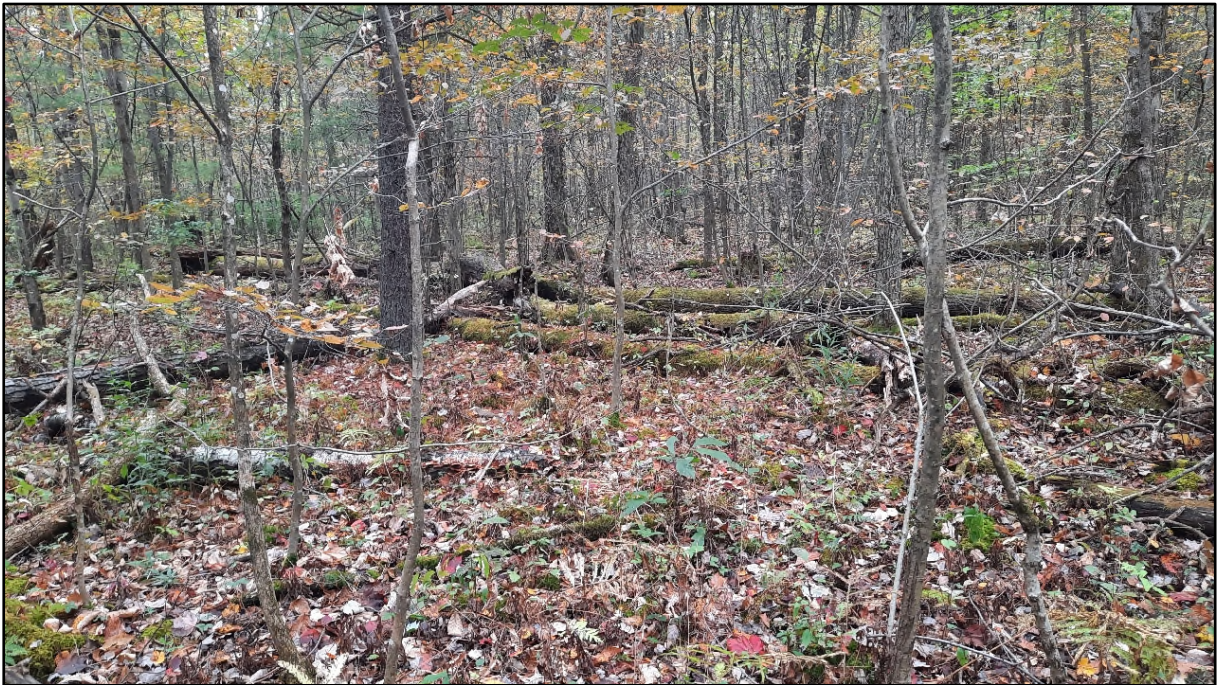
**Photo 16.** Photo facing southwest from the northern/central portion of the study area depicting the larger WC wetland complex from its eastern boundary. This wetland receives hydrologic input from the hillside located to the west and ultimately drains to the east where the slopes increase. This wetland contains little topography and is a generally flat area situated between areas of higher slopes.

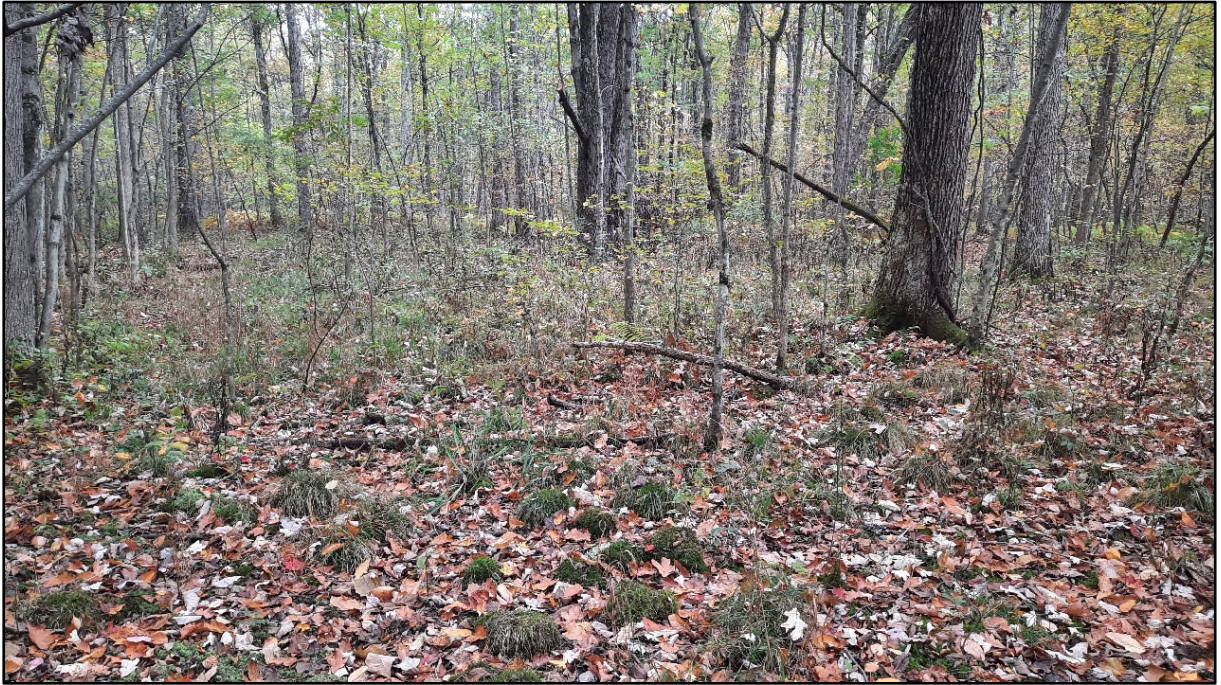
**Photo 17.** Photo facing northeast depicting wetland WC from is western boundary.

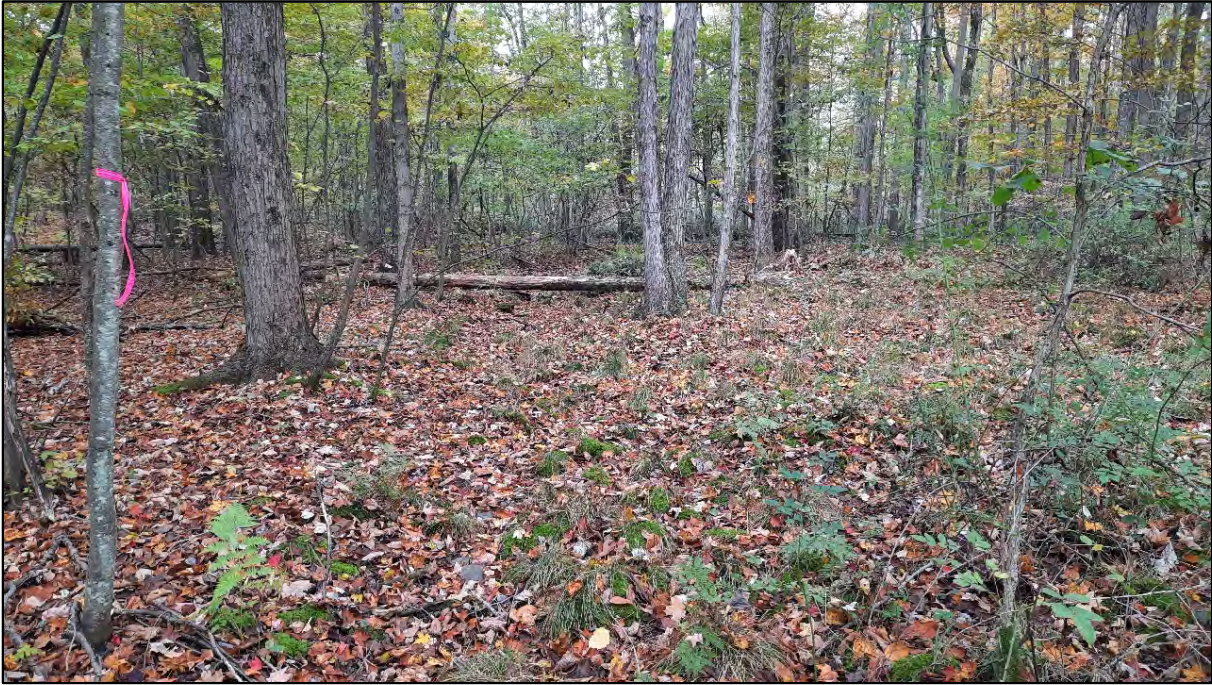
**Photo 19.** Photo facing west near the western limits of the study area depicting where topography increases and wetland WC becomes more channelized and drains to the west.

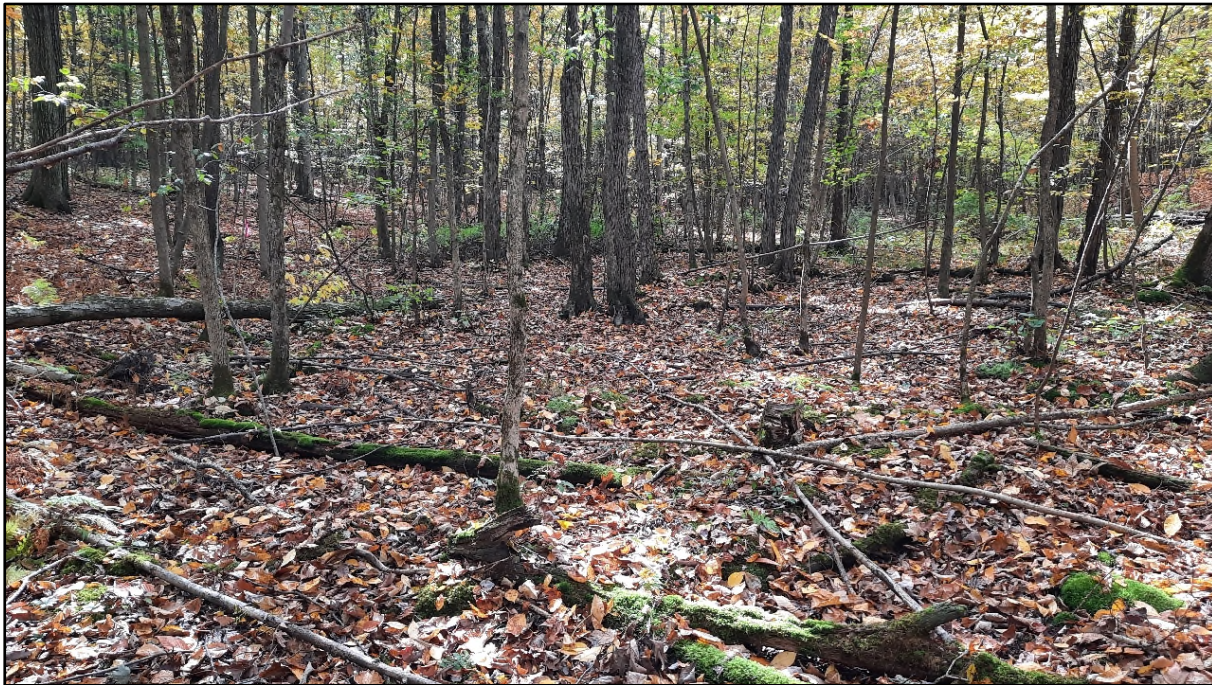
**Photo 20.** Photo facing south from the southwestern portion of the study area depicting the delineated isolated wetland WD. This wetland is a localized depression and is characterized by species including red maple (*Acer rubrum*, FAC), slippery elm (*Ulmus rubra*, FAC) and shallow sedge (*Carex lurida*, OBL).

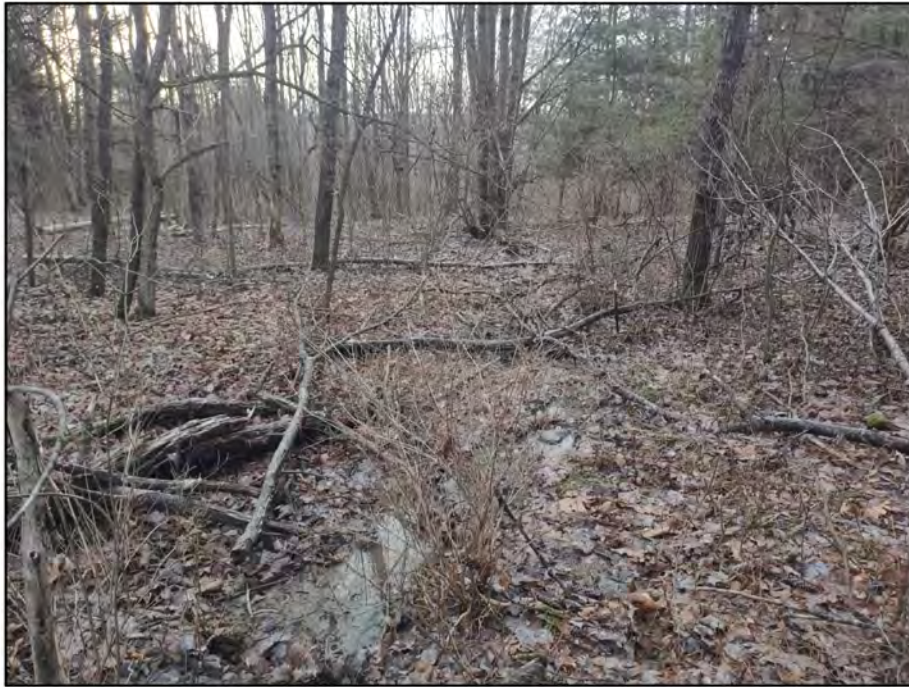
**Photo 01.** Photo from Flag S1-205 showing Stream 1, an ephemeral stream, facing south.

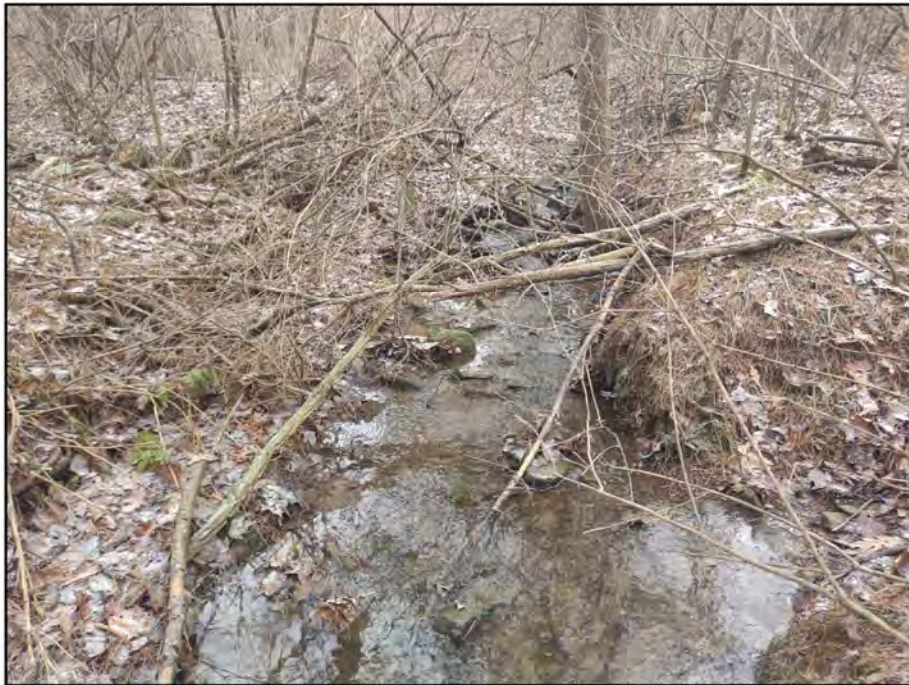
**Photo 02.** Photo from Flag S2-111 Open Start at the northern property edge facing upstream on Stream 2, a perennial stream, facing north.

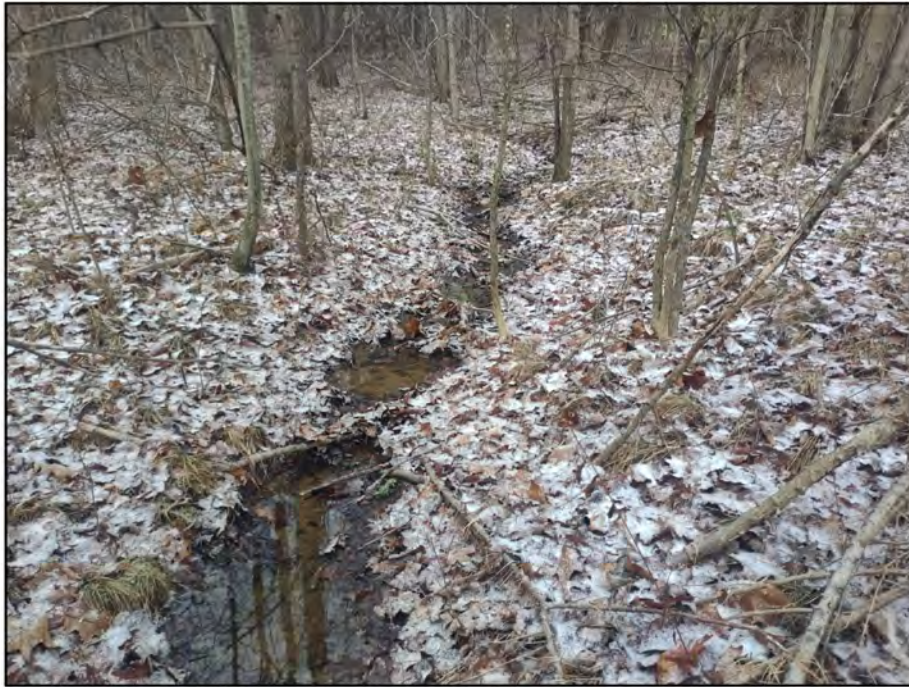
**Photo 05.** Photo from Flag S3-103 showing Stream 3, an intermittent channel that drains to Stream 2 offsite, facing west.

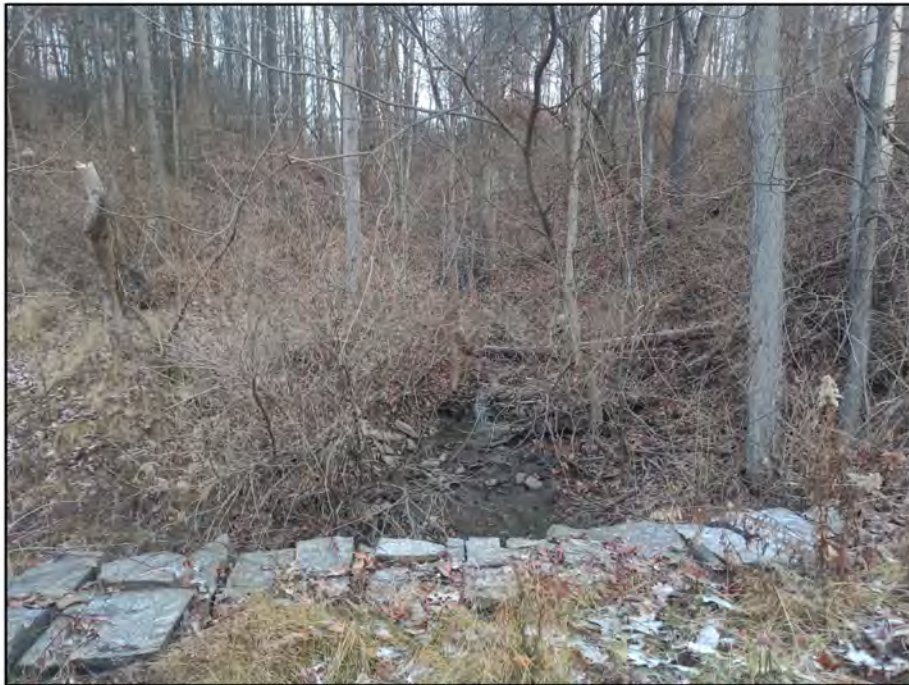
**Photo 04.** Photo showing the steep outfall of Stream 2 through a culvert outside of the delineation area, facing north.

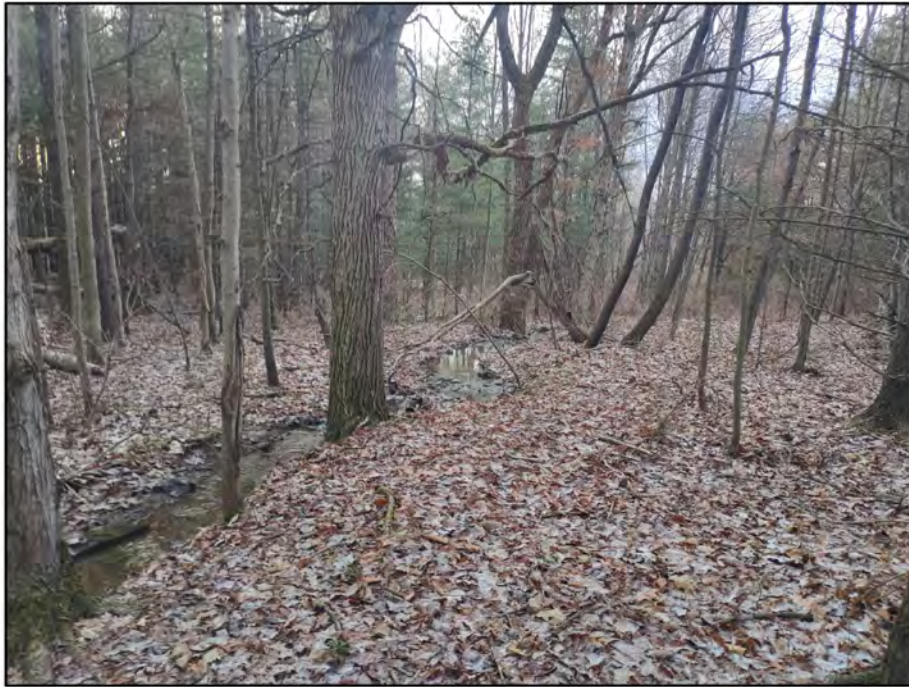
**Photo 03.** Photo showing the defined banks of Stream 2 through the forest as it flows south through the property, facing south.

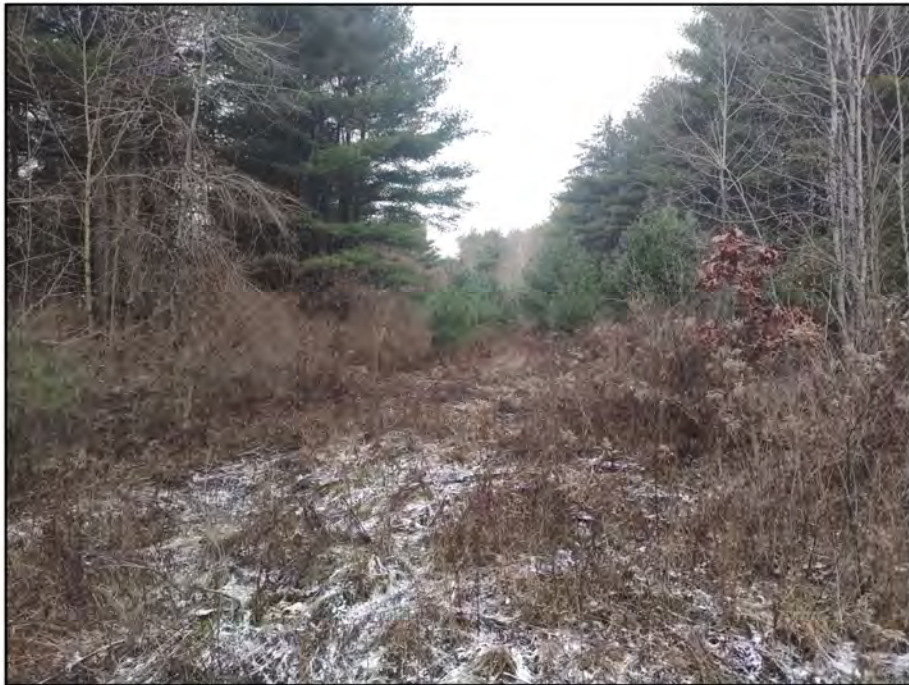
**Photo 06.** Photo from the access road that runs east-west through the rich mesophytic forest, facing west.
