**Veteran Hill Road Solar Project**  
**Town of Veteran, Chemung County, New York**

**Project Narrative**

**April 2026**

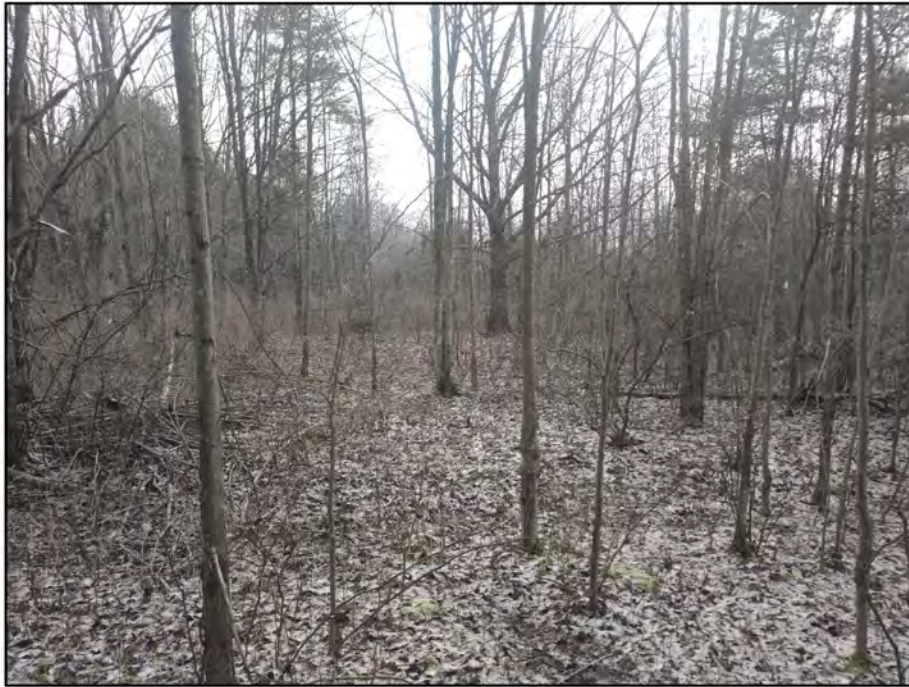
**Photo 07.** Photo showing an upland area of younger trees with larger Eastern white pine trees scattered throughout, facing west.

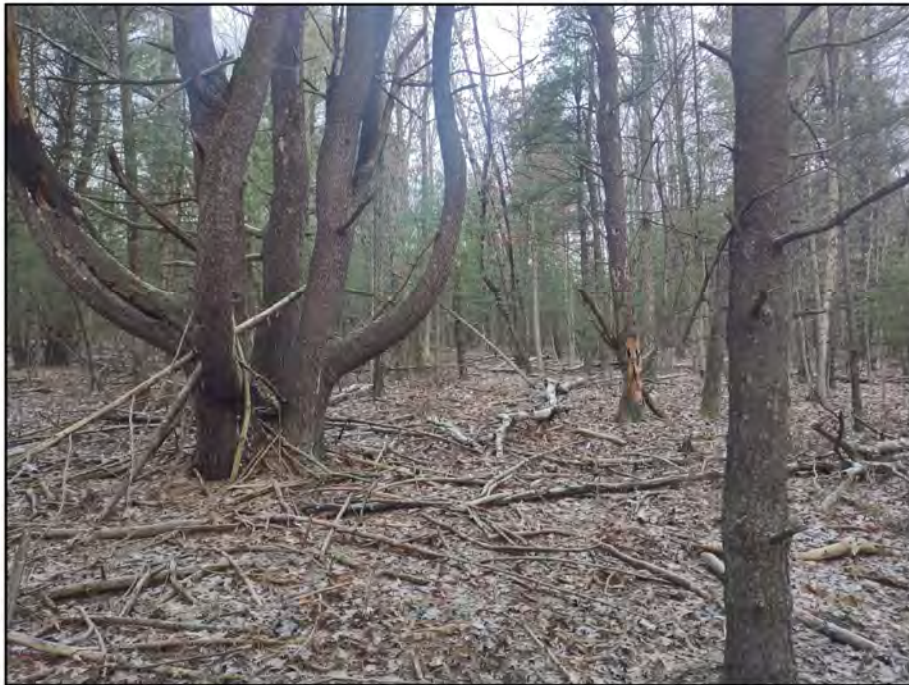
**Photo 08.** Photo showing an upland area dominated by Eastern white pine trees with a bare understory, facing northwest.

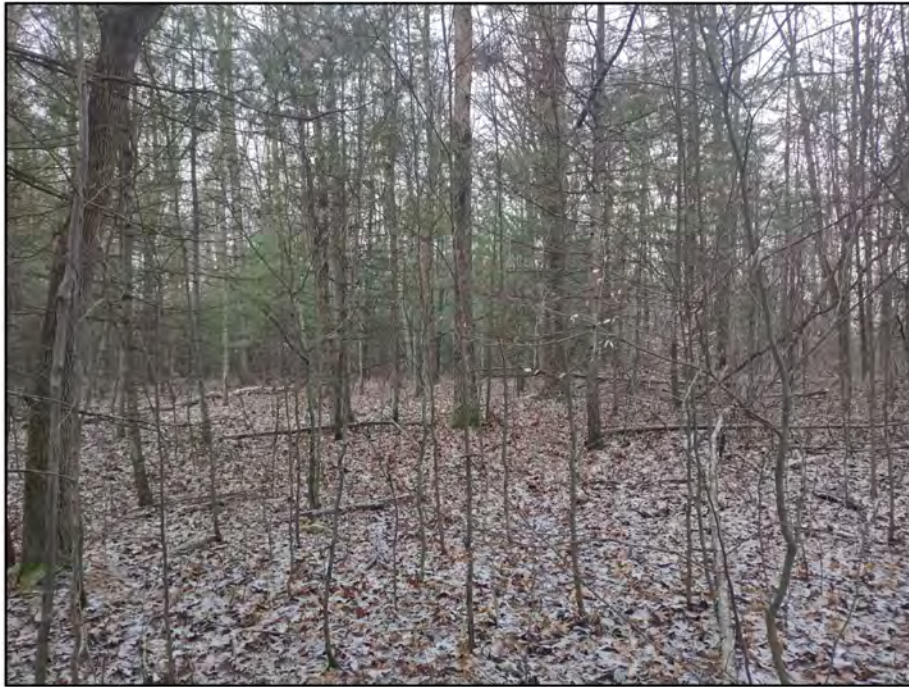
**Photo 09.** Photo showing an upland area of mixed pine and hardwoods, including American beech that was not present in the lower portions of the site, facing southwest.

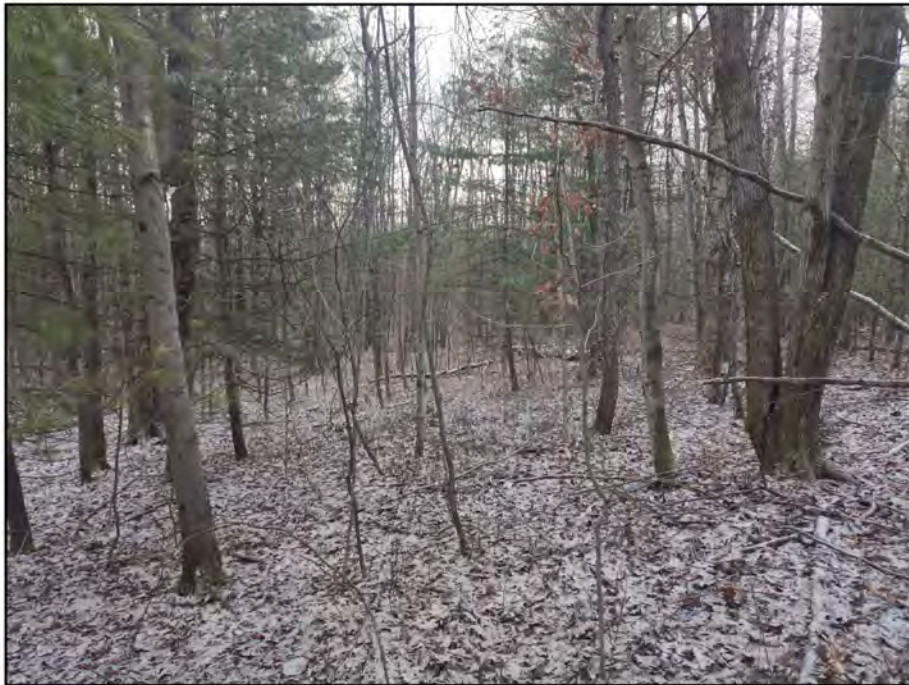
**Photo 10.** Photo showing an upland area through the rich mesophytic forest, where younger trees and saplings are more abundant, facing southeast.

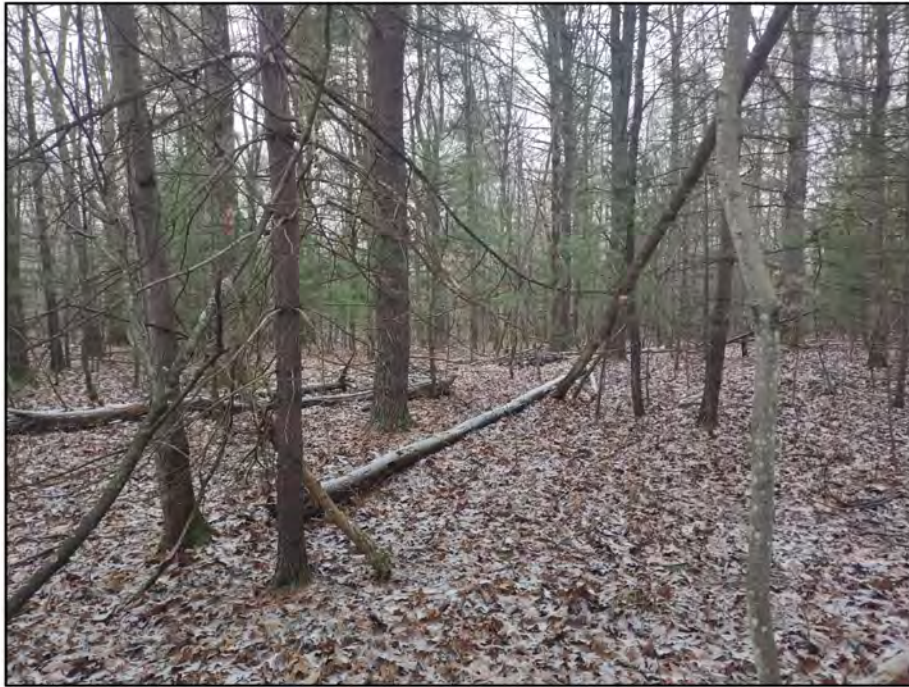
**Photo 11.** Photo showing an upland area through the rich mesophytic forest, where Eastern white pine saplings are more prevalent, facing west.

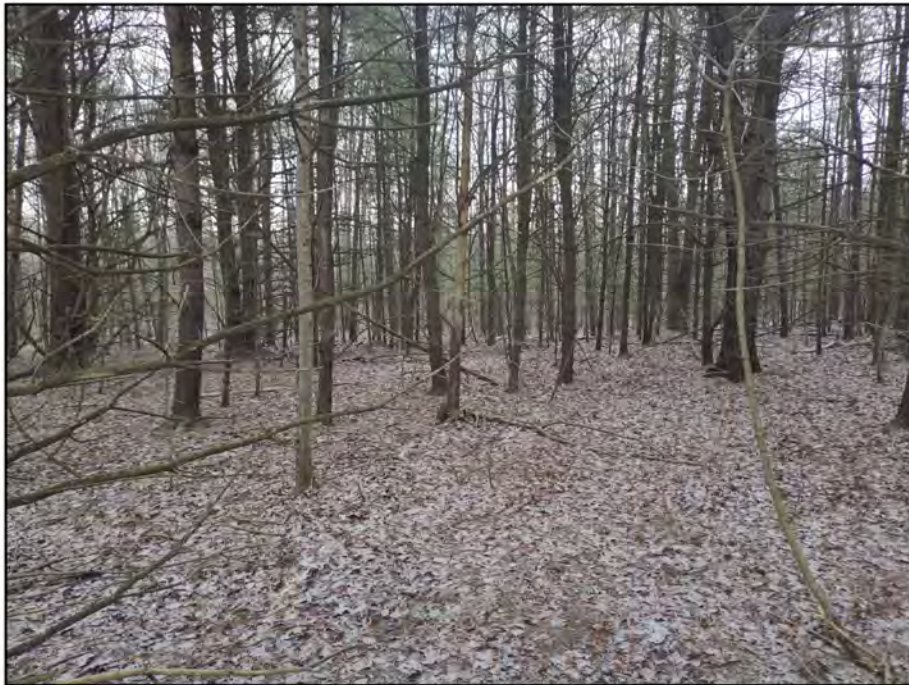
**Photo 12.** Photo showing an upland area through the rich mesophytic forest where pines are more dominant, facing southeast.

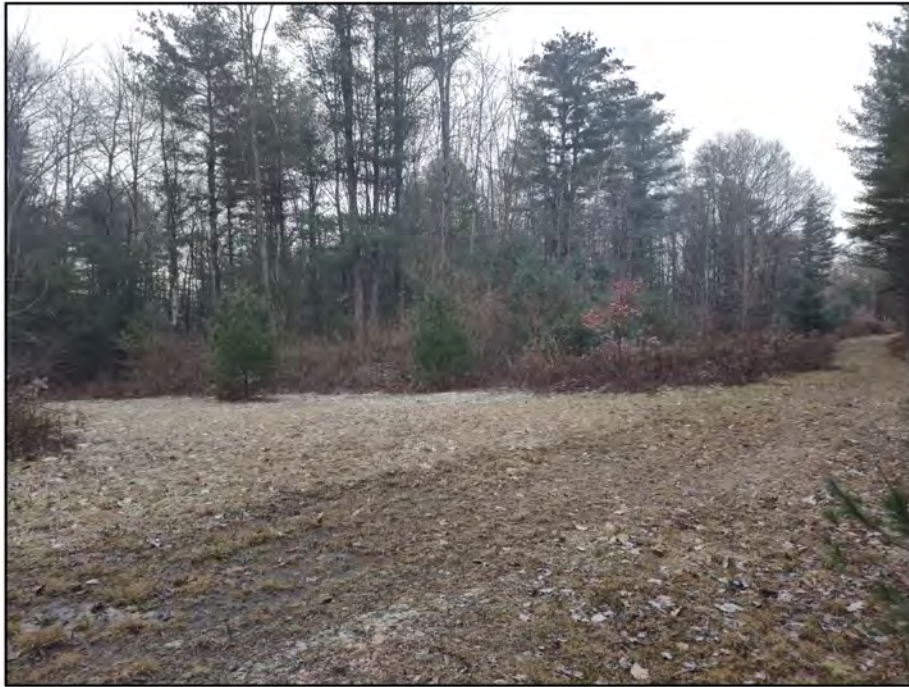
**Photo 13.** Photo showing the intersection of the north-south and east-west access road, facing southeast.

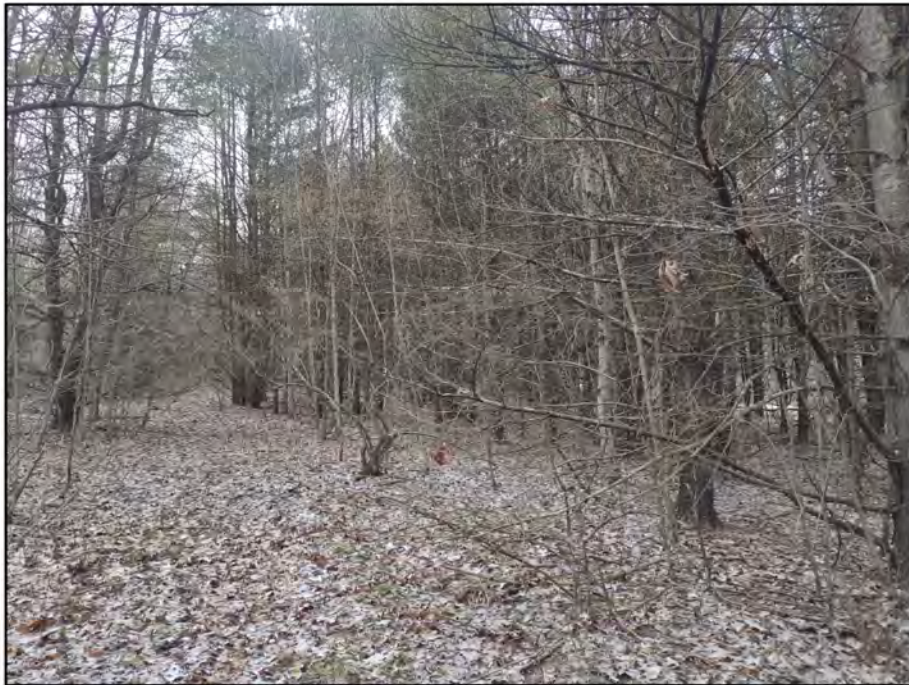
**Photo 14.** Photo showing a dense portion of Eastern white pines with the access road barely visible through their trunks in photo center-right, facing northeast.

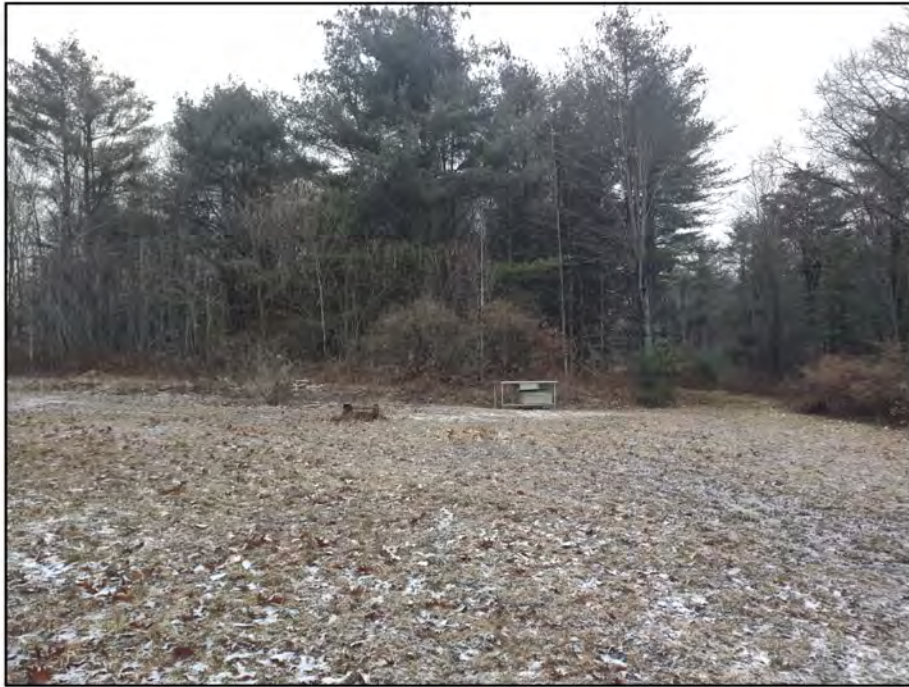
**Photo 15.** Photo showing the fork in the access road where the path on the right continues to the north-south access road, photo facing north.

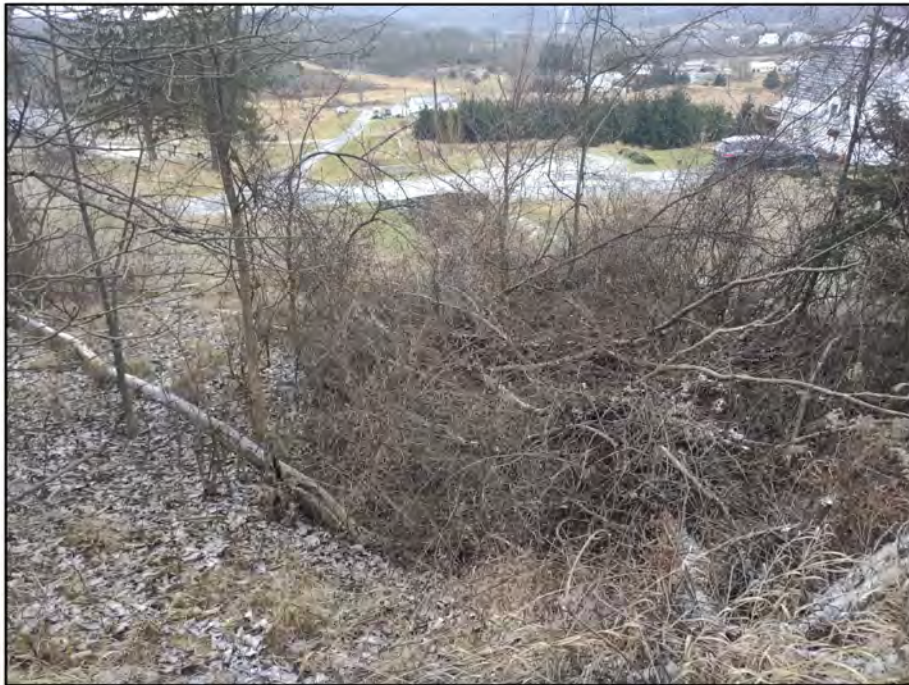
**Photo 16.** Photo showing the culvert outfall from Stream 2 as it drains under the road, showing the steep slope leading up to the property, facing south.
