## RECOMMENDATIONS FOR REPAIR AND CONSERVATION

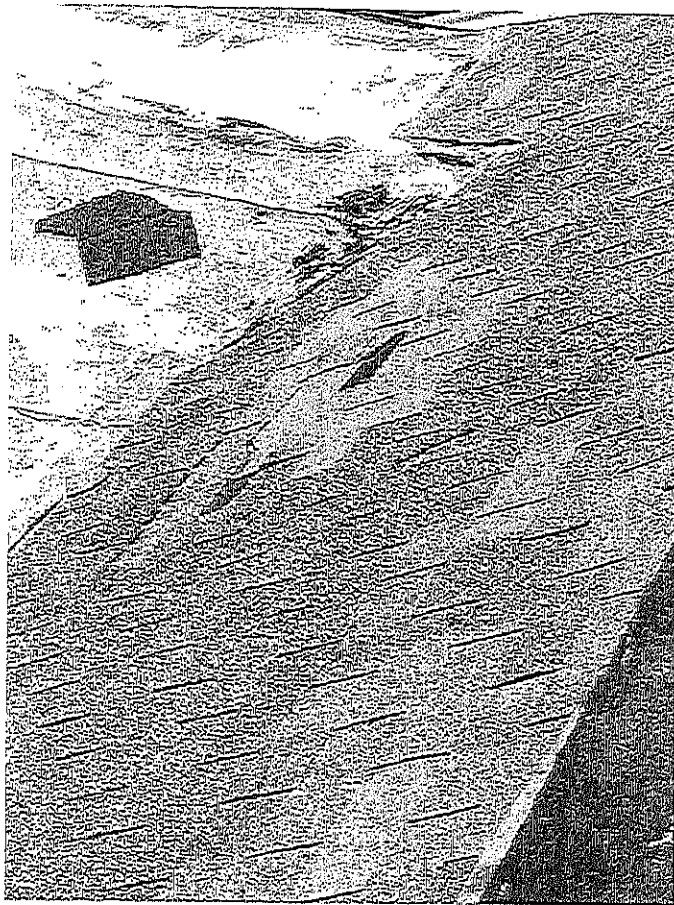
*Photo #12 - Deteriorated and poorly repaired roofing. Although the shingles were only installed in the late 1980s, many have pulled loose. Shingles used to patch openings do not match the surrounding shingles.*

- Remove all existing asphalt shingles, roof coatings and flashings down to sheathing. Replace deteriorated sheathing.
- Install new historically appropriate roofing and flashing materials.
- Replace damaged built-in copper gutters.
- Rebuild gutter outlets and provide new leaders connected to the underground drainage system.
- Clean chimney masonry of dirt and graffiti.
- Reset loose chimney bricks and replace deteriorated mortar joints.
- Replace deteriorated concrete chimney hoods.
- Replace existing copper dormer cladding with new copper to match the original condition.
- Install a new balustrade along the edges of the flat roof to match its original appearance.
- Remove exterior door and walkway to east fire escape and rebuild roof to eliminate door opening.
- Remove the brick parapet wall and return the southeast section of the roof to its original configuration.

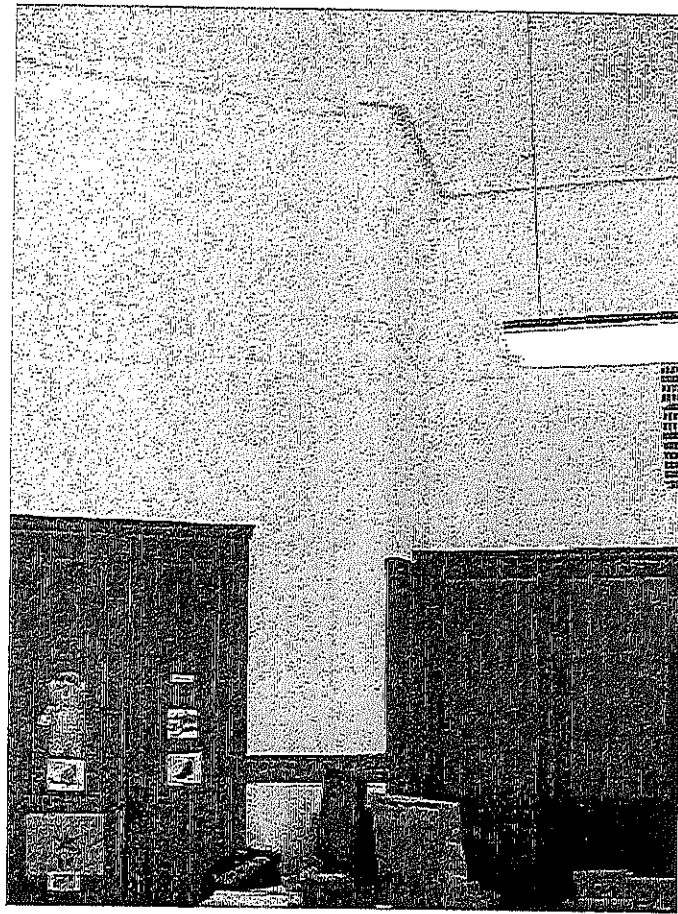
*Photo #18 - Active water infiltration has damaged plaster walls in Room 108. Note the incompatible modern suspended fluorescent light fixture.*

- ❑ Remove modern vinyl tiles and carpeting to expose original wood floor. Repair damaged wood flooring and restore finish to original appearance.
- ❑ Correct sources of water infiltration and plaster damage in Rooms 104A, 108 and Auditorium 114. Replace or repair damaged wall and ceiling plaster.

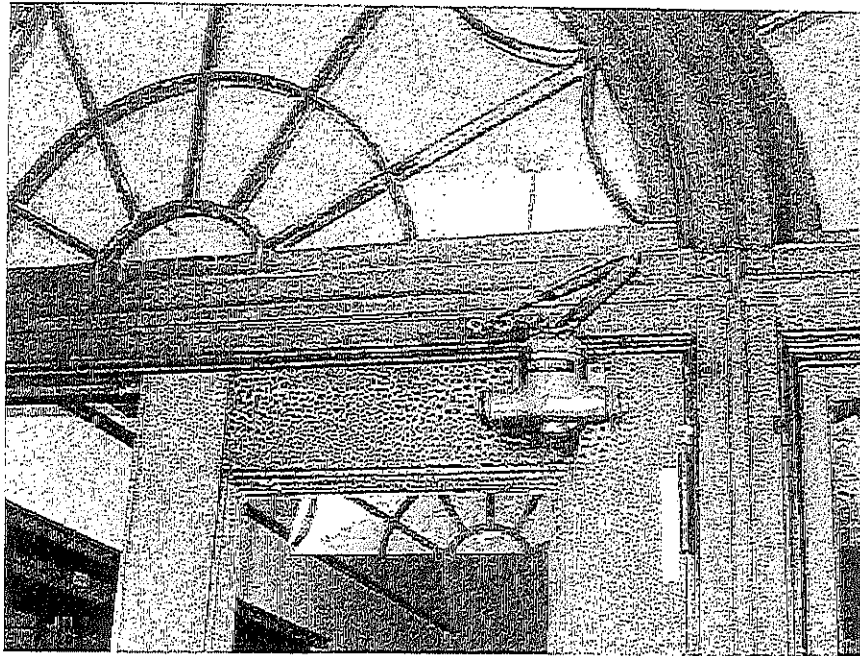
*Photo #20 - Varnish finish on woodwork in Entry Vestibule 101A is severely alligatored. Glazing compound on the fan light is also deteriorated.*

- ❑ Replace obtrusive and historically inappropriate lighting fixtures, receptacles and surface wiring.
- ❑ In Entrance Vestibules 101A and 103, repair damaged doors, hardware and trim. Strip deteriorated varnish from woodwork and refinish. Repair damaged mosaic floor tiles. Replace deteriorated glazing compound on transom windows.

- ❑ Refinish deteriorated clear finishes on woodwork, especially window trim and all varnish coatings that have alligatored.
- ❑ Replace inappropriate wood floor patching in Auditorium 114 with dutchman repairs.

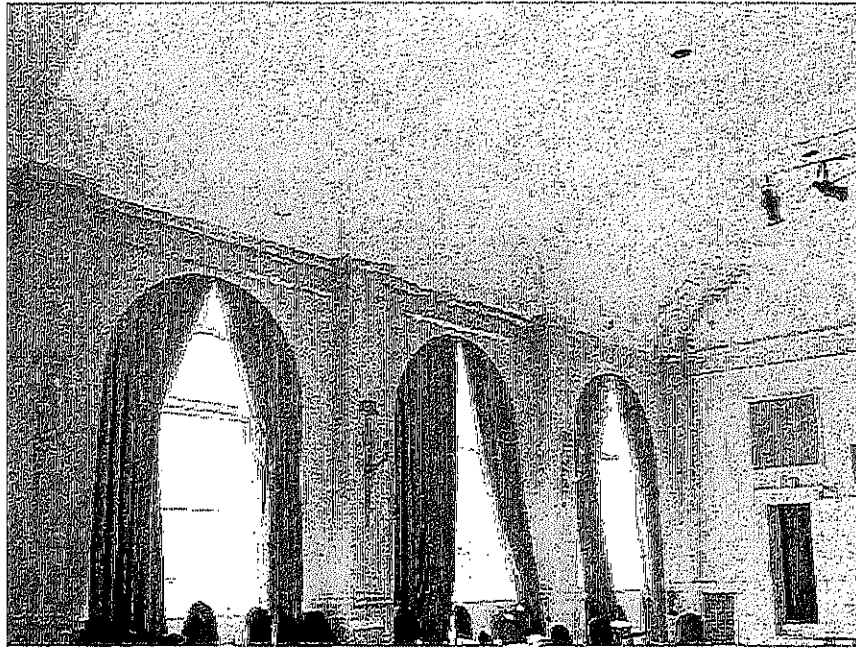
*Photo #22 - Water infiltration has damaged wall and ceiling plaster in Auditorium 114. Water appears to have migrated along the painted plaster cornice in the room, damaging the cornice and severely damaging window curtains.*

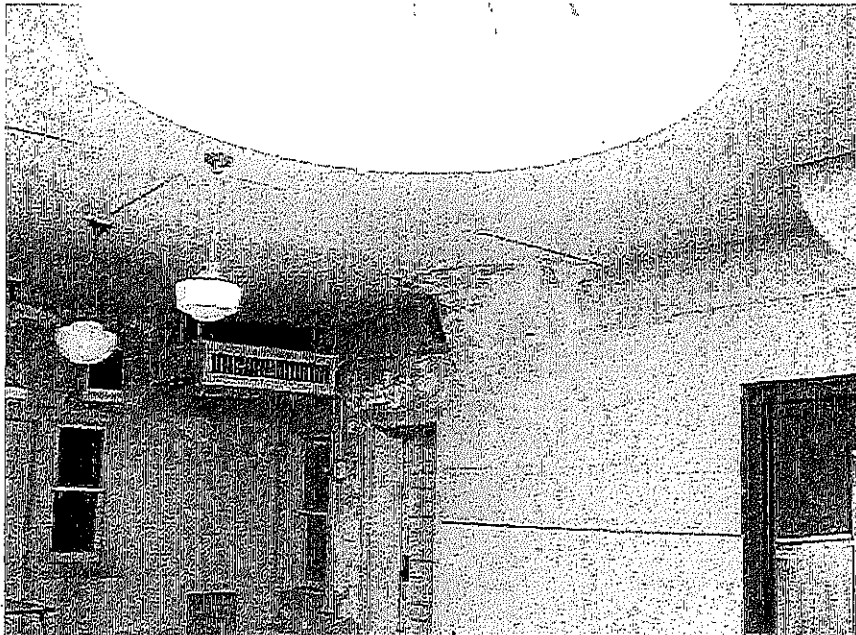
*Photo #23 - Water damaged paint and plaster resulting from deteriorated roofing in Room 301. The mechanical equipment is incompatible with the historic character of the space and is inappropriately located. Many original suspended milk-glass shaded light fixtures remain on the third floor.*

- ❑ Replace deteriorated plaster with new plaster.
- ❑ Remove deteriorated paint, prepare, prime and paint plaster and wood surfaces to match historic appearance.
- ❑ Restore windows to weather tight condition.
- ❑ Repair plaster ceiling and wall cracks.
- ❑ Patch holes in plaster.
- ❑ Repair and refinish floors to match historic appearance.
- ❑ Repair scratches on wainscot and refinish to match the original appearance.
- ❑ Remove paint from historically stained woodwork.
- ❑ Install historically appropriate light fixtures in all rooms.
- ❑ Remove VAT flooring in Room 308.
- ❑ Remove vertical piping in Room 308 and patch wood floors.
